Recording of buildings along
Wolfe Tone Street and Vicar Street,
Kilkenny
for the
Kilkenny Central Access Scheme

Rob Goodbody
Historic Building Consultant
March 2013

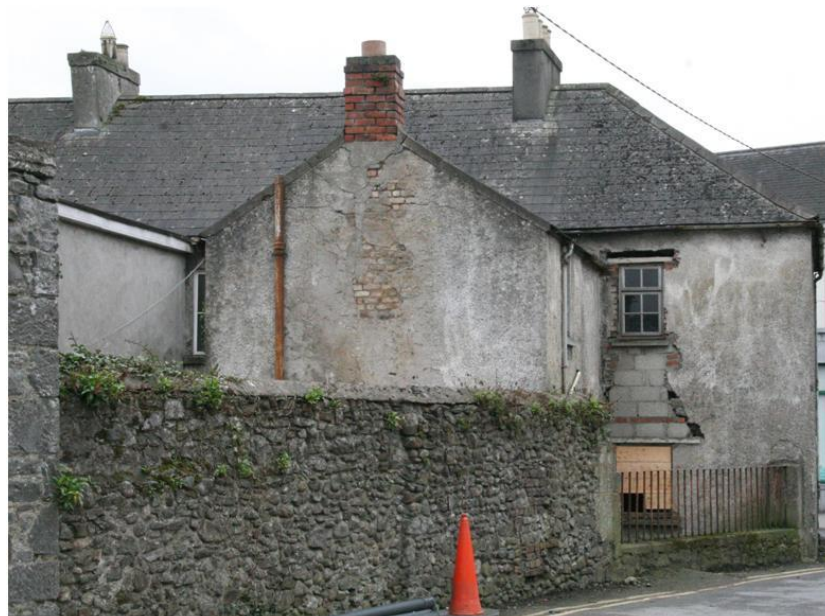
Plate 15: Rear elevation of 20 Vicar Street

The side elevation of number 20 Vicar Street is pebble-dashed with no opes. The hipped roof terminates at eaves with uPVC guttering. The rear elevation on the northern side of the return is roughcast rendered and has a window ope on each floor, located close to the wall of the return. The lower window is boarded up externally at ground floor level and has a casement window on the upper floor. The area between the windows has been broken open and filled with concrete blocks, though not finished. The lintel over the upper floor window is concrete and has been inserted without the ope around it backfilled. The return is roughcast rendered and has a two-over-two timber sash window on the upper floor level and no windows at the lower level.

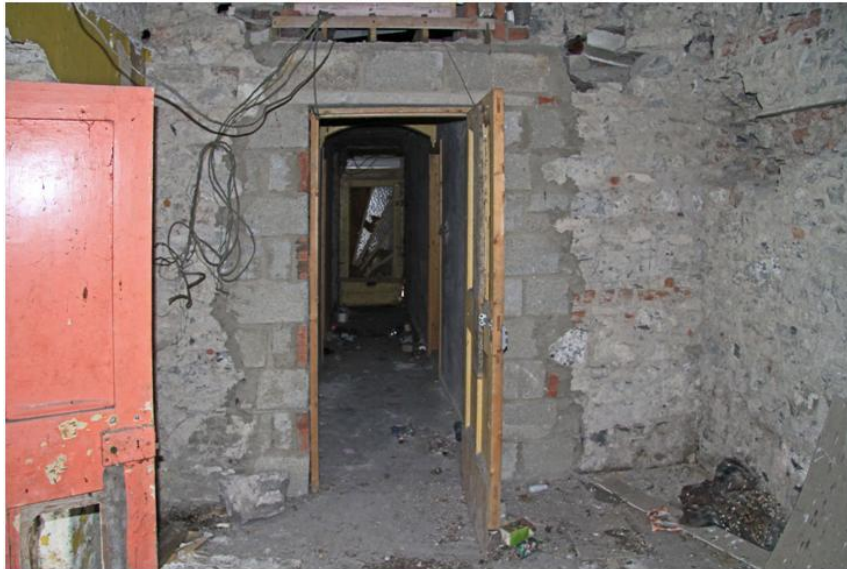
Plate 31: Doorway to return, with view to front door beyond

The return at the rear of 20 Vicar Street has been stripped, with the ceiling and floor above missing and the plaster taken off the walls. The doorway from the main house is in the centre of one wall and has been modified, with an area of concrete blocks and bricks around, and a concrete lintel over the door.

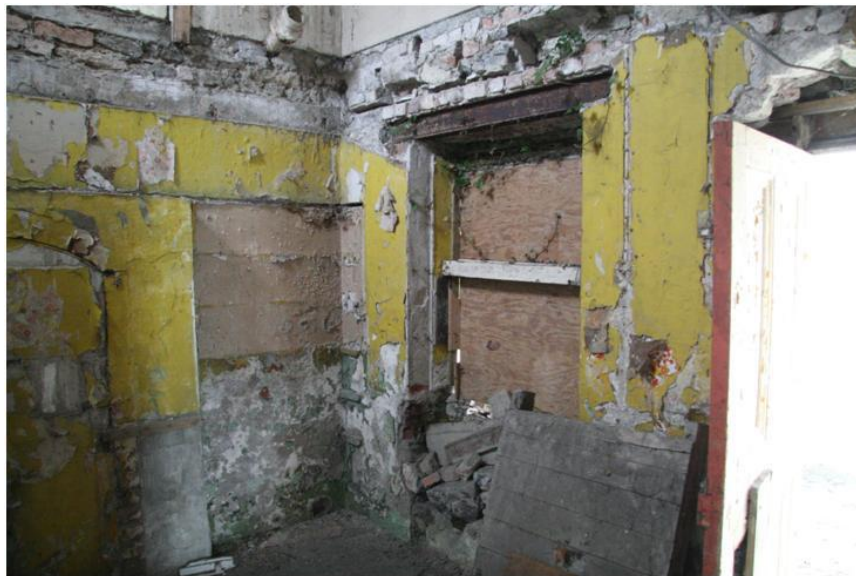
Plate 34: Window to side of return

The window lighting the return is in the same external wall as the door. This has a steel I-beam serving as a lintel on the inner face, with timber adjacent. The window is missing and the wall beneath the window ope has partially collapsed.

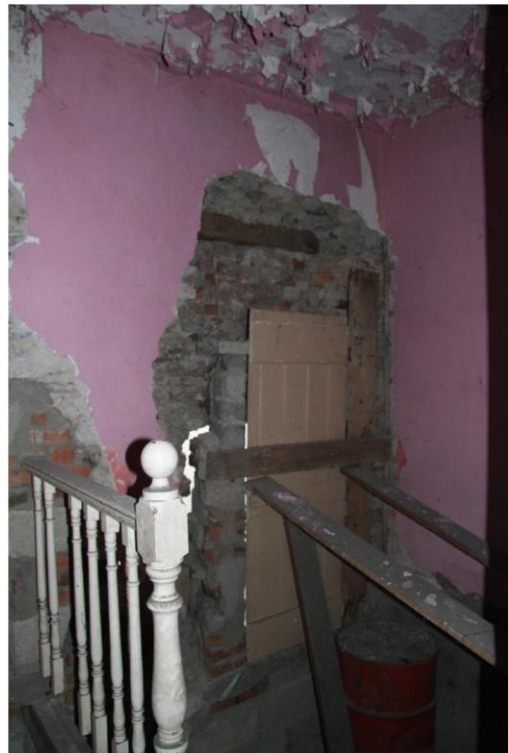
Plate 36: Ope in rear wall at staircase

The rear wall of the house adjacent to the staircase has been altered, with the creation of a new ope in place of the original. The view of the exterior of this ope suggests that the window head has not been altered, through there is a timber lintel at a higher level than the present window head, visible in the adjacent photograph. Below the window the rear wall of the house has been rebuilt in concrete blocks, as described above in considering the exterior, and as seen in plate 15 above.

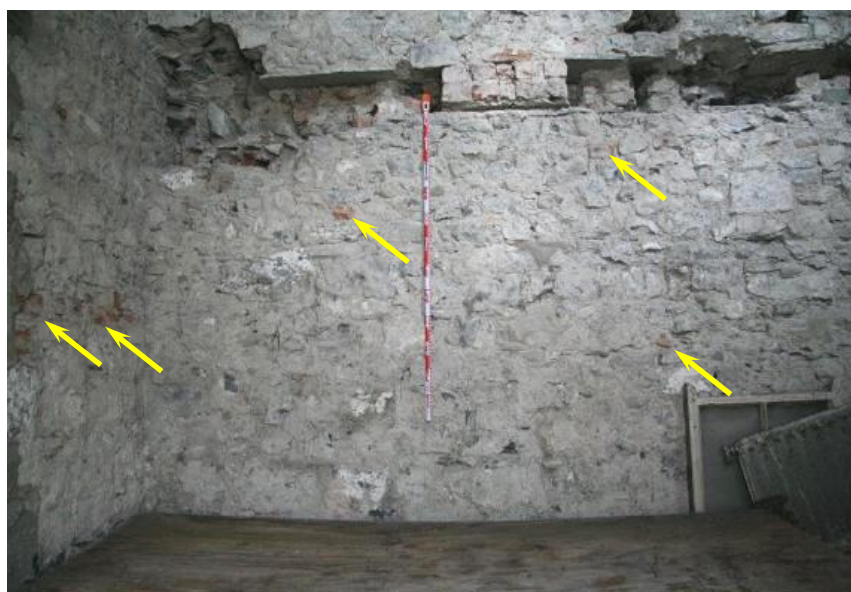
The investigation of the interior of this house began with the return, which has been stripped of plaster and the intermediate floor, leaving the masonry open and readily examined. Some of the plaster still clung to the walls, but enough was visible to ensure that the masonry could be examined without removing further cover of plaster. Here it was found that the stone walls had significant amounts of brick fragments. At the level of the intermediate floor a great deal of brick was used to facilitate regular spacing and firm anchoring of the floor joists.

*Plate 54: Interior of northern wall of return of number 20 Vicar Street.
Fragments of brick in the walls are indicated with arrows*

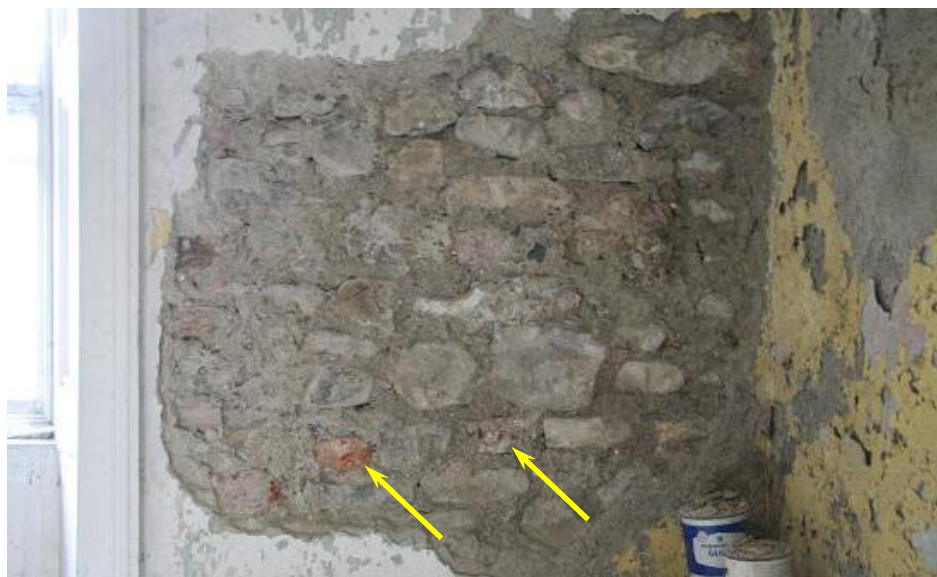
Plate 55: Interior of front wall of number 20 at northern corner

In view of the identification of brick in the rear wall, found in the investigation of the return, no opening up was done in the rear of the upper floor. Plaster was removed from walls in four locations, one at either end of the front façade, near the corners of the building and one on each side wall.

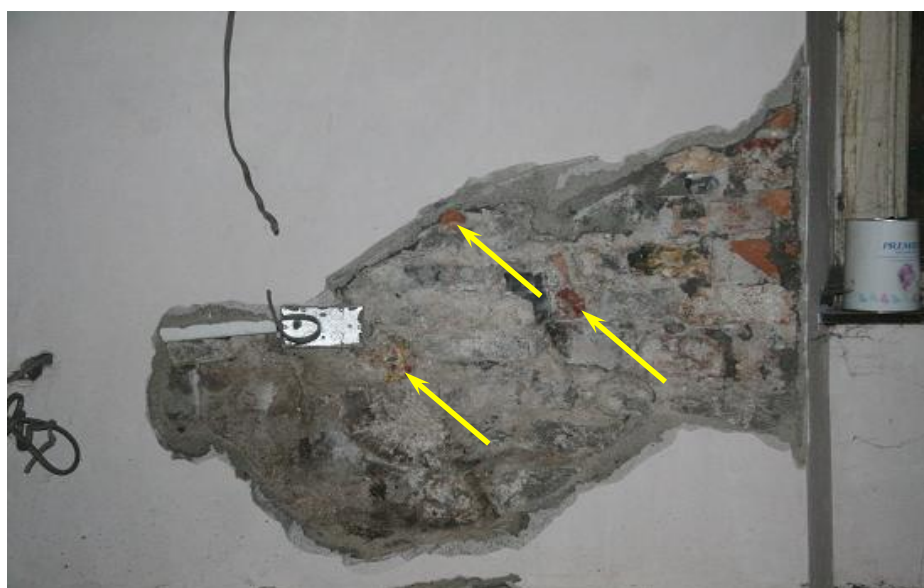
Plate 59: Opening in front wall at ground floor of number 20

The first opening was made on the inside of the front wall to the left of the window in the larger front room. This ope was commenced at the window so as to establish the extent of the brick lining to the window ope, if any.

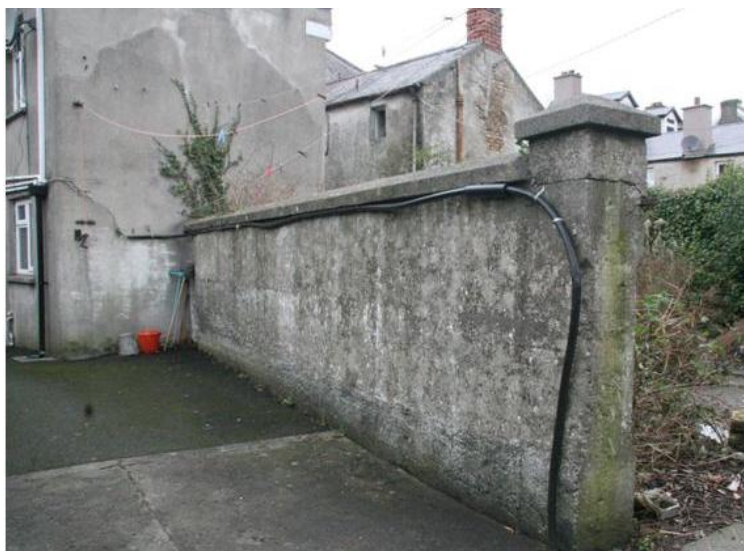
Plate 122: Northern boundary wall

The boundary wall between numbers 20 and 21 Vicar Street is of mass concrete, with a concrete capping. This terminates at a mass concrete pier that is slightly thicker than the wall. It is noted that the Ordnance Survey map of 1900, reproduced in Figure 14 above, shows that there was no boundary wall at that time.
