CARRIG
BUILDING FABRIC CONSULTANTS

ISSUED FOR: **Butler Gallery**
PROJECT NO: **Condition Drawing**
DRAWING NO: **Right Elevation (South Wing)**

DATE: **24-06-10** (JTB) (PC)
SCALE: **1:10**
JOB NO: **09054** (C-06)

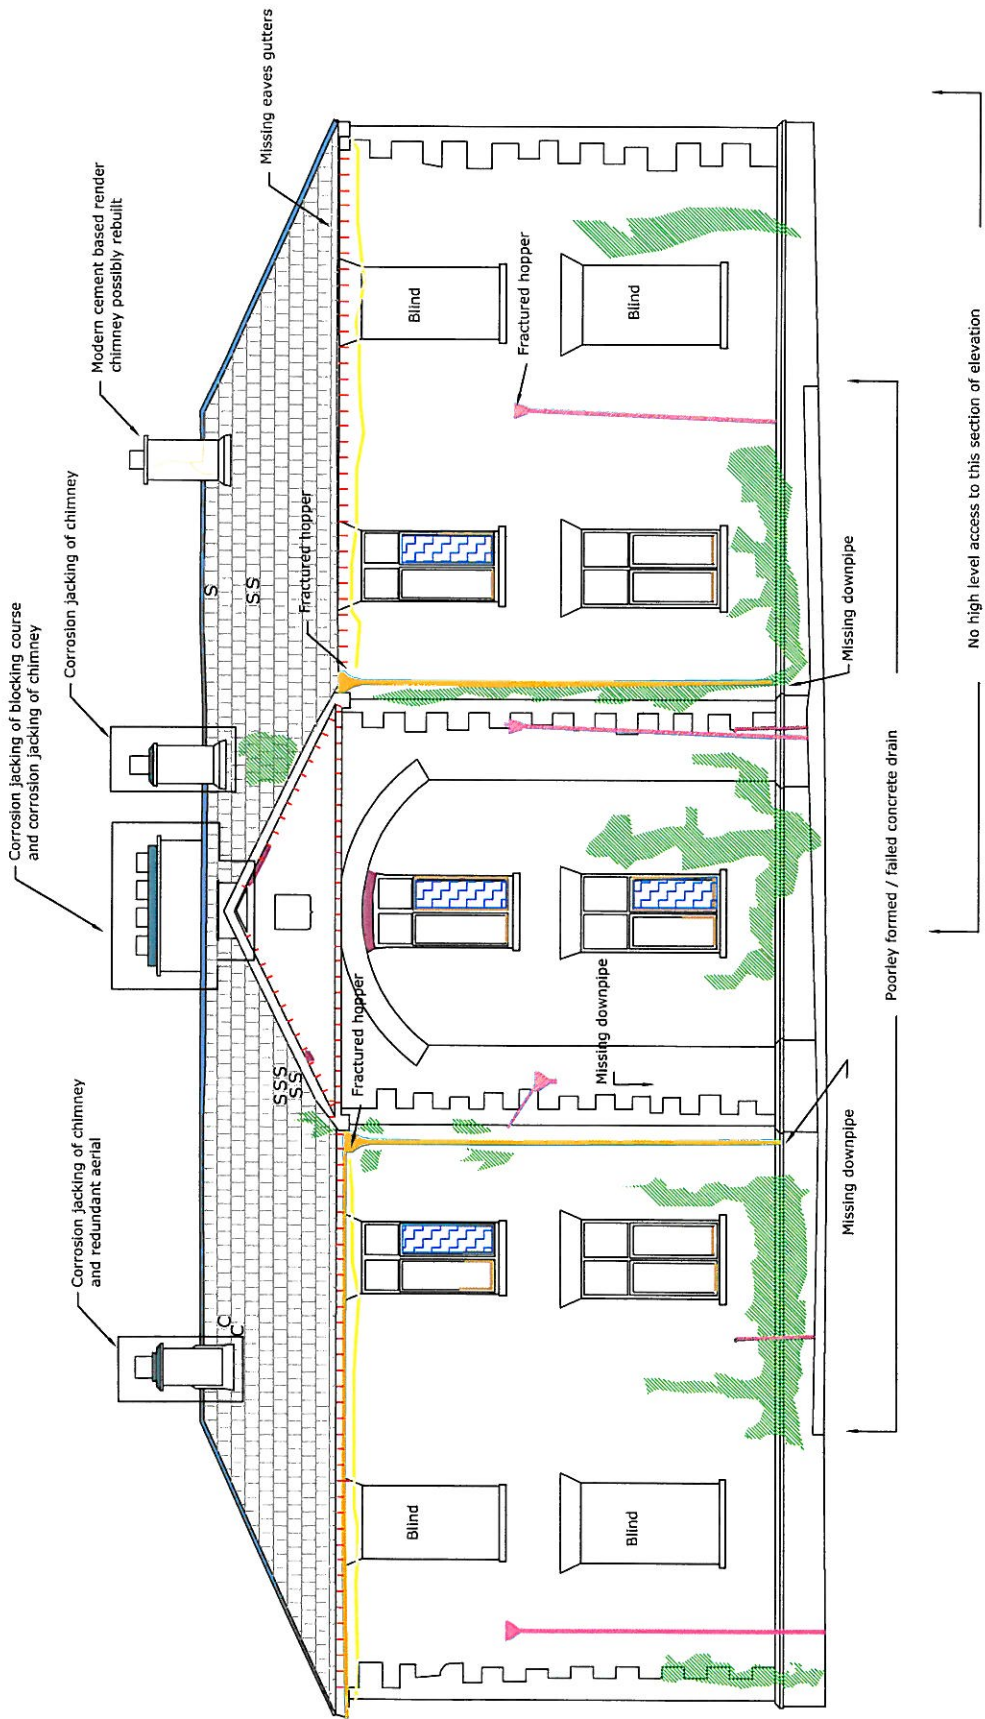
SOUTH ELEVATION (South Wing)

Note:
Cement based strap pointing to this elevation

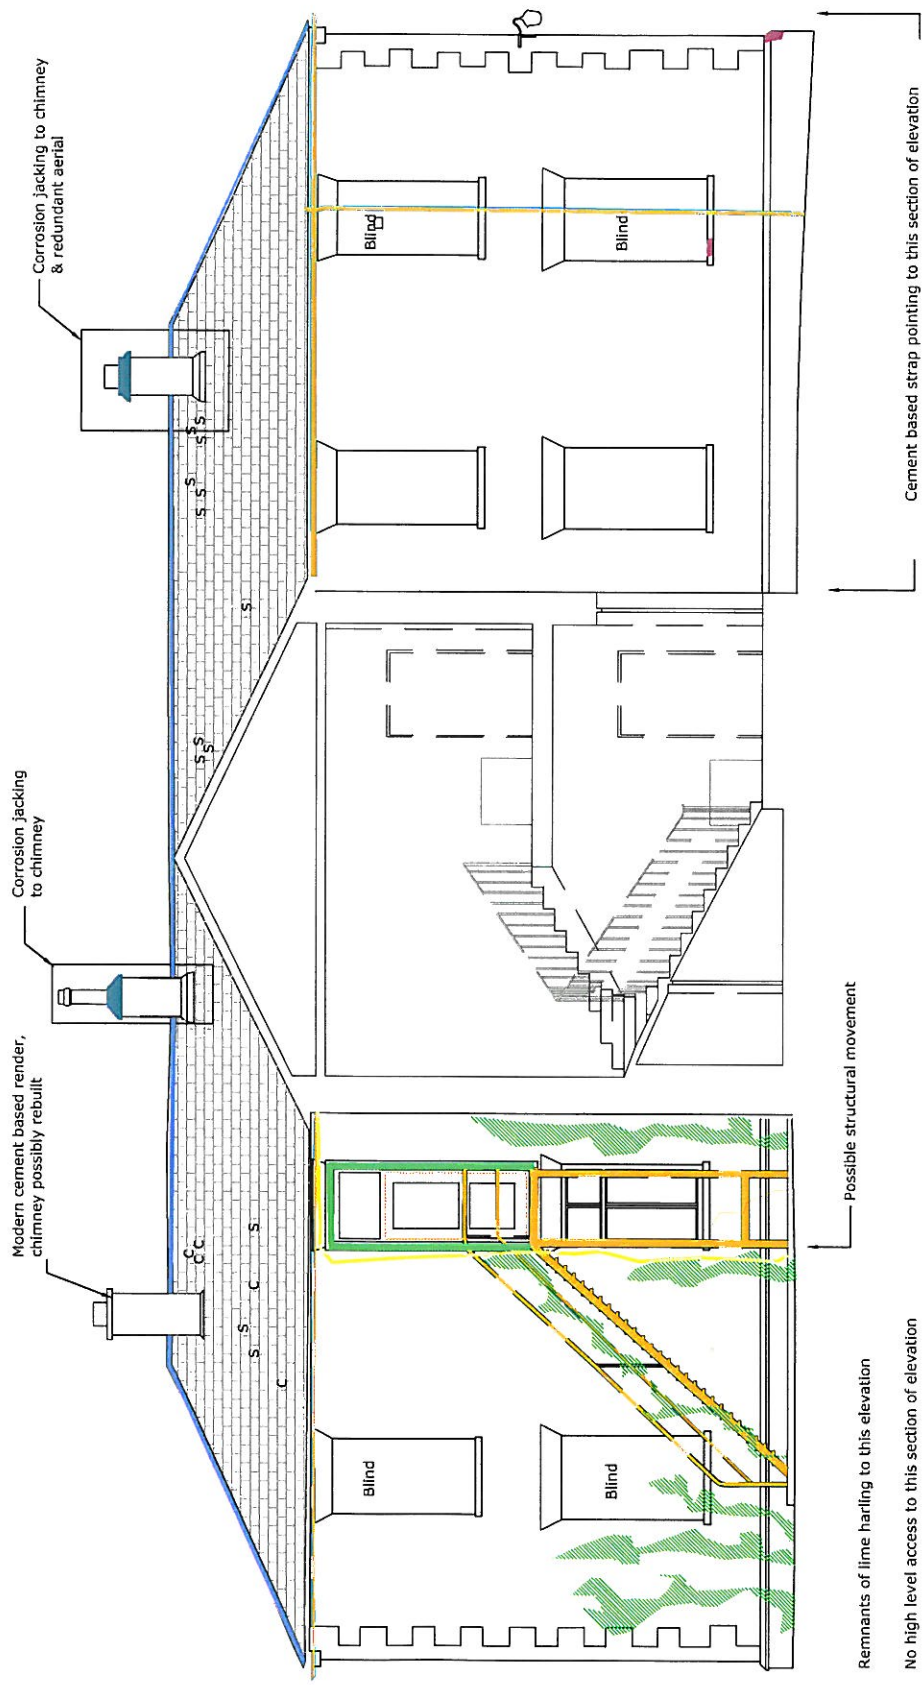
NORTH ELEVATION (South Wing)

Remnants of lime harling to this elevation
No high level access to this section of elevation

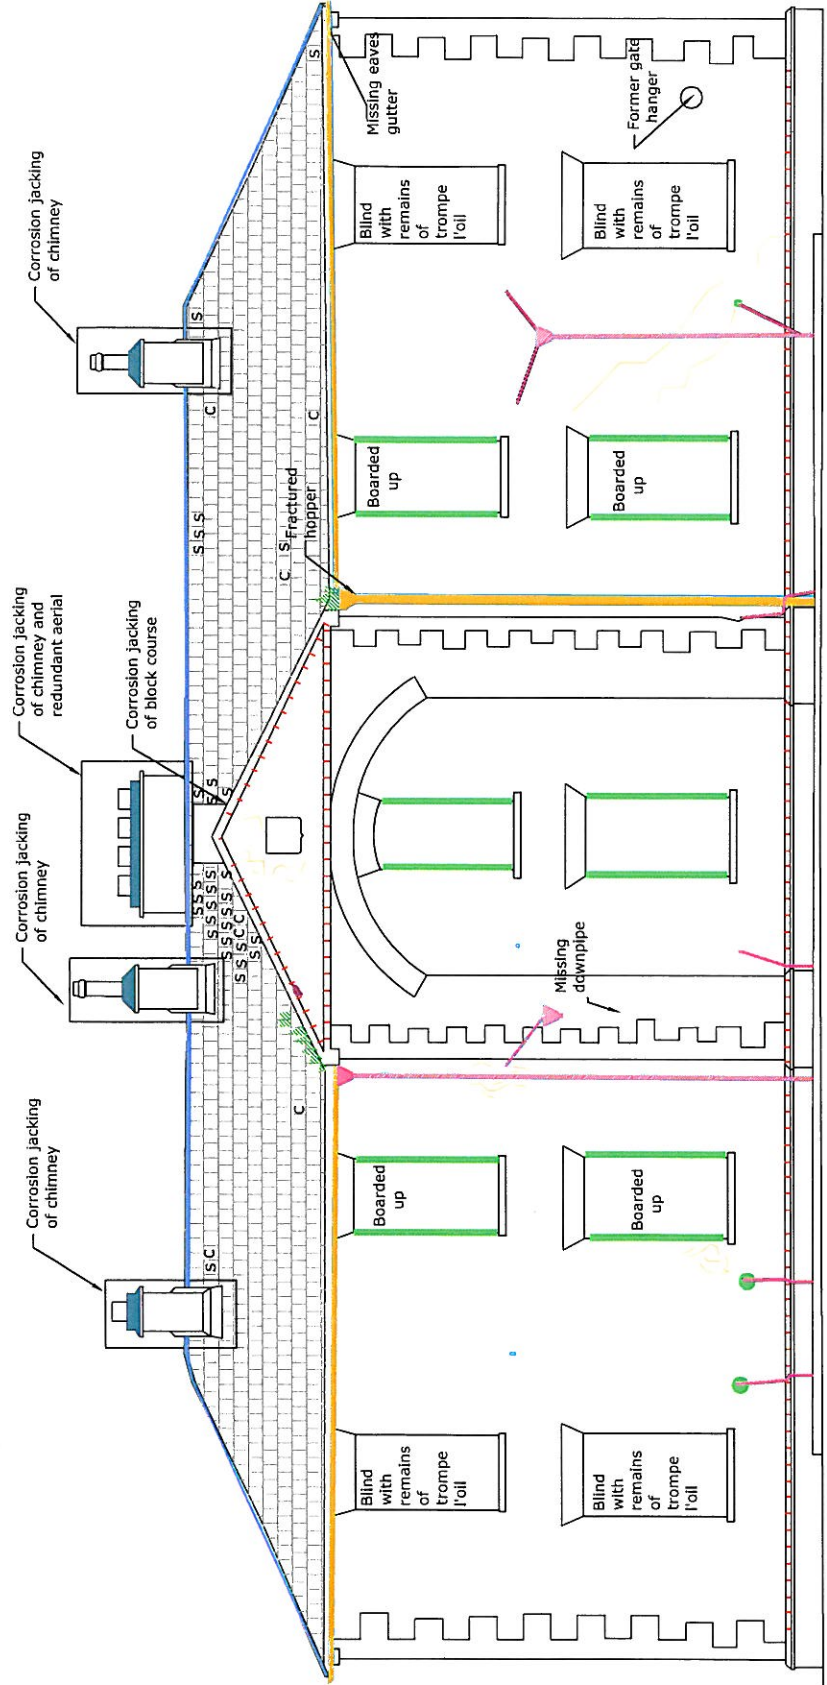
NORTH ELEVATION (North Wing)

Concrete drain

Remnants of lime harling to this elevation

Possible structural movement

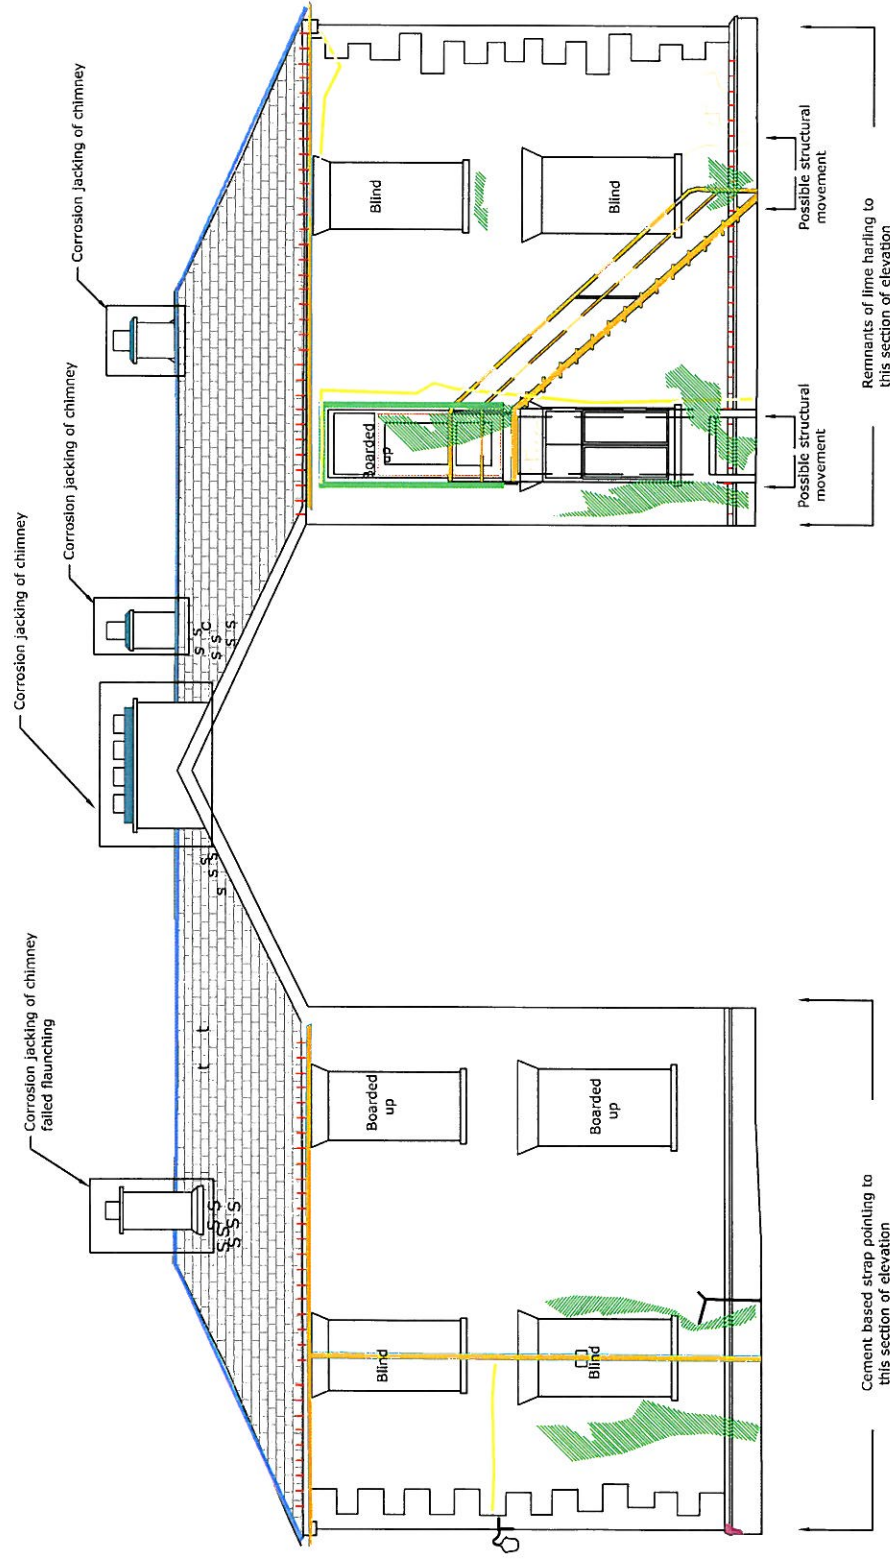
SOUTH ELEVATION (North Wing)

Note: Cement based strap pointing to this elevation
