**PROPOSED NEW BUTLER GALLERY AT
EVAN'S ALMS HOUSE,
BARRACK LANE, KILKENNY**

**VOLUME 2
EXTERNAL CONDITION SURVEY
RECOMMENDATIONS**

July 2010

CARRIG
BUILDING FABRIC CONSULTANTS

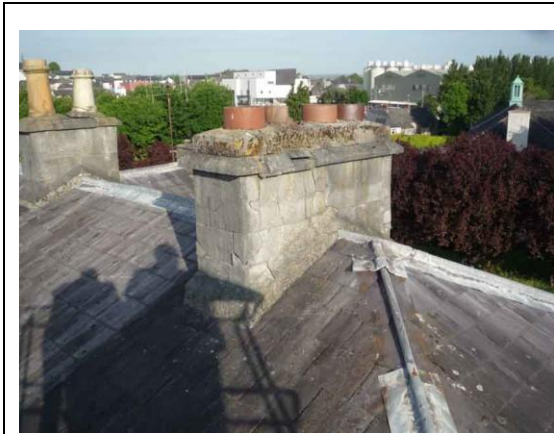
The lead ridge cappings are largely perished with significant tearing and defective seams recorded throughout. At least one section to the north wing has detached completely exposing the underlying timber to the elements. It is unlikely that the ridge capping continues to provide an effective barrier to rainwater ingress.

Fig.5: Missing section of lead ridge capping exposing underlying timber.

The existing lead flashings and ridges shall be replaced in lead as part of works to the roof. Failed mortar filets to chimneystacks shall be replaced with lead apron flashings. In general milled lead of lighter gauges can be safely used provided it is suitably detailed. The Lead Sheet Association has published a comprehensive set of guidelines that must always be followed.

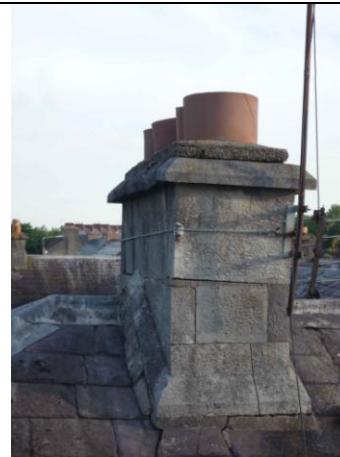
Cracked mortar fillets are recorded to the base of all chimneystacks and to the raking masonry of the pedimented breakfronts. Here, the exposed location and the continued action of rainwater have caused the mortar to fail at these locations.

Fig.6: Cracked and failed mortar fillet to the base of chimney stacks.

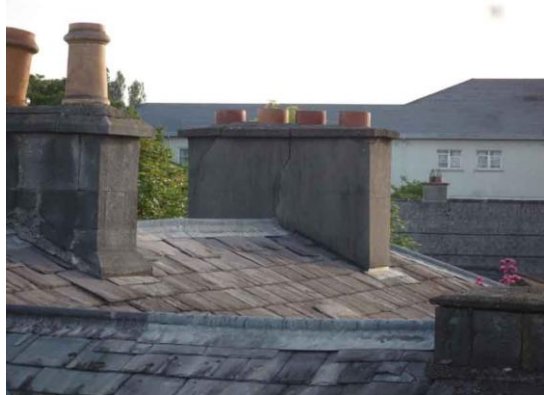
A rendered chimney stack rising over the south wing appears to have been re-built during the late 20th century. This rebuild does not faithfully replicate the detailing of the original masonry stacks and detracts somewhat from the composition. Cracking recorded in the render is likely to reflect differential settlement between the existing and new build elements.

<p>Fig.7: Rendered chimney stack to the south wing - this stack appears to have been rebuilt.</p>	<p>Fig.8: 19th century chimney pots to the south wing. Note this are out of alignment.</p>

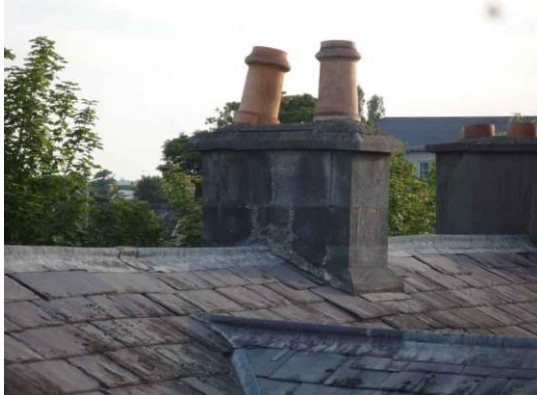
The majority of the buildings eight chimneystacks carry modern chimney pots with five 19th century chimney pots surviving to stacks rising over the south and north wings. Though all flues are disused, caps to weather against rainwater ingress, have not been fitted. Elsewhere redundant television aerials and associated metal strapping is recorded detracting from the historic masonry.

Modern pots shall be removed and replaced to match the early octagonal pots. All pots shall be fitted with caps to prevent rainwater ingress and birds from nesting while ensuring adequate ventilation of the flues.

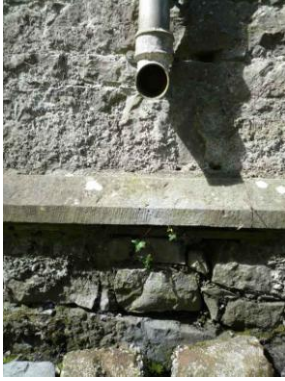
<p>Fig.9: Downpipe and socks terminate above plinth course.</p>	<p>Fig.10: Detached section of rainwater goods now tangled amid vegetation.</p>

The rainwater goods shall be replaced with cast-iron goods to match existing 20th century hoppers, eaves gutters and downpipes (these works will be carried out in 2010 funded by the local authority conservation grant scheme). Downpipes shall be fitted with appropriate necks to ensure that these continue below the base plinth to ensure water discharges without excessive splash back.

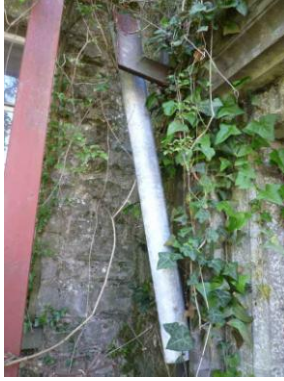
Missing sections of gutter and downpipes are recorded throughout with varying degrees of corrosion and damage recorded to surviving lengths, ranging from significant breaches to cracked hoppers. Here, rainwater is likely to penetrate within the fabric of the building as corresponding walls become saturated.

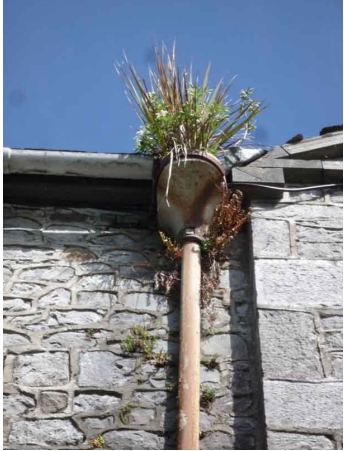
A build-up of debris and the colonisation of plantlife are also noted in a number of locations including eaves gutters and at hopper heads/outlet junctions. Such blockages prevent the free discharge of rainwater and increase the likelihood of moisture ingress within the historic building fabric.

<p>Fig.11: Blocked hopper heads facilitating the ingress of rainwater within the building.</p>	<p>Fig.12: Insensitively installed soil pipe dissecting blind window openings to the north wing.</p>

It is recommended that gutters, hoppers and downpipes should be inspected on a twice-yearly basis and where necessary cleared of debris.

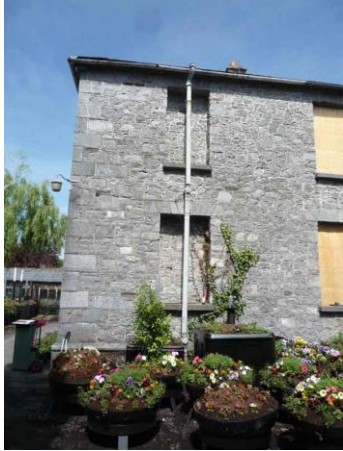
uPVC soil pipes have been insensitively installed to all elevations with little regard for the buildings architectural composition.

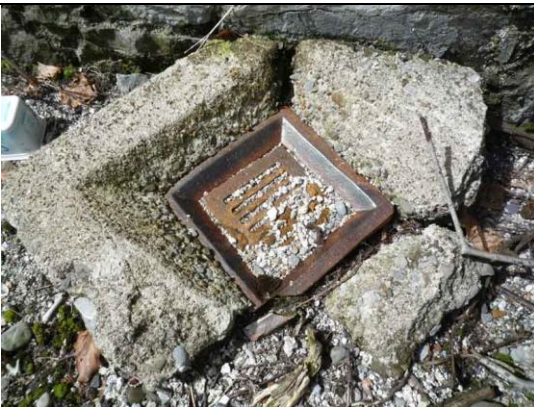
Although a drainage survey was not carried out as part of this study a number of blockages were recorded in the ground drains. Where drains are blocked this is likely to lead to a saturation of the surrounding subsoil, exacerbating moisture ingress and areas of rising damp within the building.

<p>Fig.13: Blocked ground drain to the east of the building.</p>	<p>Fig.14: Poorly formed and fractured drainage channel.</p>

The concrete pavers to the east and the defective drainage channels to the north and south shall be removed. Ground drainage around the building shall be improved with the installation of a circuit French drain.

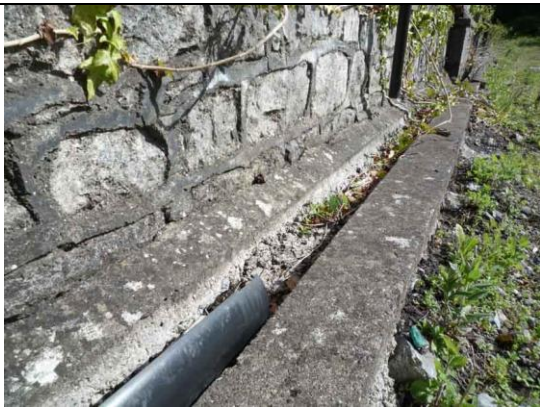
Concrete drainage channels have been formed to part of the north and south elevations however these are now fractured and no longer route rainwater discharge away from the building.

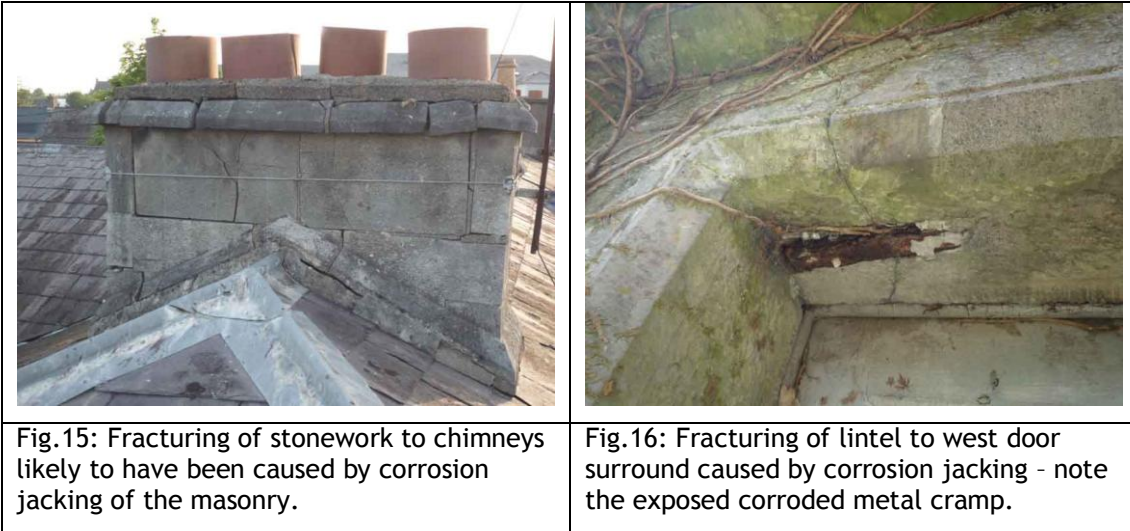
In addition to the corrosion related movement recorded in the masonry of the historic chimneystacks further jacking and displacement of masonry is noted to the blocking courses rising over the pedimented breakfronts. Here, movement is thought to be caused by corrosion of embedded iron cramps. Given the exposed location and the absence of an effective damp proof barrier water ingress is likely to have accelerated the corrosion and subsequent expansion of these metal ties. In places this has led to cracking and popping of stonework with notable displacement of masonry elements in

extreme cases. Further corrosion relating fracturing has occurred in the door surrounds where exposed metal cramps are clearly visible.

Corrosion of the metal cramps has led to movement and fracturing of stonework to the blocking course rising over the pedimented breakfronts. Based on initial inspection this masonry shall be carefully dismantled to systematically remove the embedded iron cramps and to replace these in stainless steel. A methodology for numbering and recording the masonry elements will be devised. Masonry shall be re-bedded in a lime-based mortar to match existing.

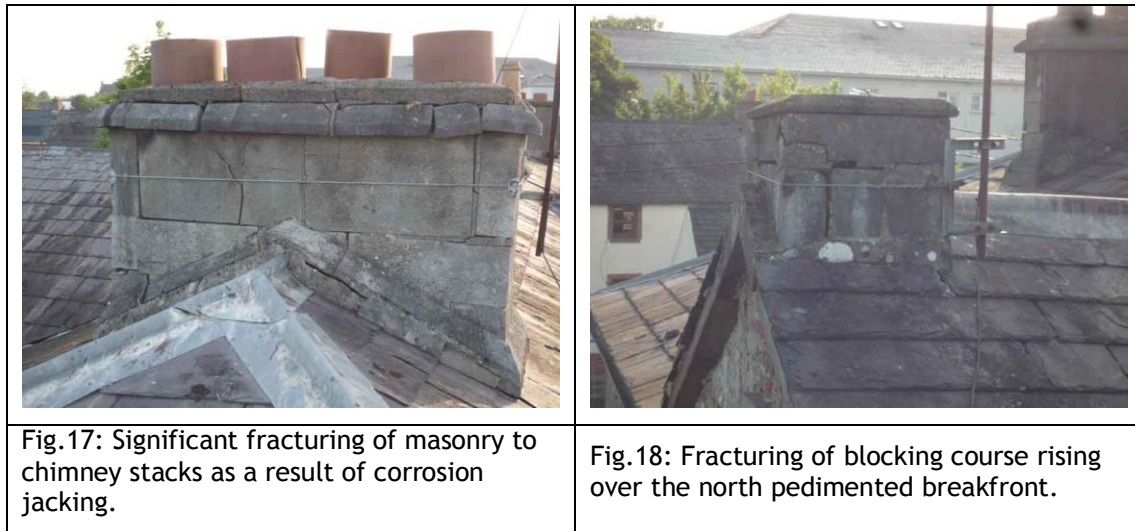
Fracturing of stonework with associated shelling and loss of masonry elements is recorded in locations which have been affected by the corrosion of embedded metal cramps with significant fracturing recorded in the masonry chimney stacks and blocking course of the pedimented breakfronts. Here, stresses placed on the stonework through the rusting and subsequent expansion of embedded ferrous metal cramps have caused the limestone to burst, chip and fracture.

Further fracturing is recorded in three cills across the ground and first floors where differential settlement has lead to fracturing along weak points in the masonry.

In all cases root causes of structural movement to the chimney stacks and blocking courses shall be addressed prior to repair of fractured masonry. Open fractures/fissures shall be caulked with a lime based pointing mortar to colour match existing stone. Fine hairline cracks shall be resin injected. A virtually invisible form of repair, resin injecting will help consolidate the material and prevent the ingress of moisture. Where the fracture has led to detachment of material this shall be carefully patched with a suitable mortar repair mix. Care must be taken to produce an accurate colour match for the stonework and to mould the mortar to match the profile and tooling of the surrounding stone.

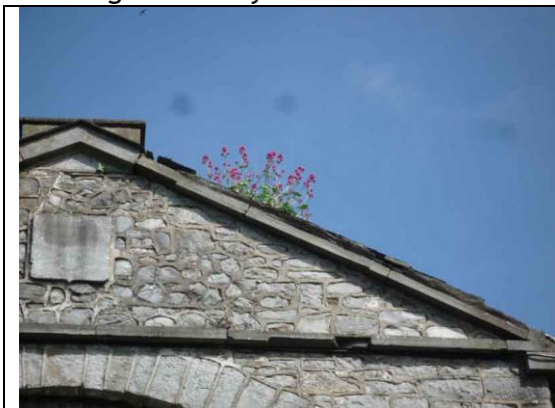
Scaling and detachment is recorded to the raking and horizontal limestone stringcourses of the pedimented breakfronts. The degree of scaling varies in severity from localised surface blistering to significant detachment. When laying stonework it is vital that the direction of the bedding plane is well suited to the application and more importantly the position of the member however in the locations listed above

the stone appears to have been incorrectly bedded and therefore is more susceptible to scaling and decay.

Fig.19: Scaling & detachment of stone to the horizontal string course to the south pedimented breakfront.

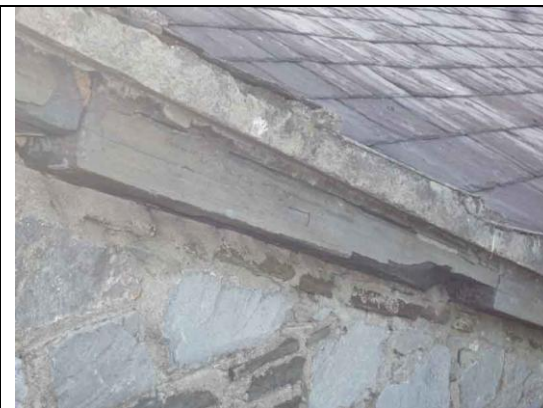
Fig.20: Detachment of stonework from the raking stringcourse to the pedimented breakfront to the main block.

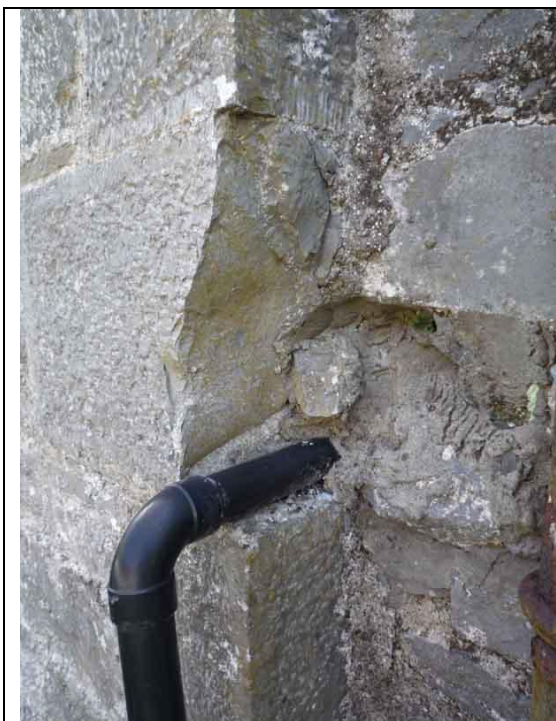
Mechanical damage has occurred where the crude installation of uPVC soil pipes has resulted in the chipping of the surrounding material. Further damage is recorded to the southwest corner of north wing and the northwest corner of the south wing where vehicle impact has occurred.

Fig.21: Mechanical damage of the roughly dressed quoins through careless and insensitive installation of soil pipes.

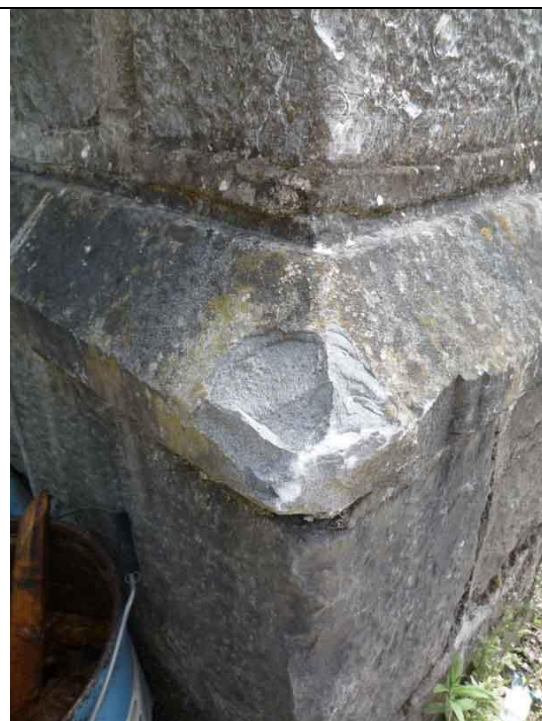
Fig.22: Chipping of stonework to the northwest corner of the south wing caused by vehicle impact.

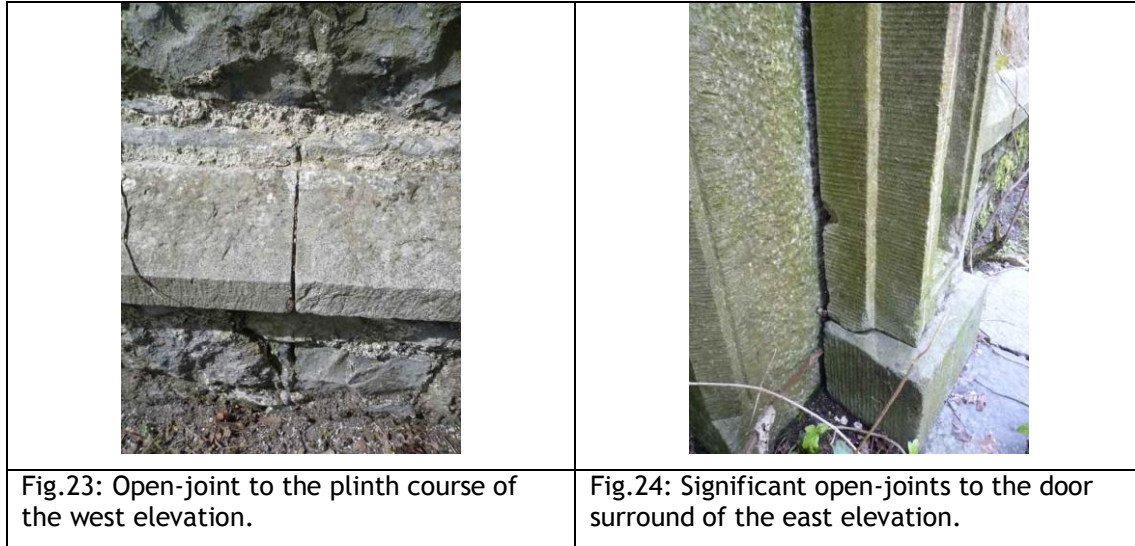
Open joints are recorded to the chimney stacks, limestone eaves course, blocking course, pediments and to localized areas of the north and east elevations. Further notable areas are recorded to the door surrounds of both the east and west elevations where the ingress of water within the structure has led to visible signs of moisture related damage to corresponding internal timber and plasterwork.

The joints shall be hand finished to a slight recess with the stone surface and any excess removed. It is recommended that a contractor experienced in such work be employed to carry out the above.

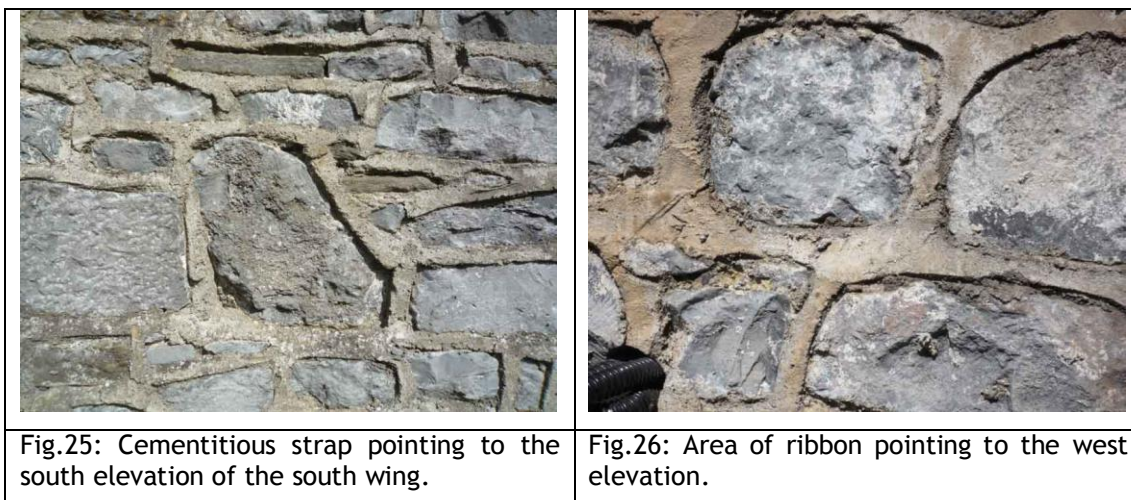
The west elevation of the principle block, west elevation of the north wing and the west and south elevations of the south wing have been re-pointed in a cementitious material. This mortar is harder and more impermeable to moisture than the stone thus increasing water movement within the masonry and building as a whole. It should be noted that significant levels of internal damp, moisture ingress and efflorescence are recorded in areas where the external masonry has been pointing in cement based mortar.

In addition, an incorrect pointing method has been adopted. Proud-standing ribbon pointing detracts from the aesthetics of the walls, changing its overall appearance and allows moisture to accumulate at joints increasing the likelihood of water penetration within the structure.

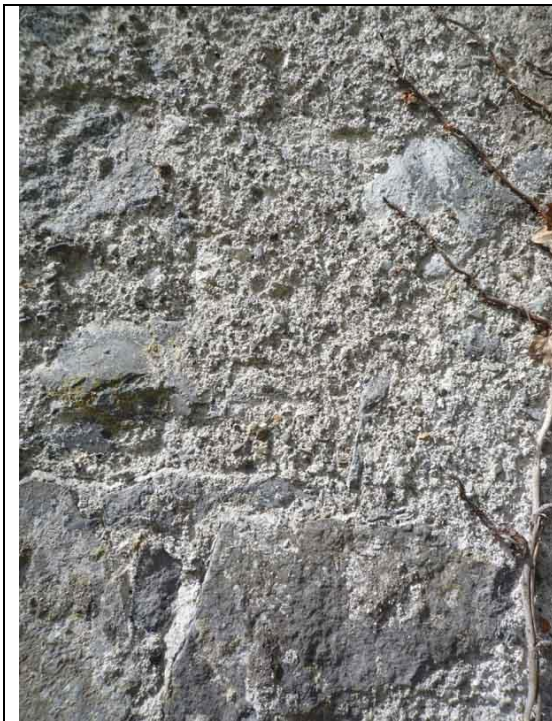
Fig.27: Area of surviving harling to the west elevation of the main block.

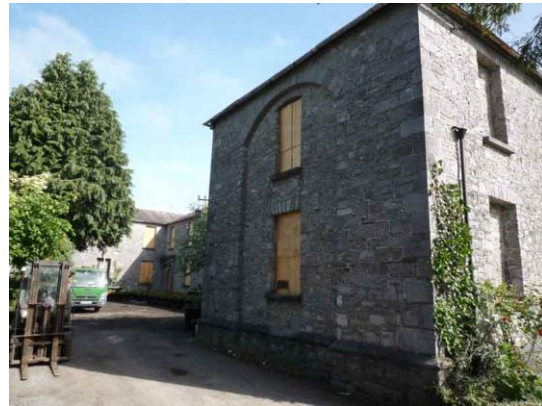
External renders provide protection from direct exposure to the elements and in the case of Evan's Home the absence of such protection is likely to facilitate the ingress of water. Materials analysis was carried out on a sample of surviving harling indicating that this is a lime based render with an aggregate consisting of well rounded pebbles.

Fig.28: Exposed stonework to the western elevations.

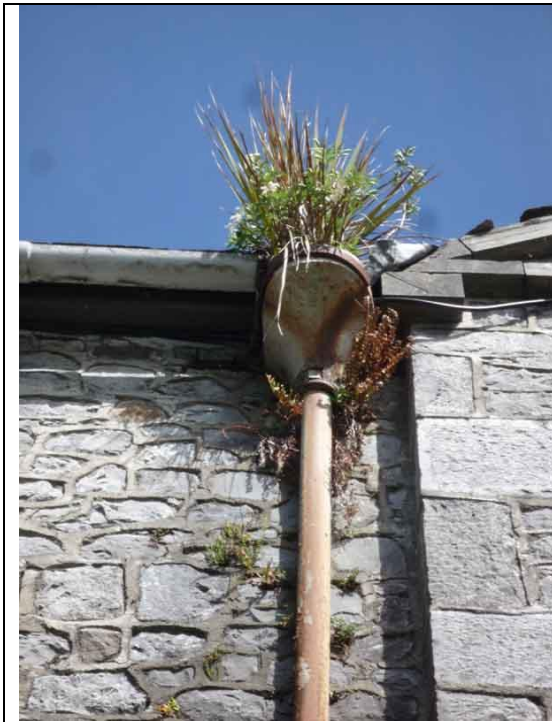
Advanced plant life is noted to a number of hopper heads and parapet gutters with blockage of the outlet to the south and west elevations - here the risk of rainwater ingress is likely. Further colonisation is noted to areas of open joints at the high-level stonework of the pedimented breakfronts. Ivy growth is noted to the south and east elevation and despite efforts to control this, new growth is recorded.

Fig.29: Plantlife to hopper located at the south elevation.

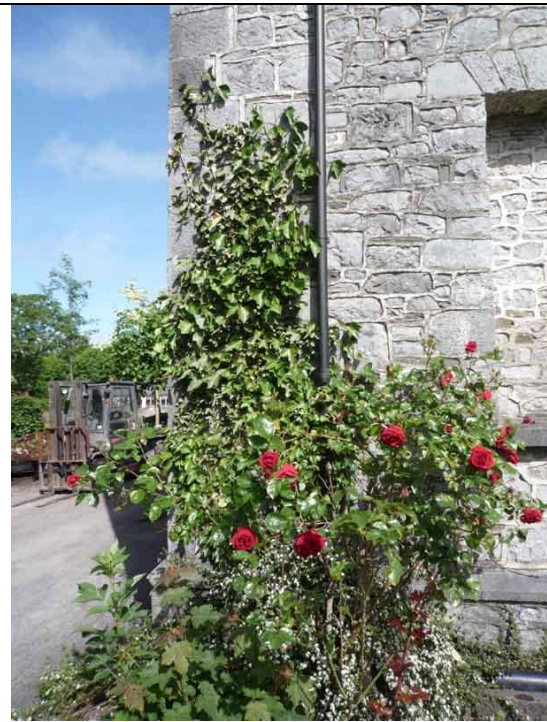
Fig.30: Ivy growth to the south elevation.

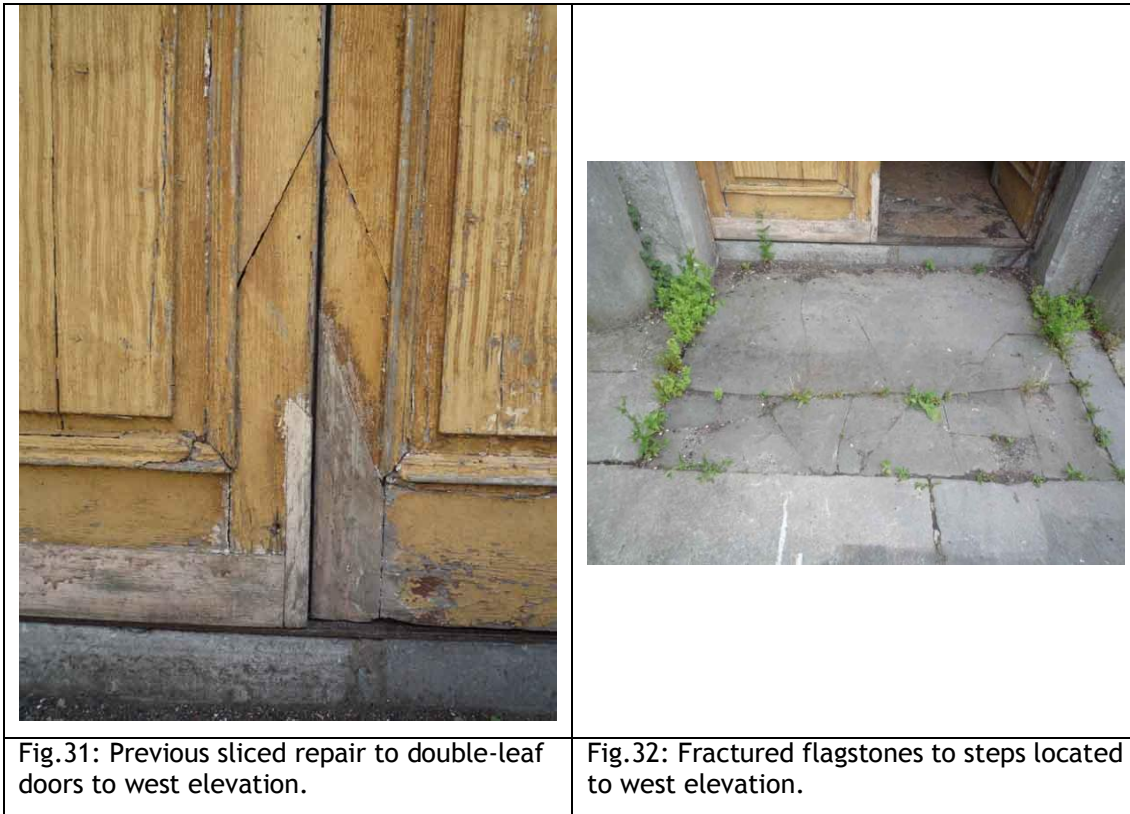
All original and early doors appear to be in good condition however there is some evidence of paint failure throughout. Localised areas of timber decay are noted to the bottom rails with some evidence of previous repair to the principle doors located at the west elevation.

The creation of two fire exit doorways to the rear/east elevation by altering existing first floor window openings is visually obtrusive and detracts from the composition of the building. Some structural movement associated with the installation of these exits is recorded in the surrounding masonry.

Settlement has caused the limestone flags to the entrance steps to the west elevation to sink and fracture. The cast-iron boot scraper to the northernmost opening to the west elevation is missing.

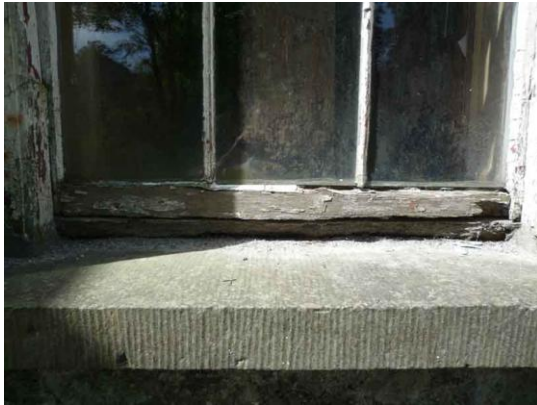
Seven early timber sliding sash windows survive to the east elevation of the principle block. Varying degrees of paint and putty failure are recorded to all timber sash windows indicating that these are now in need of maintenance. Limited areas of localised wet rot, particularly at cills and bottom rails are noted to some frames, where sustained levels of both internal and external moisture have led to decay. A number of glazing panes to these sashes are broken and cracked.

Fig.33: Localised timber decay to early sash window.

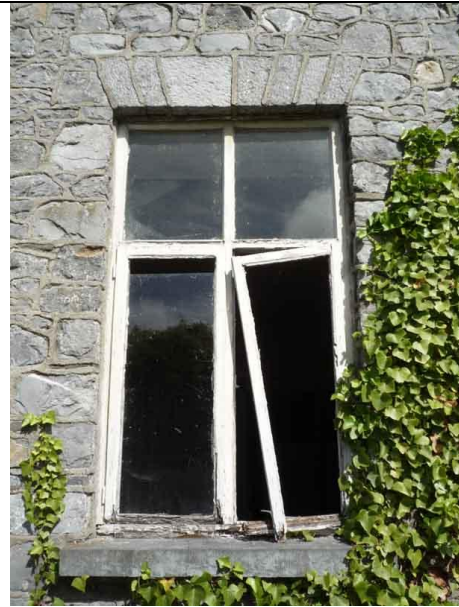
The remainder of the windows have been replaced with inappropriate timber casement windows c.1990. These display signs of advanced timber decay with areas of wet rot noted to bottom rails leading to a slippage and loss of glazing panes across all elevations. Given the accelerated decline, it is likely that this decay is as a result of poorly specified or inadequately treated timber in combination with poor maintenance. These windows now require complete replacement.

Fig.34: Complete failure of the timber casement windows.

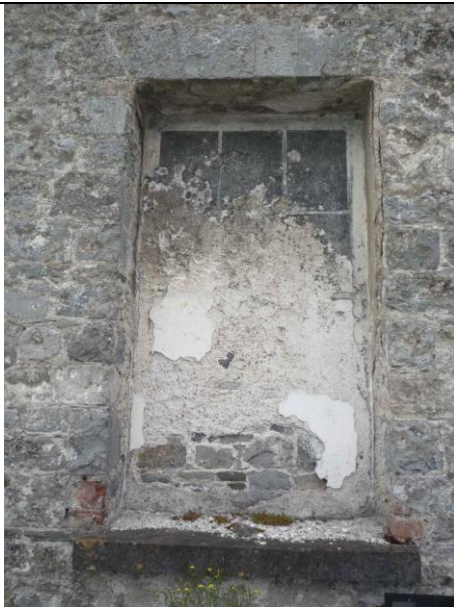
Prolonged exposure to the elements has led to failure of the render where saturation over time has caused this to delaminate, bulge and ultimately detach. It is notable that areas of survival occur at high level where the render is sheltered by the recessed soffit.

Fig.35: Blind window opening with trace remains of trompe-l'oeil window to ground floor (east) of north elevation.

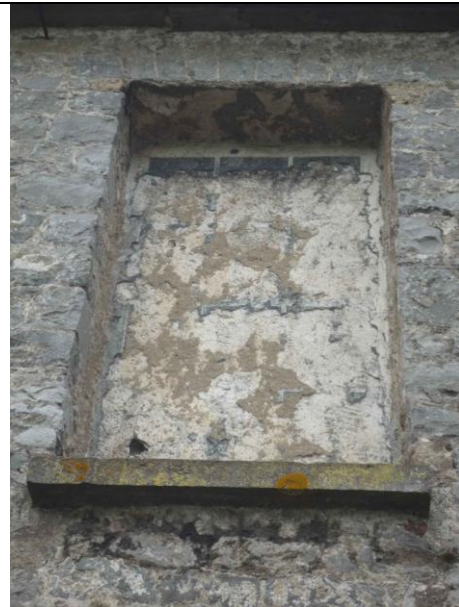
Fig.36: Blind window opening with trace remains of trompe-l'oeil window to first floor (east) of north elevation.

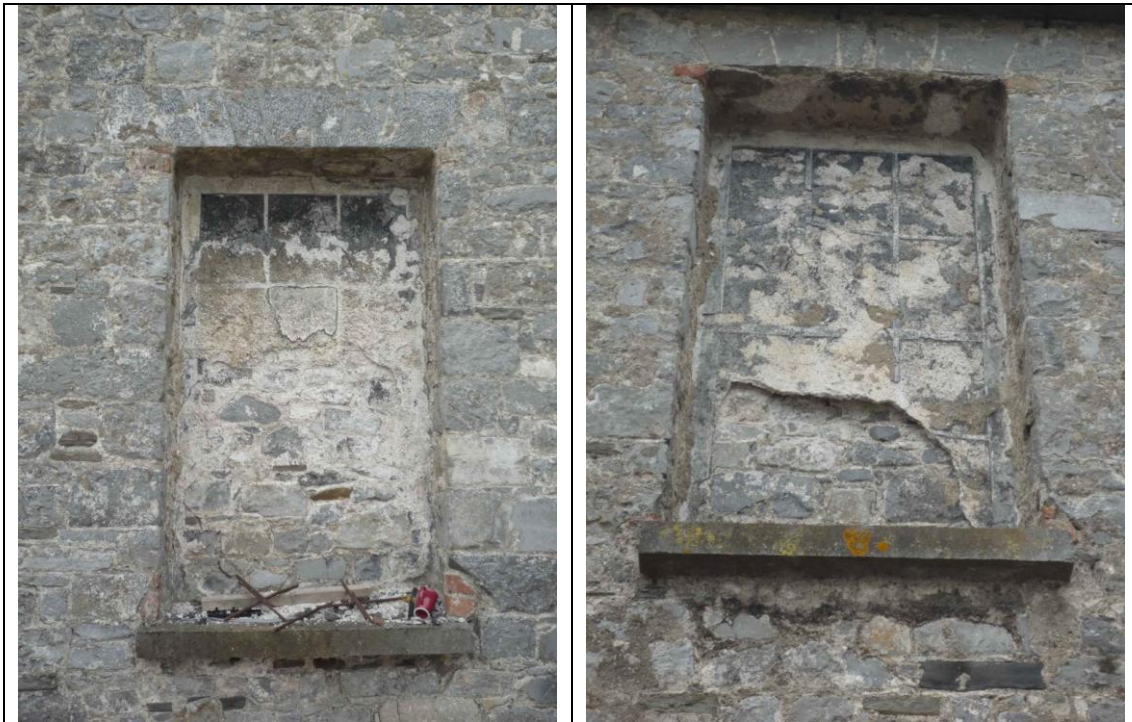
Fig.37: Blind window opening with trace remains of trompe-l'oeil window to ground floor (west) of north elevation.

Fig.38: Blind window opening with trace remains of trompe-l'oeil window to first floor (west) of north elevation.

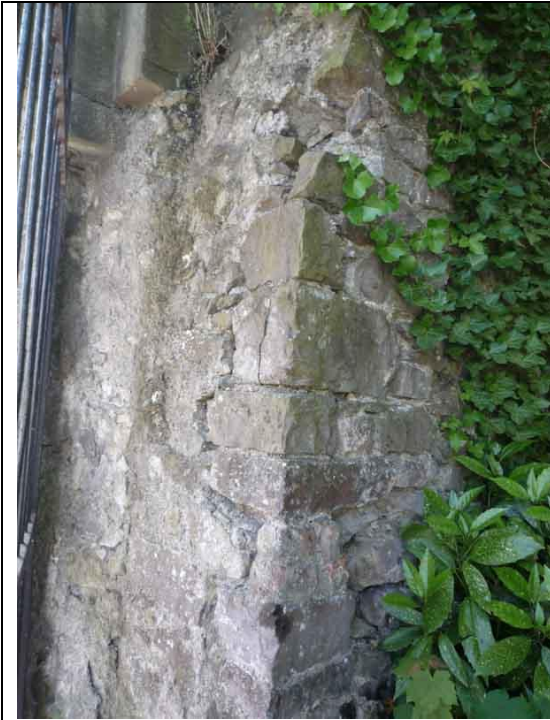
Pockets of missing and loose masonry are recorded to northern and southern sections of the boundary wall where loss is likely to have occurred as a result of the actions of vigorous route systems.

Fig.39: Pocket of destabilised masonry to a section of the southern boundary wall (adjacent entrance gateway).

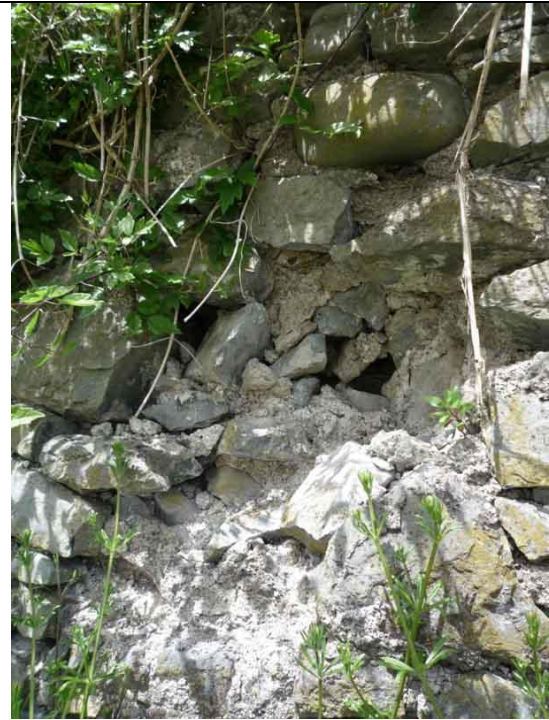
Fig.40: Pocket of missing and loose masonry to the northern boundary wall.

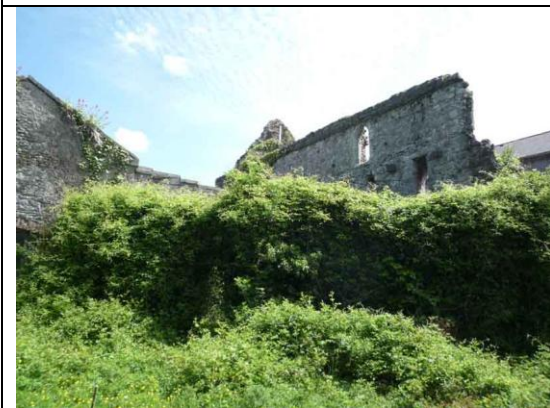
Fig.41: Blanket vegetation to the outdoor sanitary block to the southeast of site.

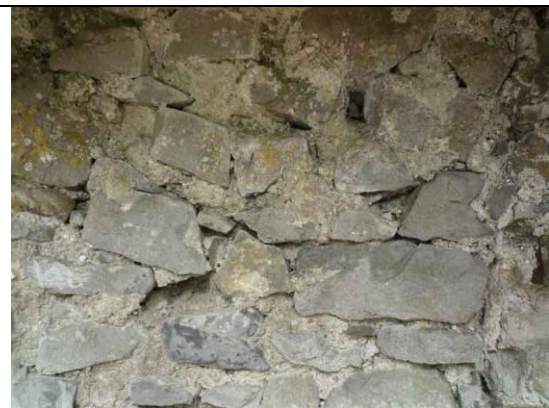
Localised areas of open-joints are recorded to the boundary wall, gateway and sanitary blocks. Here, driving rain in the presence of exposed skyward surfaces coupled with the colonization of vigorous plant-life has lead to a loss of pointing material.

Fig.42: Open-joints to northern boundary wall.

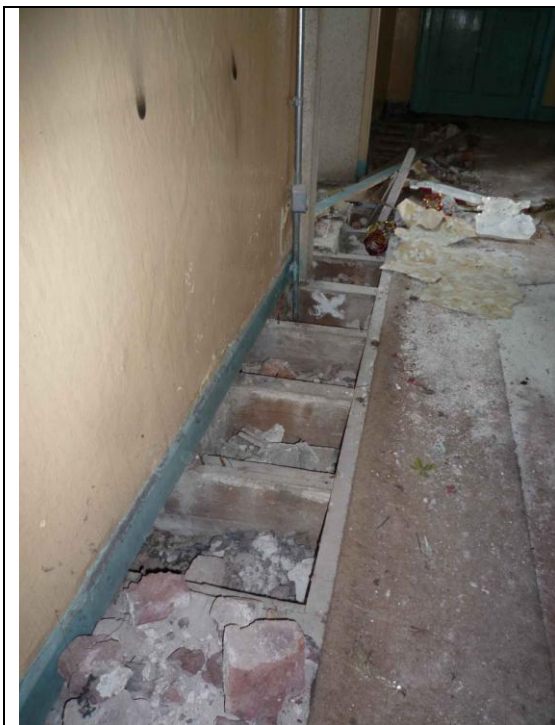
Localised areas of missing floorboards are the most common condition recorded to the first floor. In most cases these boards have been removed to facilitate previous surveys. Areas of missing floorboards present a health and safety risk for building users.

Fig.45: Section of missing floorboards to F08.

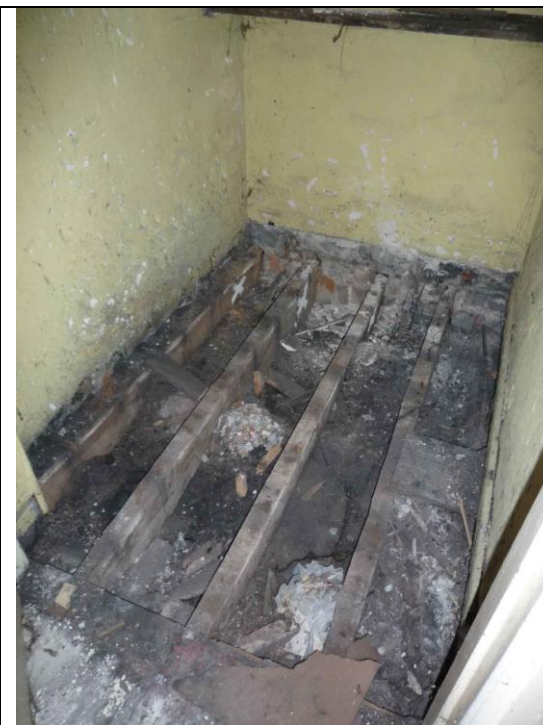
Fig.46: Missing floorboards to F06.

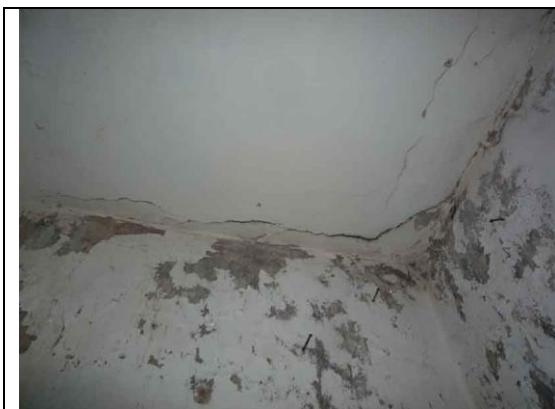
Fig.47: Cracking of ceiling plasterwork to G10.

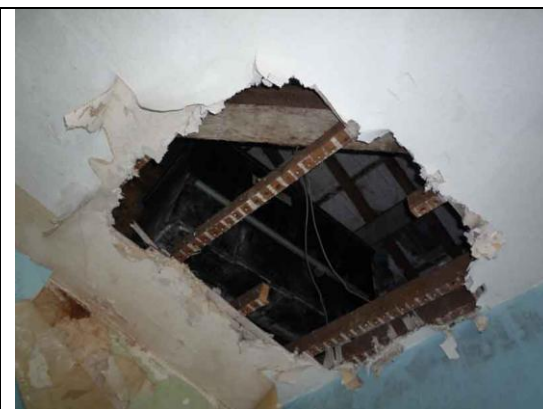
Fig.48: Significant hole in ceiling plaster over F01.

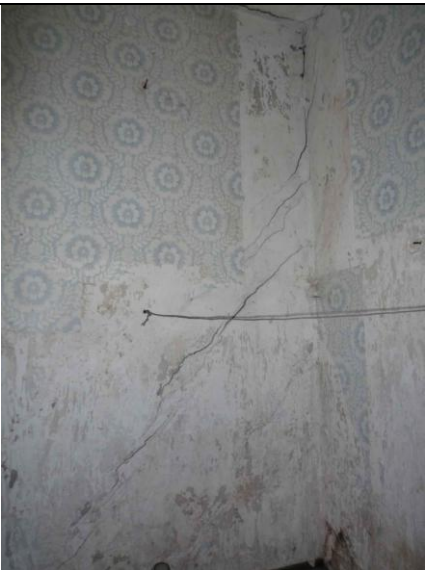
<p>Fig.49: Cracking of plaster to the north wall of G01 corresponding with cracking to the external wall.</p>	<p>Fig.50: Plaster failure to room G27.</p>

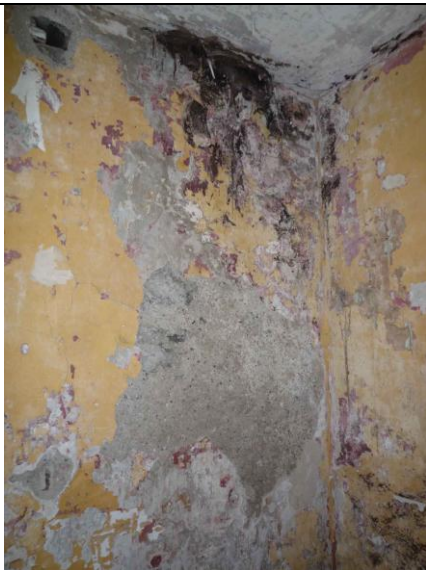
Sections of missing plasterwork are concentrated to the external walls where damp has been allowed to penetrate and where saturation has caused the plaster to delaminate and detach. Elsewhere some sections have been stripped to facilitate investigation of underlying timbers.

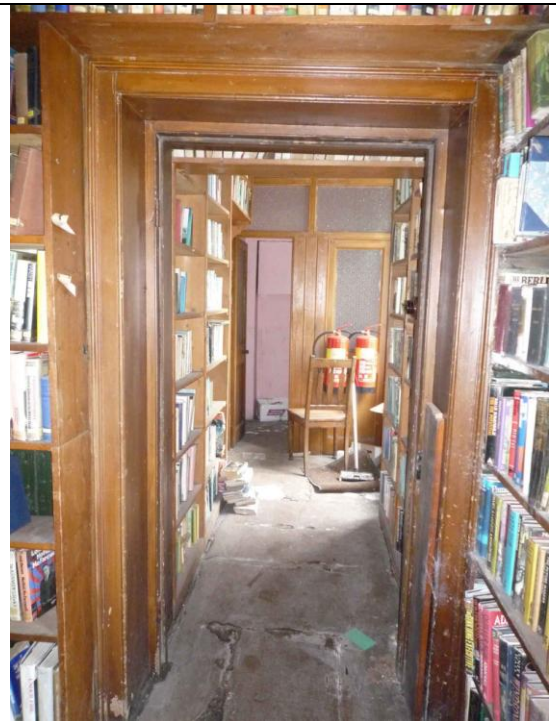
Fig.52: Missing door leaf to opening giving access from G15 to G16.

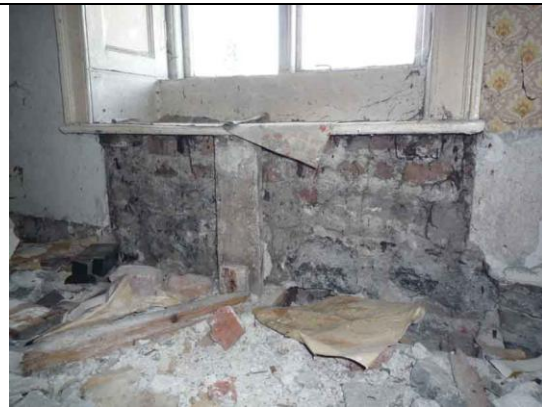
Fig.53: Missing apron panel to window opening at F07.

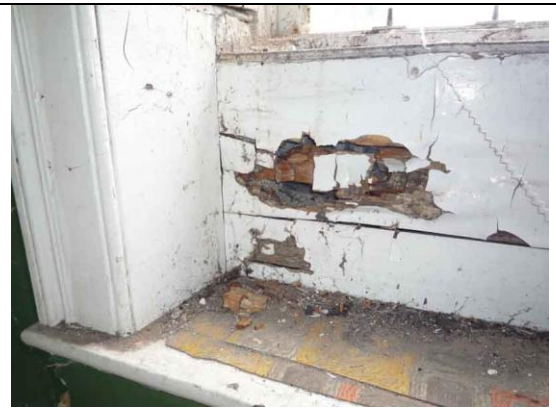
Fig.54: Timber decay of window back to west window opening of F11.

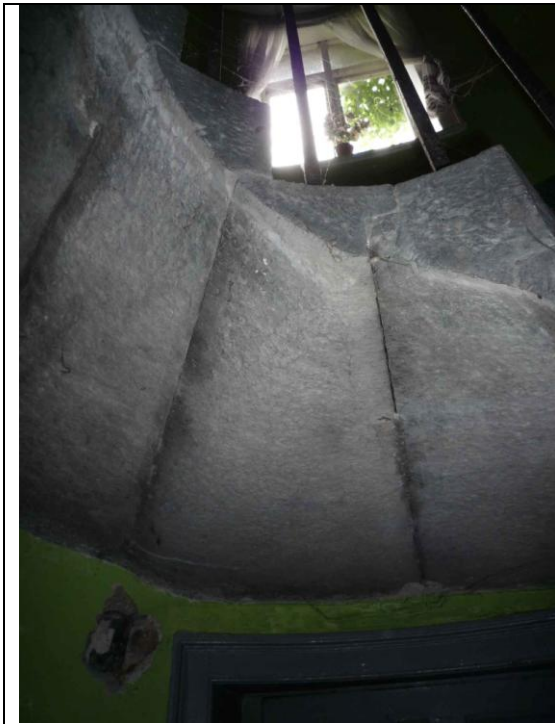
Open joints are recorded to the undercarriage of the staircase located in G19. Elsewhere missing balusters are recorded to the newel of the staircase located in G11. No other conditions were recorded to the cantilevered staircases.

Fig.55: Open joints to undercarriage of staircase located in G19.

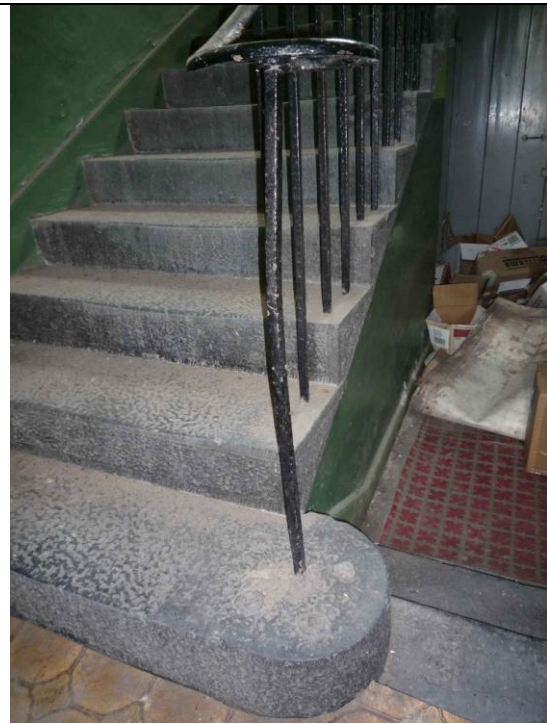
Fig.56: Missing wrought-iron balusters newel post of staircase to G11.

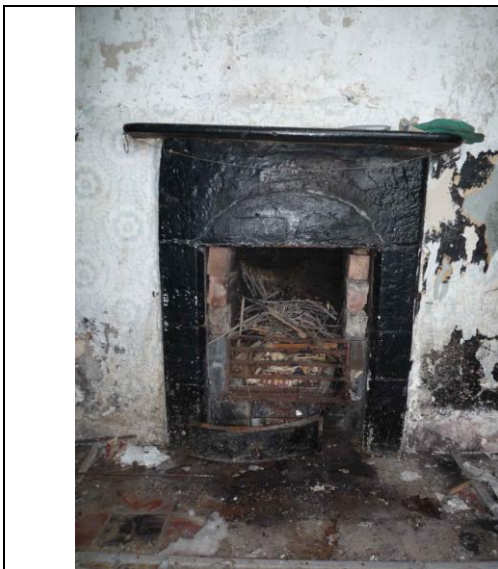
Where early stone fireplaces survive these have been heavily painted in an oil based medium which detracts from the ascetics of the fireplace. Elsewhere a number of early fireplaces have been replaced with 20th century tiled pieces. A significant amount of debris and detritus is recorded to all hearth grates suggesting that the chimney flues are in poor order.

Fig.57: Over-painted stone fireplace to G01.

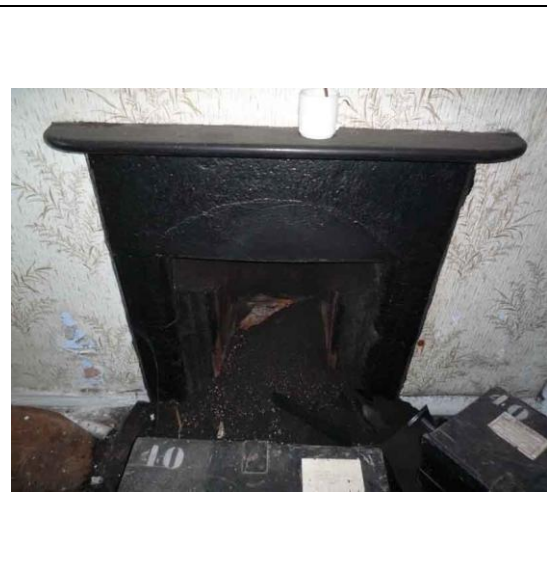
Fig.58: Detritus to the fireplace located in G29.

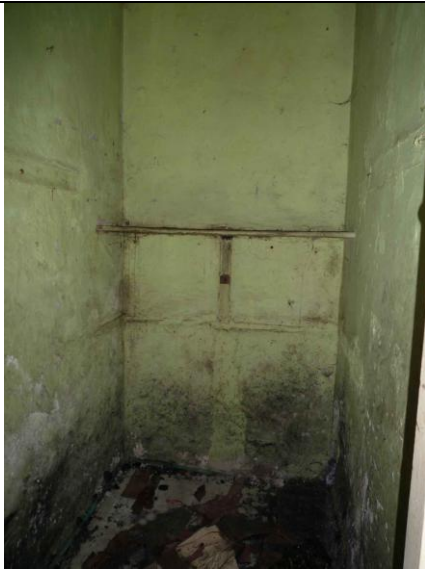
Rising damp is evident in the form of resulting paint failure, efflorescence and plaster failure throughout the ground floor. An excessive level of dampness is noted in the rooms where external walls have been re-pointed in cement based mortar. It is noted that the existing external drainage is blocked throughout leading to saturation of the surrounding ground exacerbating levels of dampness to the internal ground floor.

Fig.59: Plaster failure at low level as a result of rising damp to G20.

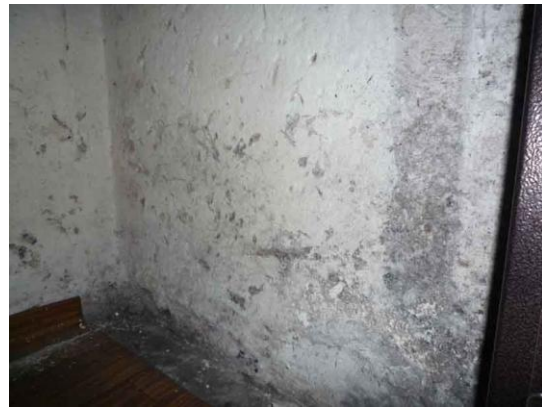
Fig.60: Rising damp to the west wall of G24.
