**Tree Survey Report
Flood Relief Scheme
Ballyhale
Co. Kilkenny**

Project Name: Ballyhale Flood Relief Scheme, Ballyhale Co. Kilkenny

Drawing Title: Tree Survey/Constraints Plan

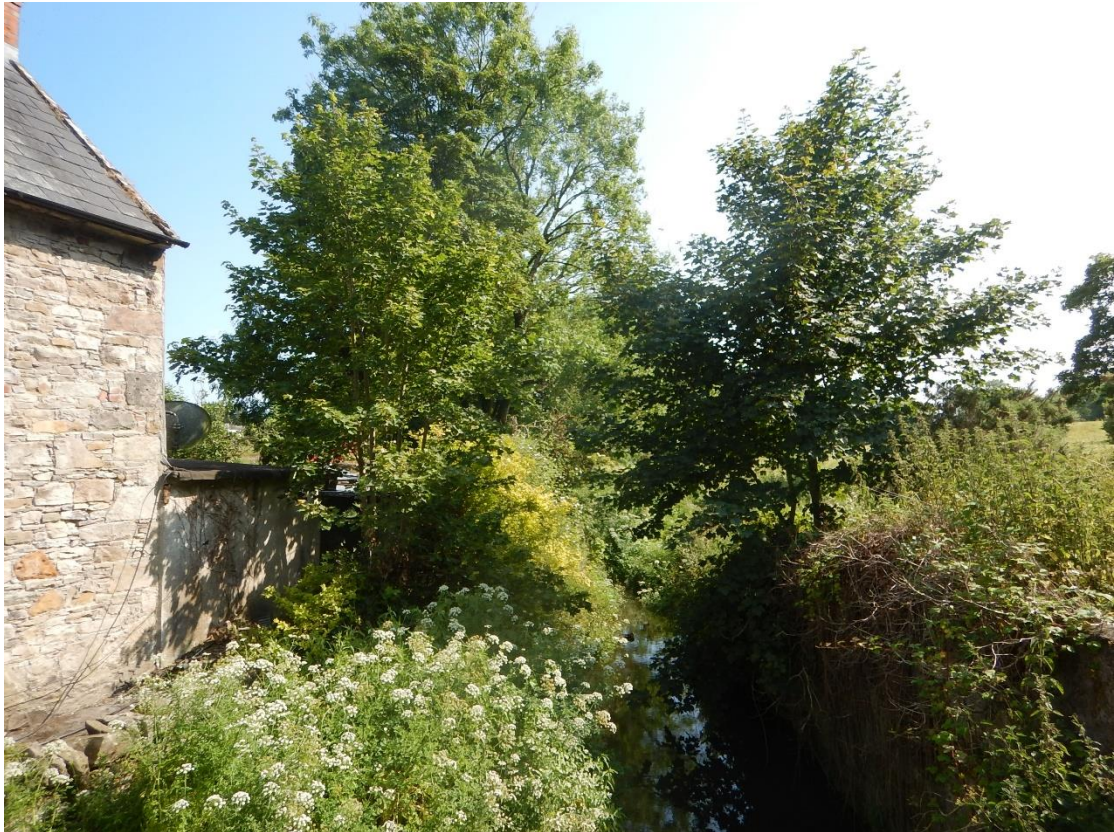
1. Semi mature Sycamore trees (T7) on either side of the stream bank (with trees T3-T6 behind)

Trees T3, T4, T5, T6 and T7

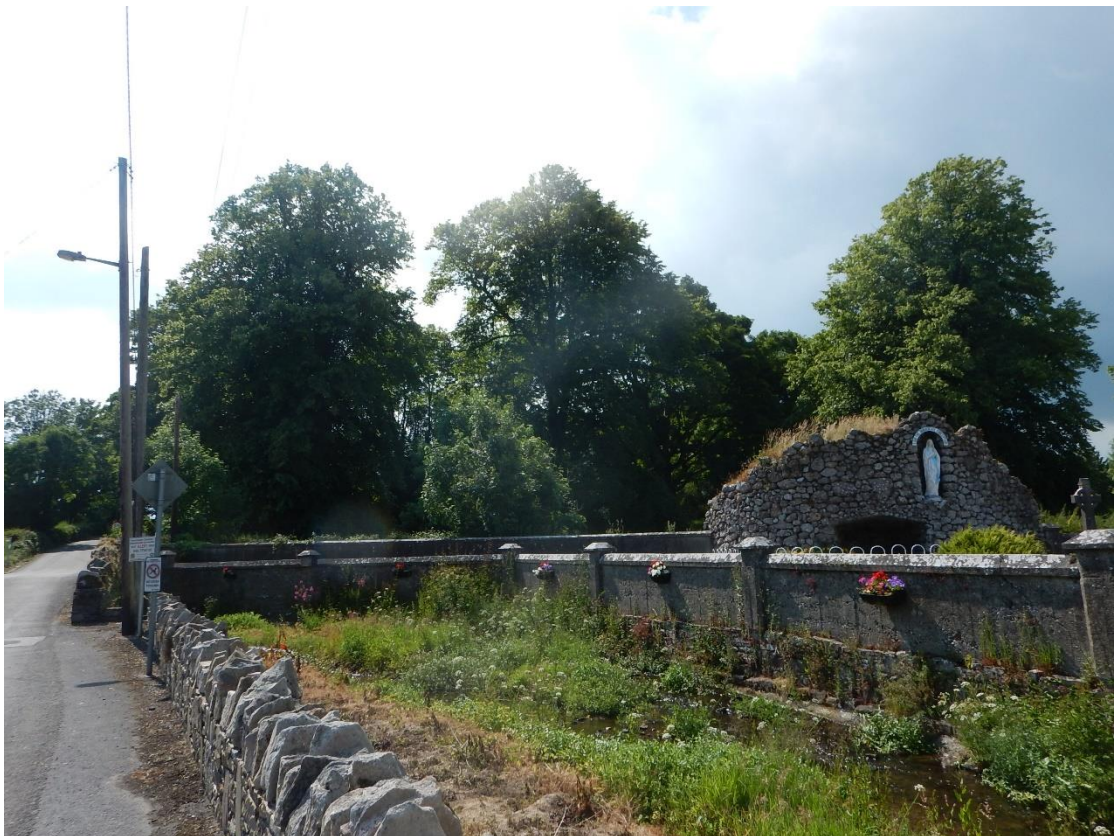
The most significant arboricultural features within the survey area are the Common Lime (*Tilia x europaea*) trees located on pastureland to the west of the churchyard. These four trees are substantial specimens of considerable age and size and are of high amenity and heritage value. One of the trees (T11) has developed a structurally defective union as the main stem divides and so was downgraded to category B (moderate value) as per BS5837. The other three trees (T10, T12-13) were graded category A (high value).

2. Large mature Lime trees (T10-T12) close to the church; these are very high value trees

The works in this area must be well planned and supervised to avoid any unintended negative impacts on the four mature Lime trees (T10-13) located west of the watercourse. These trees are of *very high* amenity and heritage value and *must* be protected from construction activity during the proposed building works. The key recommendation in this area is that the construction activity should not cross the watercourse to the west bank which is, in effect, one large tree root zone. If machinery etc. *must* cross over the land within the root protection areas (RPAs as shown on the tree survey drawing) of these trees for reasons that are unavoidable and unforeseen, they *must* use suitable ground protection (such as ground protection mats) that prevents any significant soil compaction. If direct supervision of the works to prevent encroachment into the RPAs of the trees is not practical, then the trees should be protected by temporary 'construction-proof' fencing positioned along the west bank of the watercourse, with the fencing clearly labelled as not to be moved.

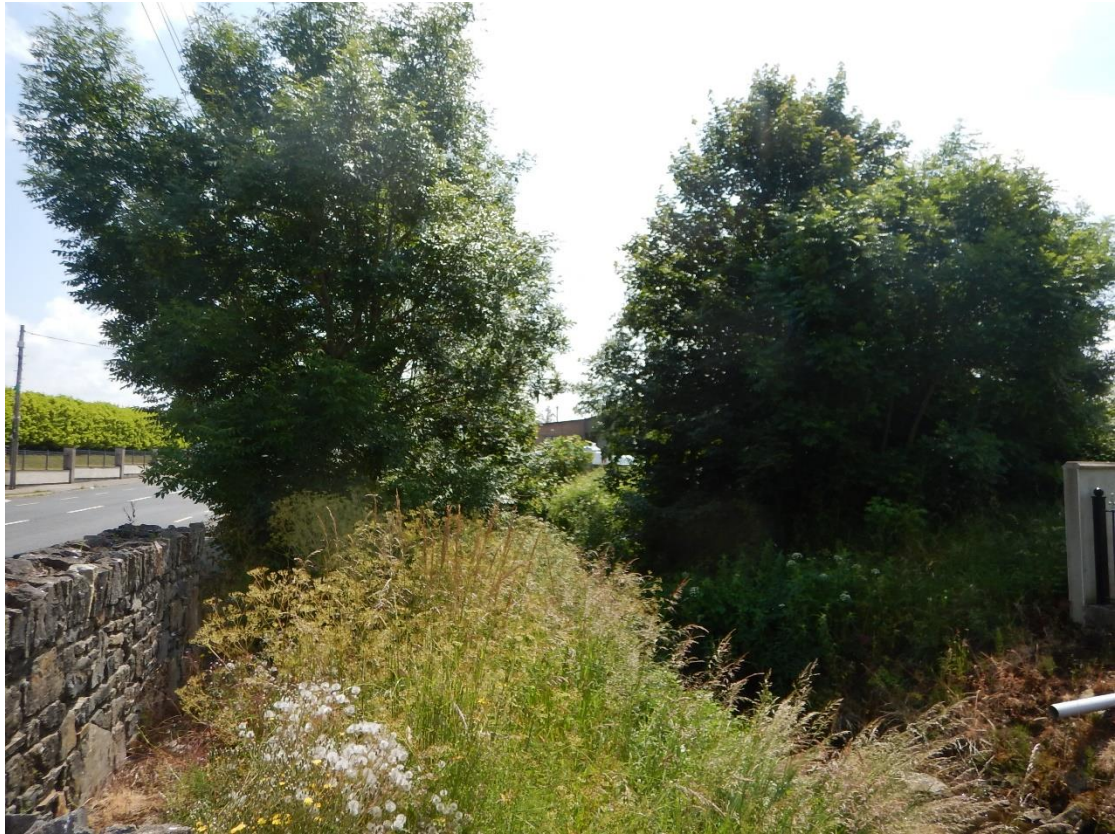
3. Young Sycamore and Ash trees (G4 and T26) along the river channel

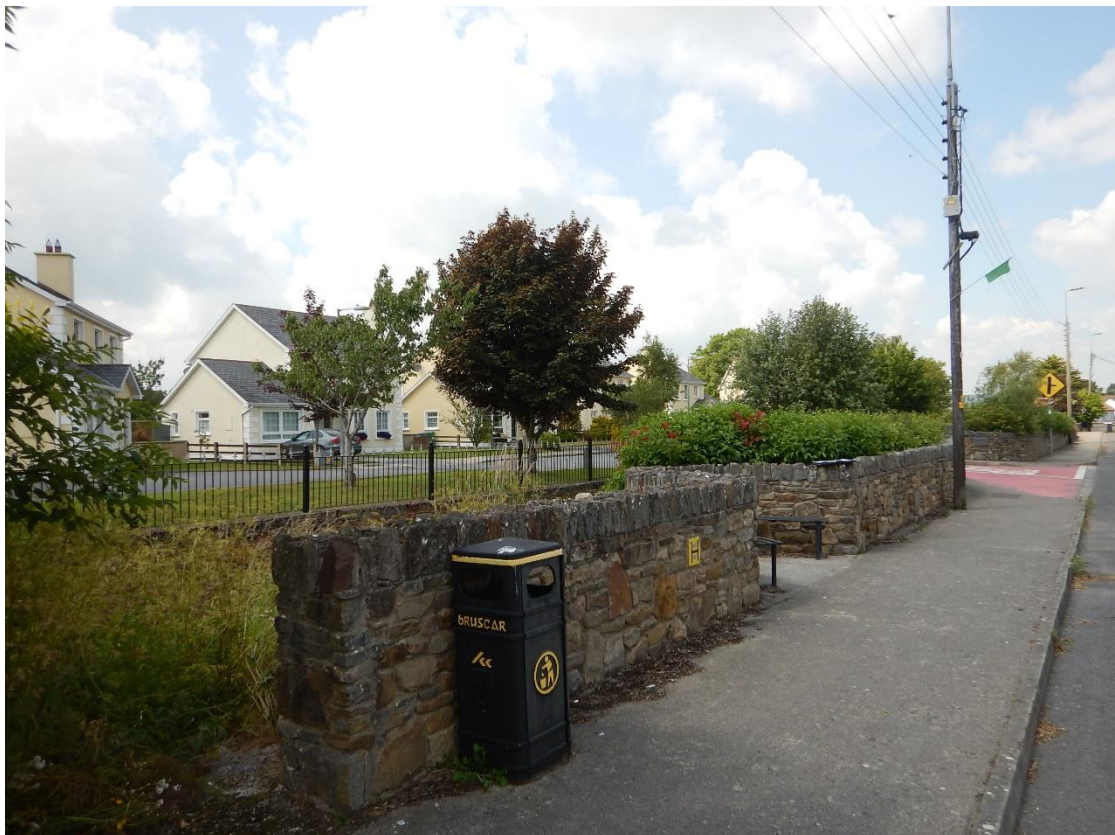
4. Amenity planting (G5, G6 and G7) in Hazelbrook

The proposed channel realignment and revised fencing layout in the Hazelbrook cul de sac should be carried out with a minimum of encroachment towards the landscape trees located in the green open space between the houses and river channel. All works should be kept outside of the nominal RPAs of the trees making up groups G6 and G7 and tree T30 by way of temporary fencing for the duration of the works.
