Mullinavat Urban Design Study

Photographs to Accompany Text

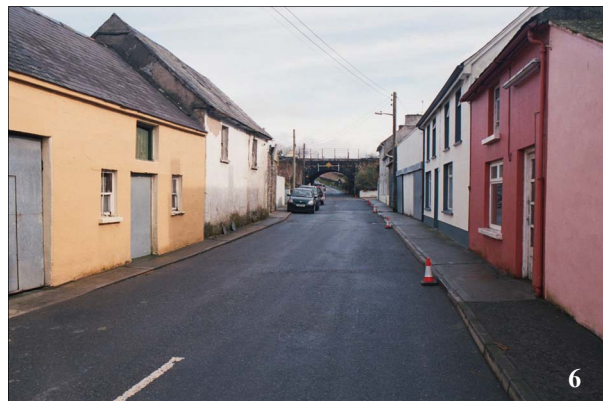
Photo 6: Despite some obsolescence in the building stock along this street, there is a strong sense of enclosure provided along much of its length. The existing urban grain (as determined by traditional plot widths, building lines and building form) should be retained in any redevelopment proposals.

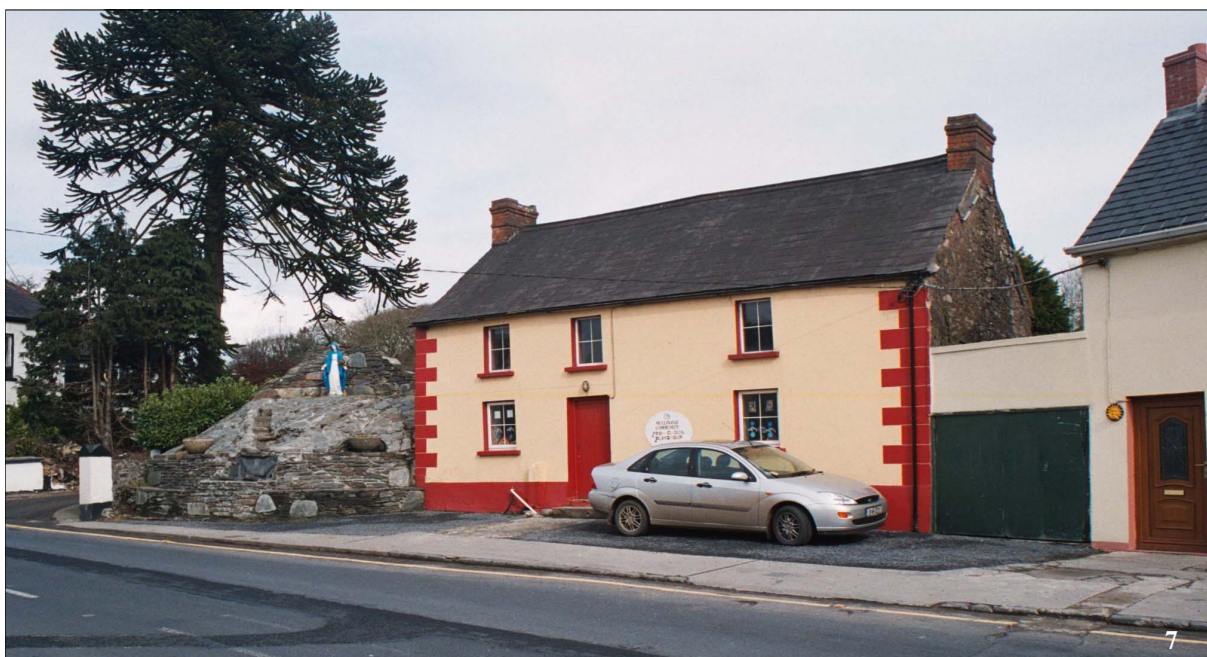
Photo 7: The building below, typifies most of the traditional building stock in the village. As evident in this photo, the building is of stone construction (see gable end), with rendered façade, slate roof and incorporating elements of brickwork (as seen in the chimney breasts). Traditional timber sash windows have been replaced with modern uPVC—an unfortunate, yet common trend.

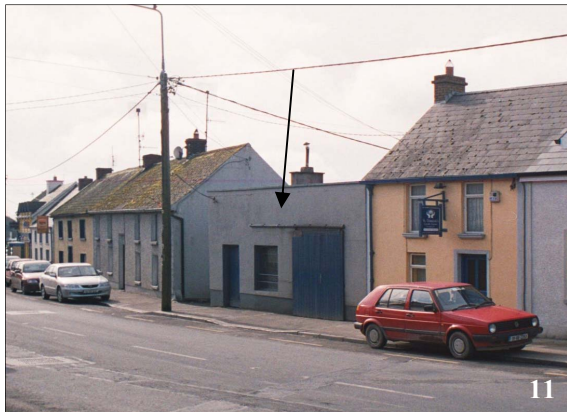
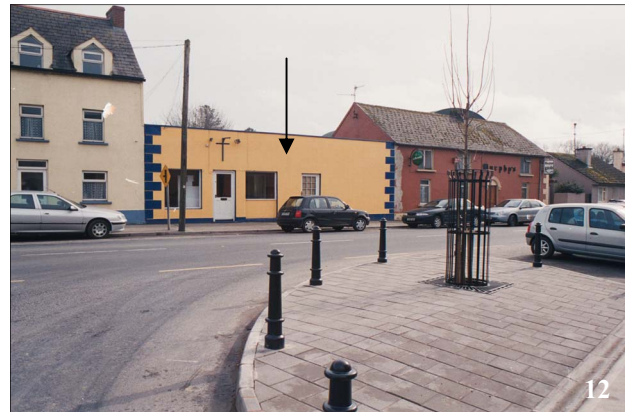
Photos 11 & 12: There are a number of single storey structures in the village, whose scale, form, façade and/or architectural treatment is inappropriate to the traditional Kilkenny streetscape and these buildings offer scope for redevelopment. In the example on the left (No. 11), the roofline and roof-pitch should match the neighbouring building on the right. In the example shown on the right (No. 12) the buildings height would rise to act as an intermediary between the higher building on the left and the existing building on the right.

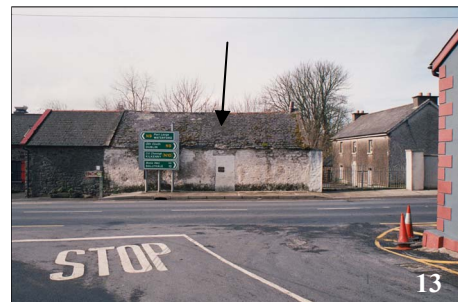
Photos 13: There are a number of buildings whose former use (i.e., agricultural) has become obsolete or the quality of the structure has become derelict or semi-derelict. In the example shown, the structure is a 'focal site' directly in view at the junction with the R704, and therefore would merit from redevelopment and enhance the townscape of Mullinavat.

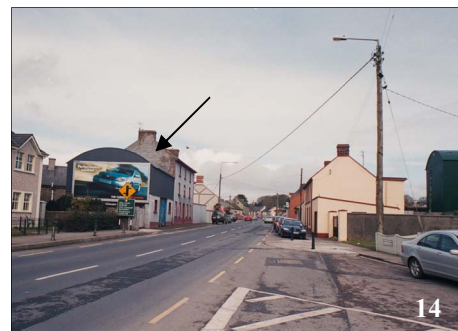
Photo 14: On entering the core of the village from the south, there are galvanized steel structures (akin to steel hay barns) and single storey structures whose scale and composition is out of character with the rest of the streetscape. The photo also reveals (see arrow) a quirky architectural feature distinctive to the south-east of Ireland—the presence of slate on the gable end of buildings. Such slate generally had its origins in England and Wales and was used as ballast in returning ships that exported timber and agricultural goods from Ireland. The slate was so predominant that it was used to clad the gable ends of buildings. It is generally associated with port towns such as Wexford, Waterford and New Ross.

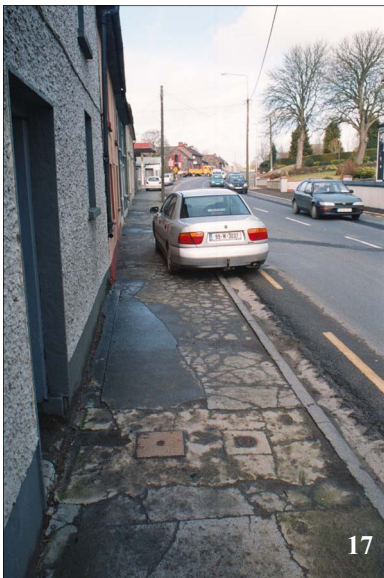
Photo 17 (left): Poor footpath conditions on the west side of Mullinavat Main Street. Note also car parking on footpath due to limited provision in the vicinity.

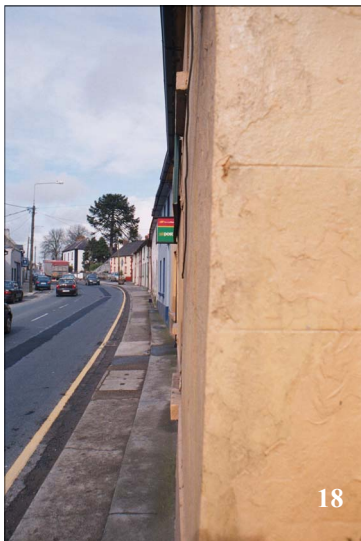
Photo 18 (Below left): Narrow footpaths close to busy road detracts from the residential amenity of the Main Street—east side.

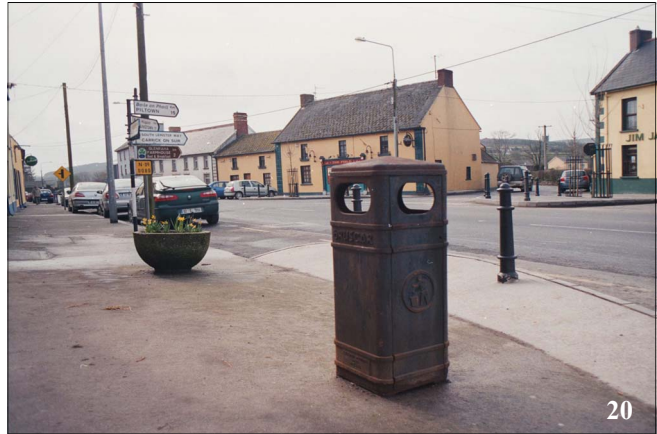
Photo 20 (top right): Elements of street furniture—planters and litter bin. Note that litter bin is in need of refurbishment and/or repainting.

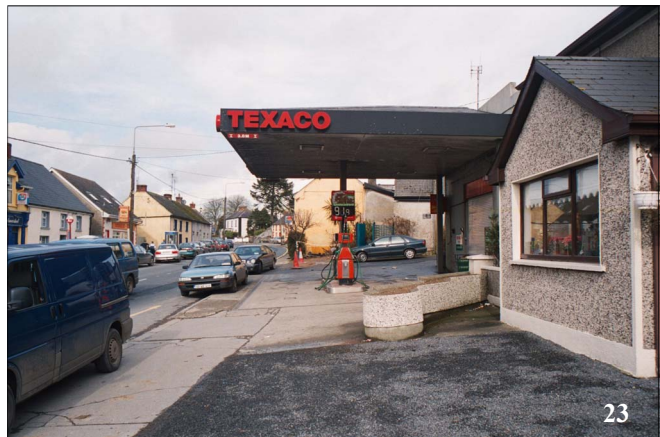
23

Photo 23: Canopy associated with service station disrupts composition of streetscape and signage is an intrusive element.
