B Irish Building & 2025 Design Awards

Heritage/Conservation Project of the Year 2025 Piltown Garda Station and Remote Working Hub

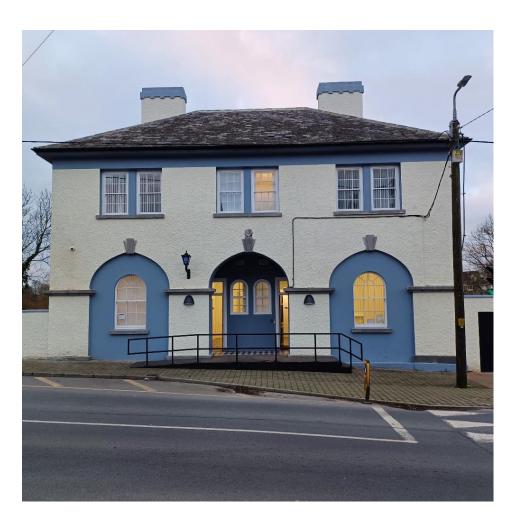
$Fig. 2-Front\ Elevation\ 2024-Existing\ colour\ scheme\ maintained$

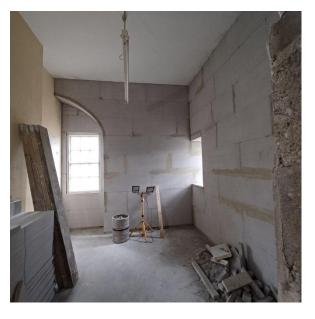
Fig.7 – Garda Station Back Office 2024 – Calsitherm Insulation

The existing internal walls consisted of a lime-based mortar which had failed in places, this was hacked off where necessary. A new Calcium silicate board and insulated lime render system was applied to improve the thermal insulation of the envelope and control moisture within the walls. This system also included a breathable paint to maximise moisture breathability.

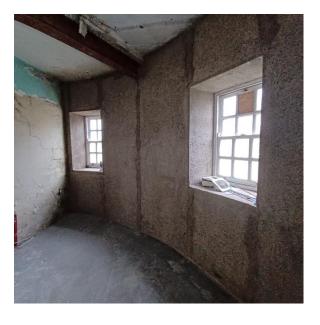
Fig.15 – Remote Hub Kitchen 2023 - Diathonite

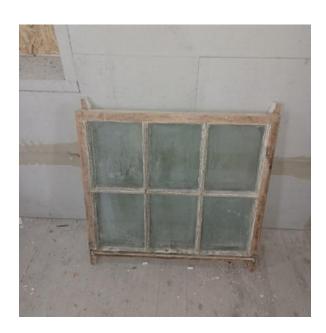
Fig.29 – Existing Window Repairs

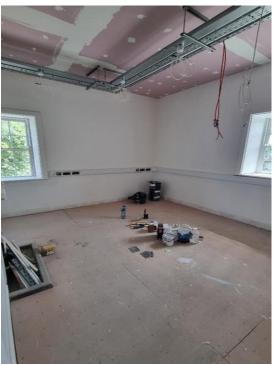
Fig.30 – First floor overlay -fire upgrade

The ground floor ceiling was upgraded to 30 mins fire resistance and the first-floor ceiling also was upgrade to 30 mins fire resistance (to protect the escape stairs).

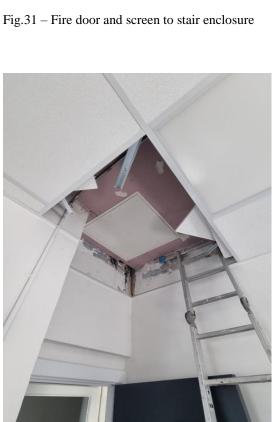
Fig. 33 - Fire rated access hatch

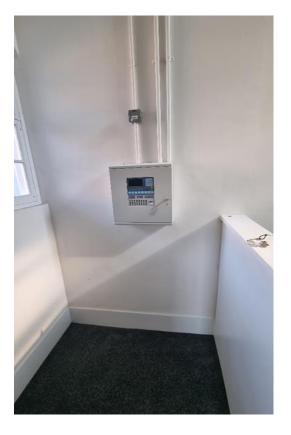
Fig.32 - Fire alarm panel

As well as means of escape measures, appropriate fire stopping measures were completed to all penetrations in the stair enclosure walls and in the ground floor and first floor ceilings and a new L3x fire detection & alarm system and an emergency lighting system was fitted.

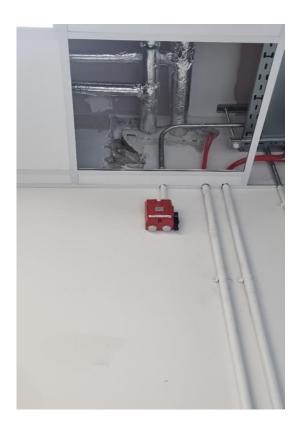
Fig 34. Fire stopping to escape routes
