**ARCHAEOLOGICAL TEST EXCAVATION AT BACK LANE, KILKENNY**

**FOR KILKENNY COUNTY COUNCIL**

**MINISTERIAL CONSENT C414; registration number E4109; metal  
detection R217.**

**CLAIRE WALSH  
FEBRUARY 2011**

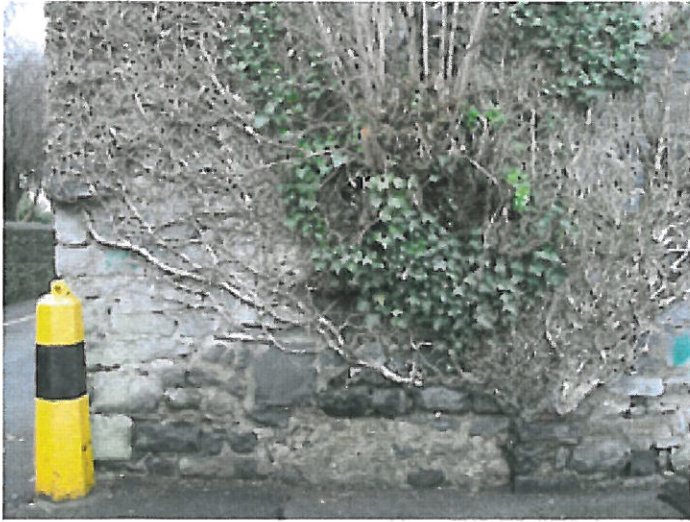
Plate 17. Wall along millrace with flat headed blocked ope.

The northern end has a blocked flat headed ope (plate ). Several discreet builds are evident at this point, and in general they are all poor masonry. Most of the stone is blocks of calp, which is coursed and lime bonded. The face of the blocks are chipped. The masonry incorporates some re used stones.

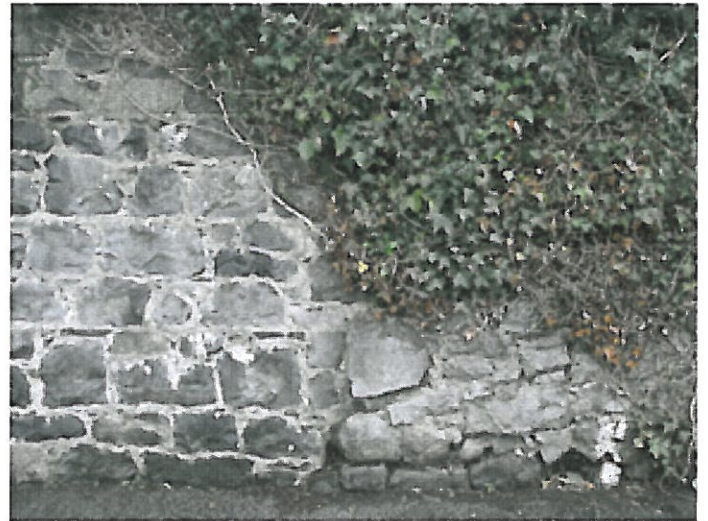
Plate 18. Wall along millrace, showing join of two builds.

Towards the southern end of the wall, the enclosure shown on the Ordnance Survey second edition is evident in the wall where the later wall to the north abuts the earlier build. The earlier masonry projects westwards beyond the addition (plate ). The stonework is weathered, however of poor build, and there is a noticeable bulge in the wall here.

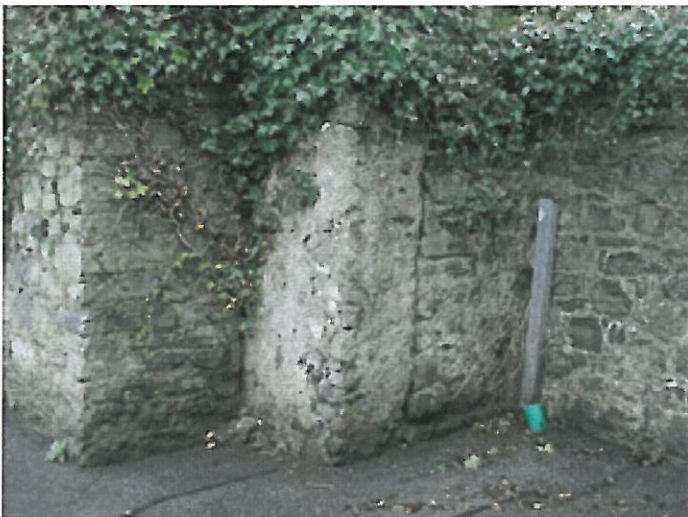
Plate 19. Untied walls at boundary at millrace.

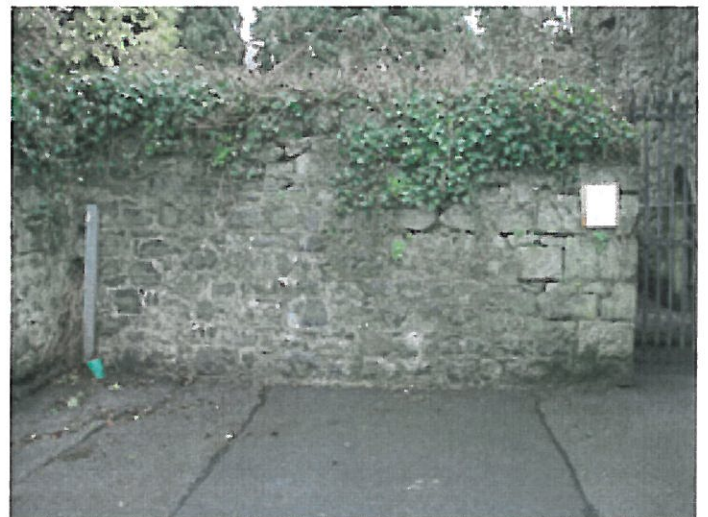
Plate 20. Wall at stepped entrance to site at west.

The stepped boundary is not shown on Rocque, but is on the 1871 map. On the 6 inch historic map, there is a different walled enclosure at this location. Several walls end along this stretch, and are not tied into one another- there is a gap between the walls (plate ). The end of this wall includes red brick. The innermost stretch of walling is of weathered limestones of mixed sizes. The corner has large quoins, which could be late medieval in date, however are probably reused in this position. The entire section of walling above ground here is of relatively recent date.

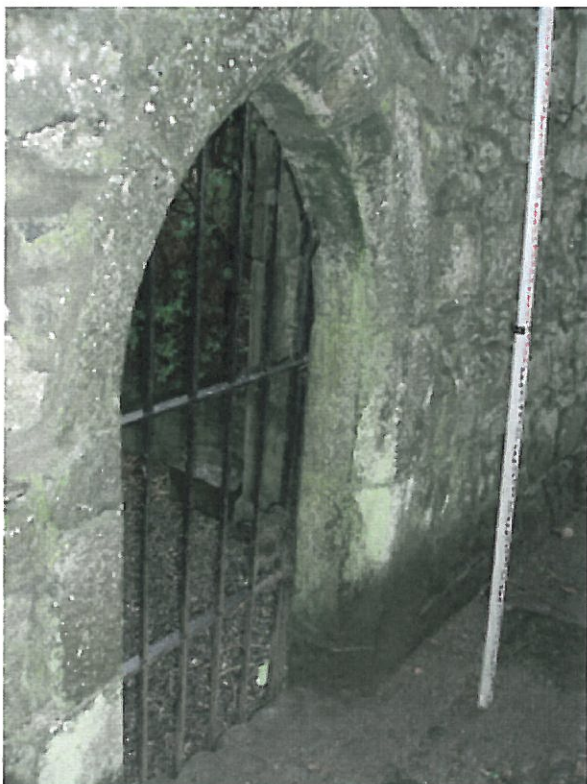
Plate 21. North door, ext, to claustral building.

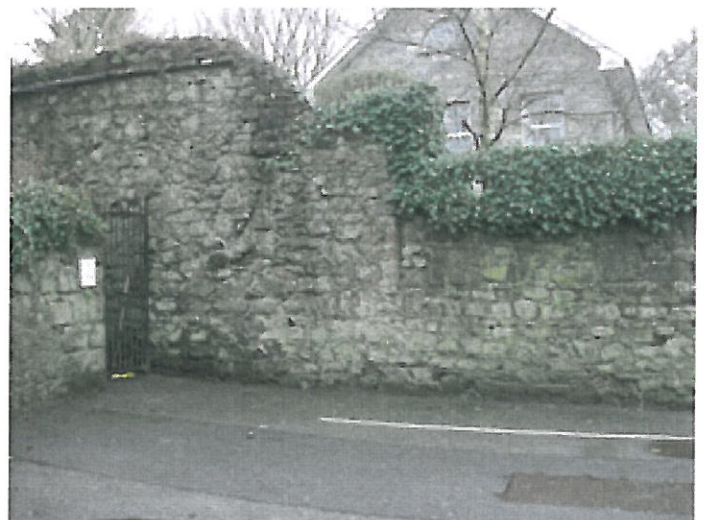
Plate 22. North wall claustral building, with added masonry to west, with brick dressed window.

The western end of the wall is late, and has a face of weathered limestone/ sandstone, and a narrow brick dressed window. The wall face bulges where the two phases of building have been stitched together. The masonry of the later building has frequent characteristic small squared blocks of limestone, and includes some brick.

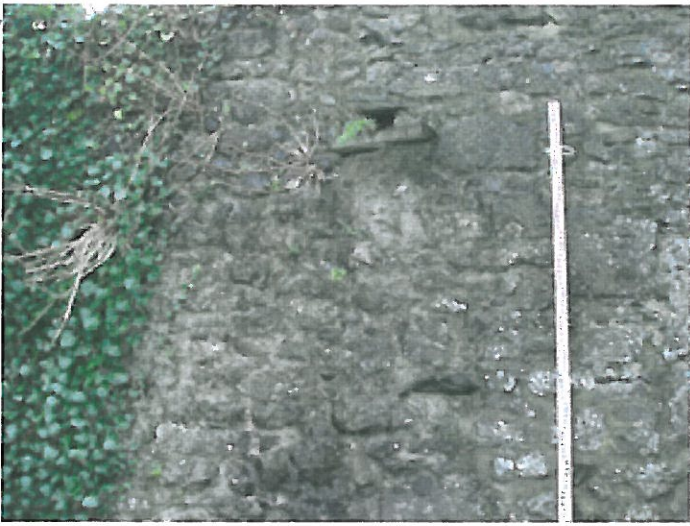
Plate 23. Drip spout in north wall, claustral building.

At the east end, there is a wall spout with a flat drip stone, the wall below is stained by moisture. Near the top of the wall, there is a course of projecting masonry, which appears to be limestone flags. (inside this building there is a suggestion of a stairwell on this wall).

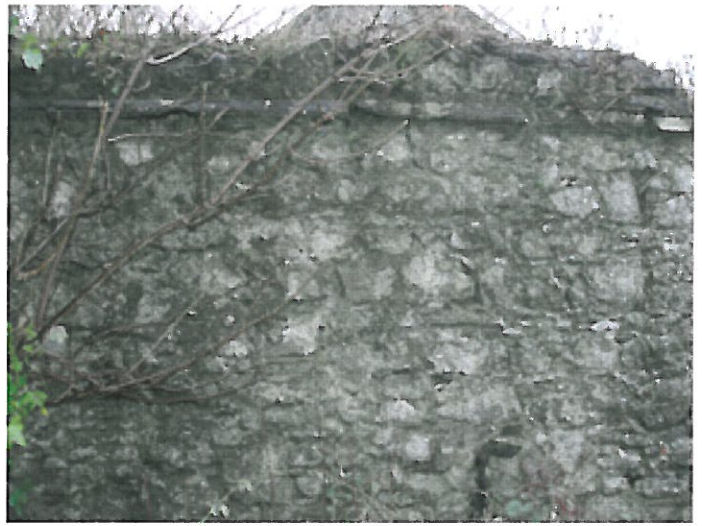
Plate 24. Ext, upper level, claustral building.

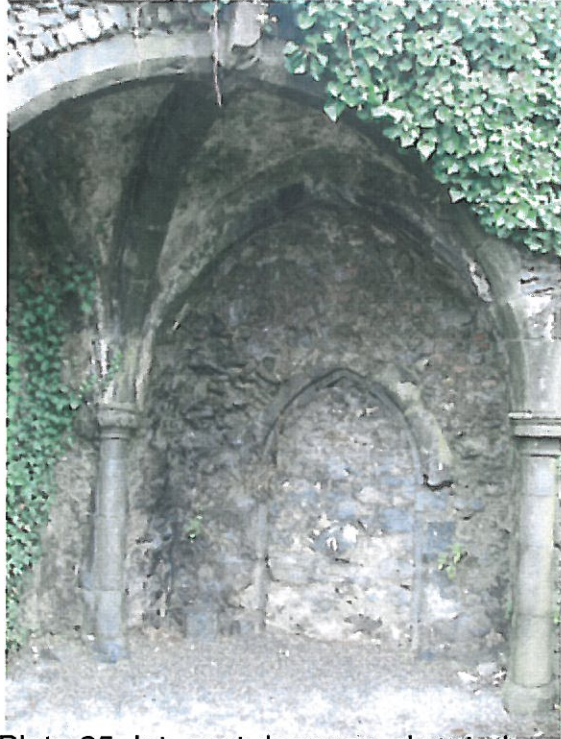
Plate 25. Int, east doorway, claustral building, note differing columns.

This is a National Monument. Most of the visible stonework is of fossiliferous limestone, probably from the Black Quarry. The building has two extant doorways, both are pointed arches, of limestone, however the exterior of the eastern doorway is of red sandstone. The original plaster remains on part of the columns, and on sections of the vaulted ceiling. The northern capital is ornate, with several human heads, however plate the columns and capitals to either side of the doorway on the east wall are of differing heights and mismatched. This queries the extent of reconstruction of this building. Much of the vaulting is studded with red brick, and small cobble type stonework, evidently patched.

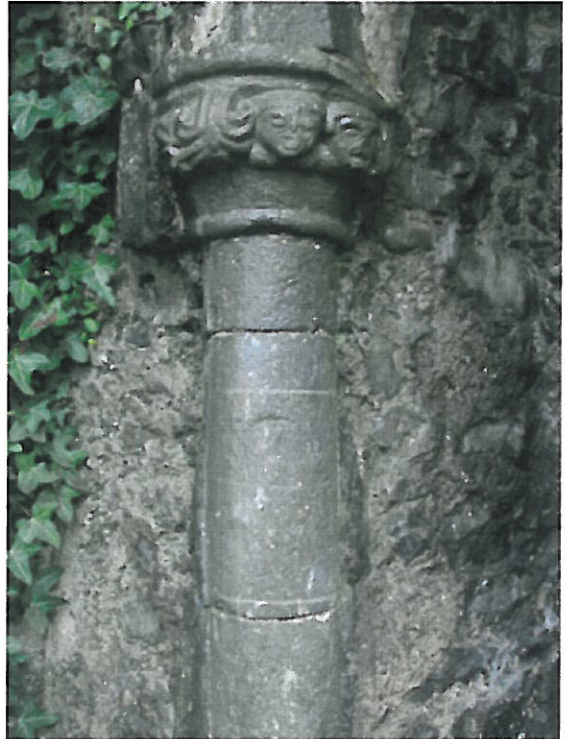
Plate 26. Column and capital with heads.

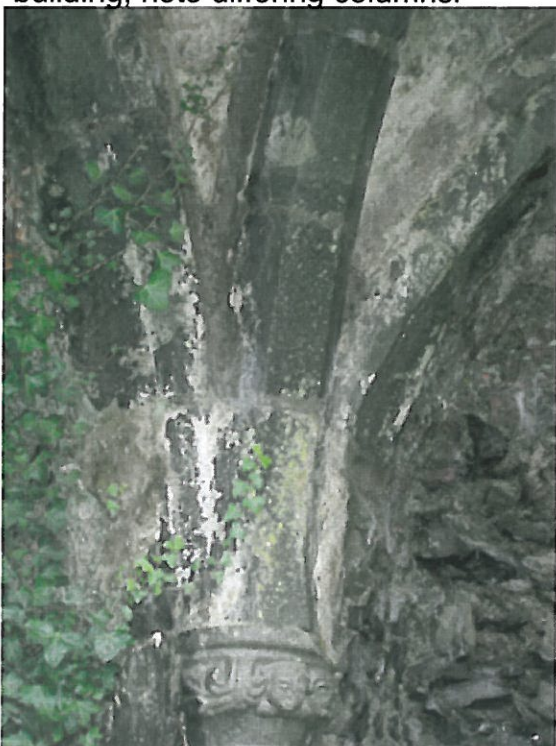
Plate 27. Voussoirs above capital.

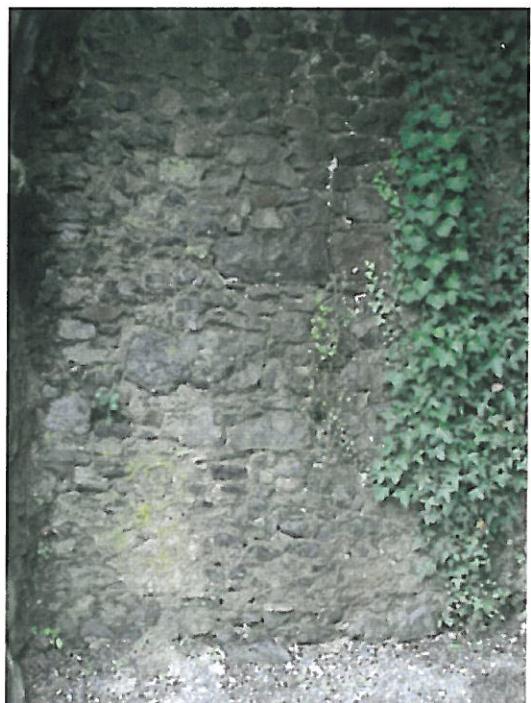
Plate 28. Detail of masonry, int north wall.

There is some evidence of a stairwell on the northern wall. It appears to have been a two storey building.

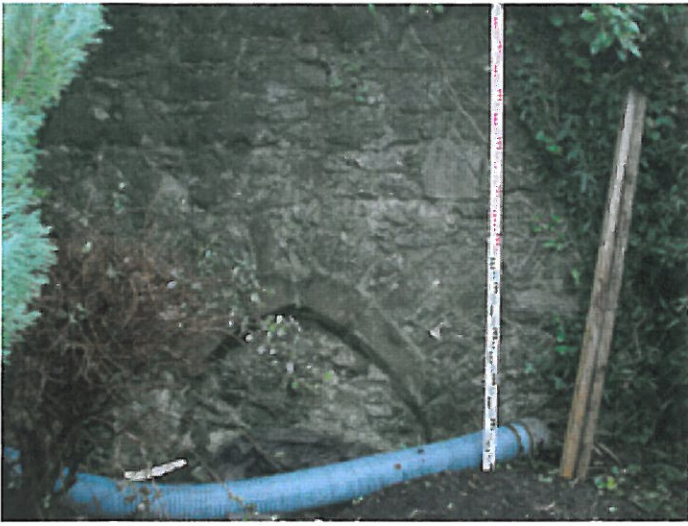
Plate 29. Ext east doorway, red sandstone, of claustral building.

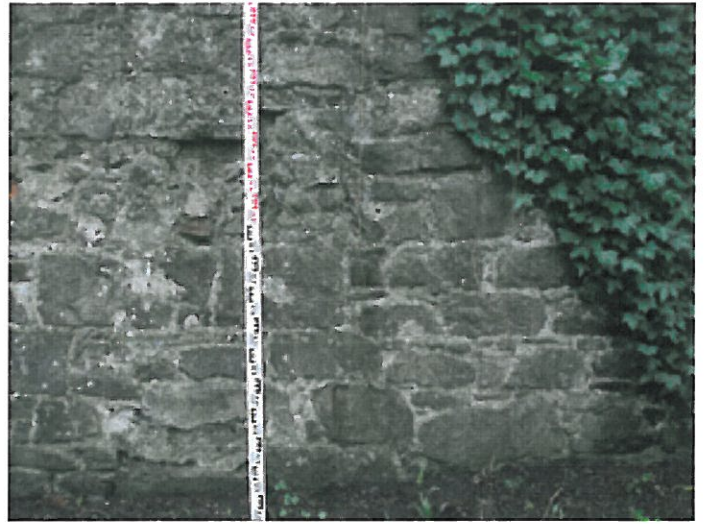
Plate 30. Red brick infill/ repair of boundary wall.

There is an irregular section of red brick and small stone in the central part of the wall, however there are no stones here that suggest a formal breach. It is perhaps a repair.

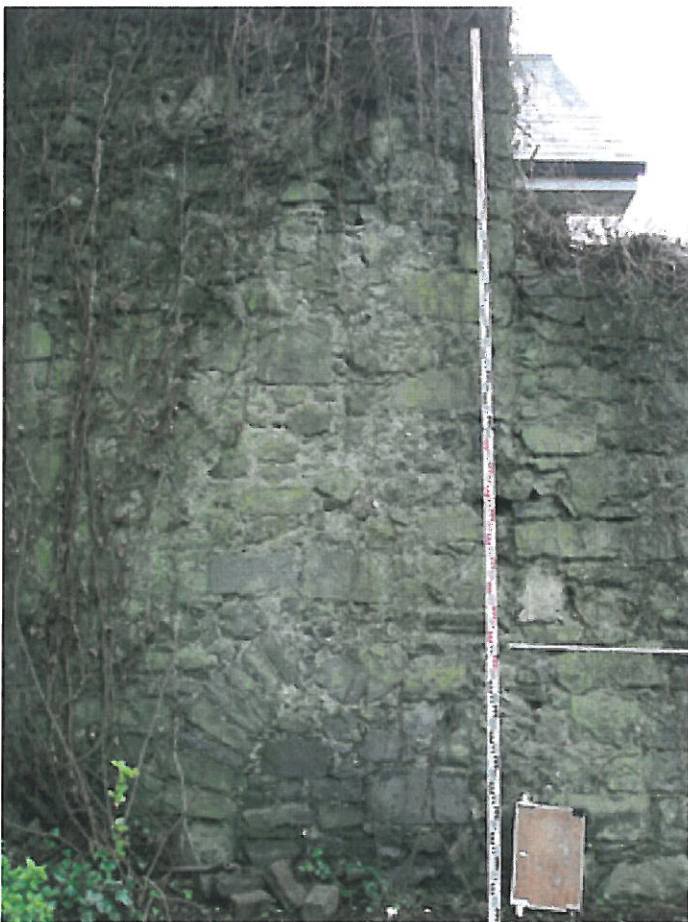
Plate 31. Blocked arch, cut /abuted by later wall.

The central section of the wall has two blocked arches, B and C. Arch B is cut through by a vertical join. The arch is of well set keystones, of angular grey limestone. The infill is composed of both large and small limestones. Next to arch B, a rectangular section of walling is evident at the lower courses. The surface of the large blocks, which resemble quoins, is laminating. A blocked opening, a probable putlock hole, and a reused sculptured sandstone are evident in the walling here. A third blocked arch, C, is higher than the adjacent arch, and is a large round headed opening, with weathered limestone keystones. The wall here is of horizontally set regularly coursed blocks.

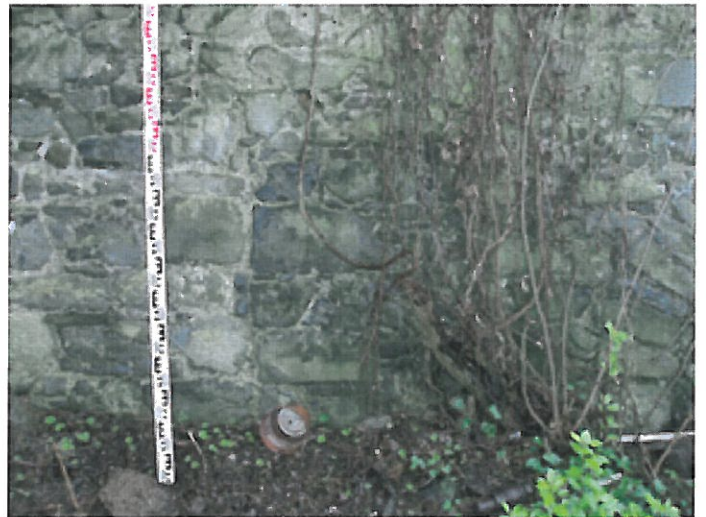
Plate 32. Join/ abutment of walls, west boundary wall.

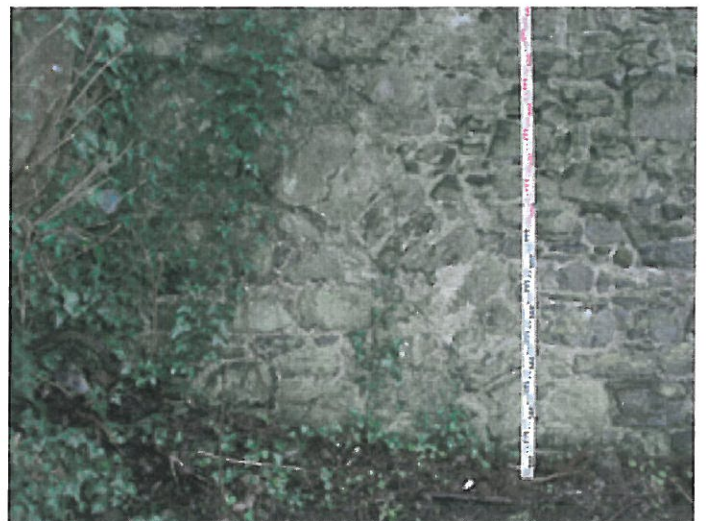
Plate 33. Blocked arch C, west boundary.

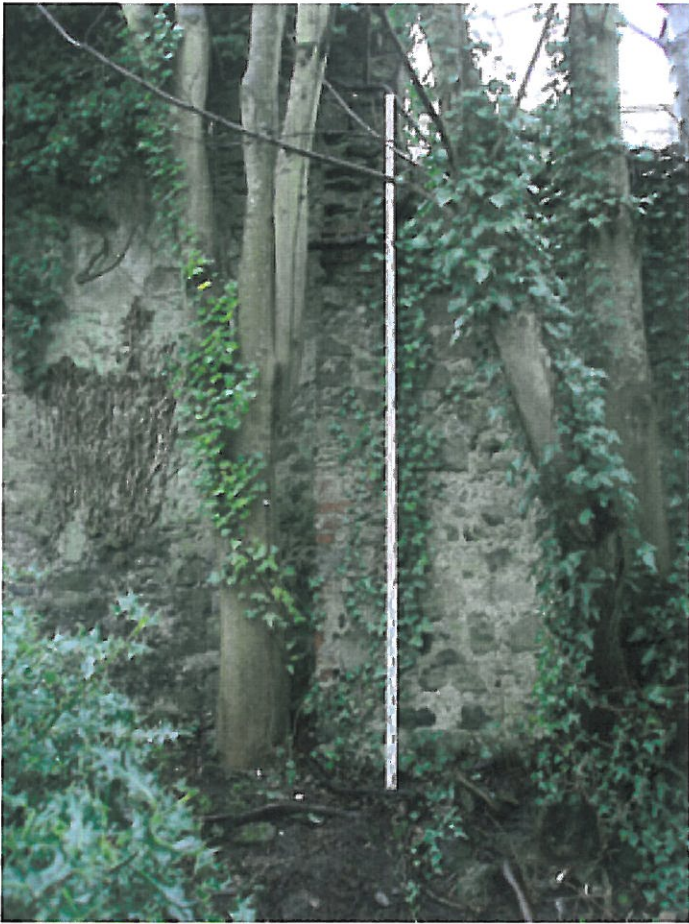
Plate 34. Brick trimmed projection where walls of two buildings on Rocque meet.

The projecting brick dressed corner of the boundary wall corresponds to the end wall of the long building on Rocque. The adjoining building on Rocque extends through the present boundary wall of the Evan's Home, and is evident here as a steep roof scar in plaster. It is also visible in the adjacent property, and it appears that an internal wall of this building forms the boundary. The lower section of walling here has several stones of a flattish headed arch, suggesting a blocked doorway with sandstone quoins.

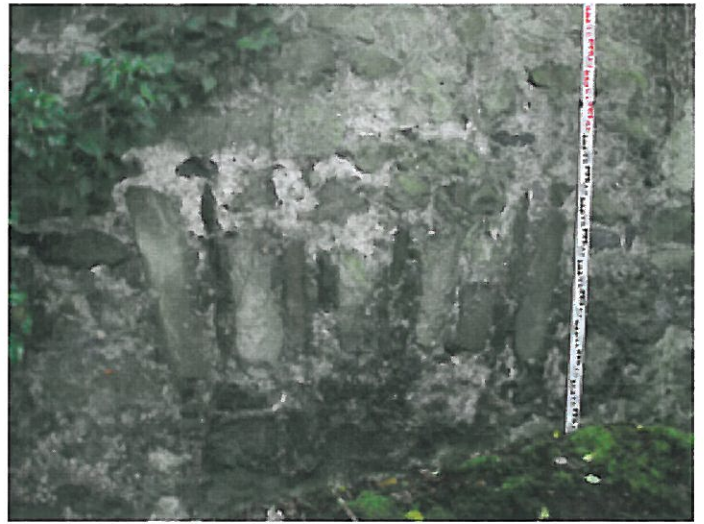
Plate 35. Voussoirs of arch over blocked ope 4.

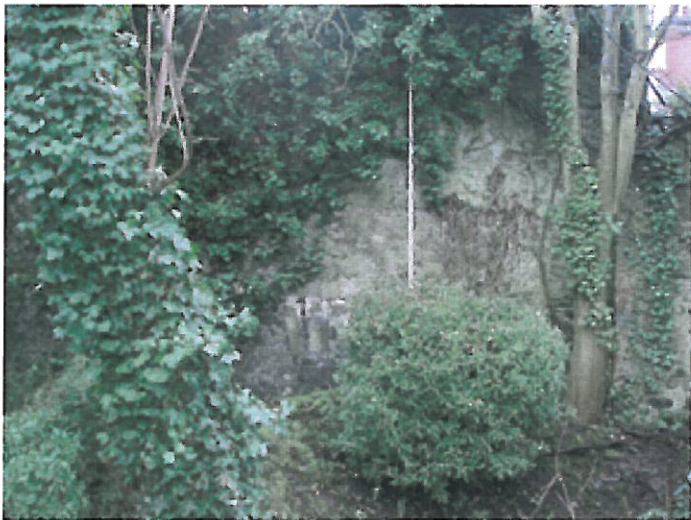
Plate 36. Scar of steeply pitched gable in plaster visible in western boundary wall.

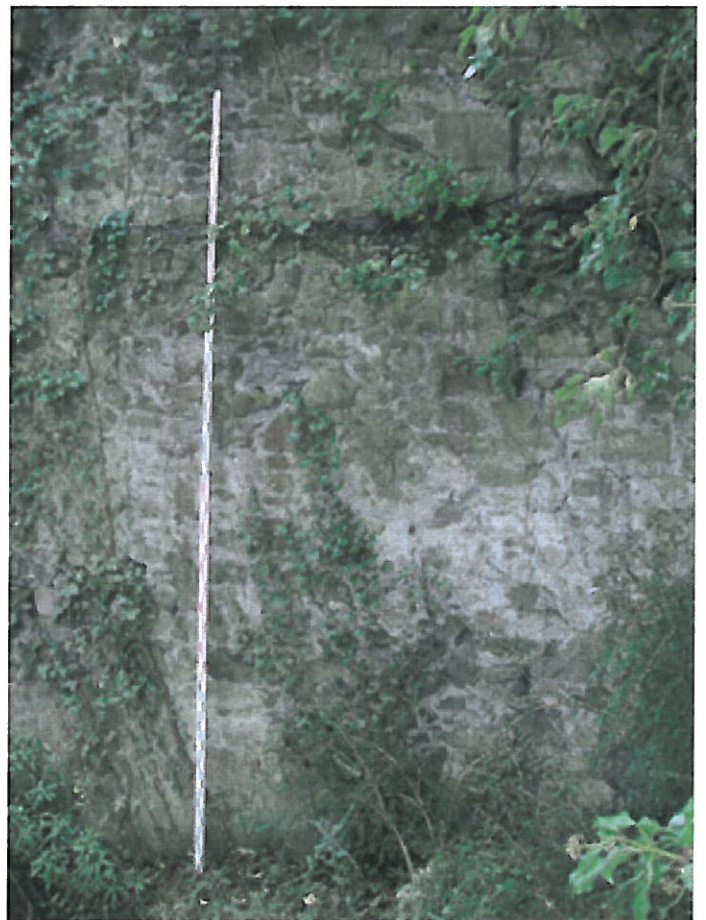
Plate 37. Internal end wall of building on Rocque, south west boundary. Scar of possible stairwell in wall.

The corner and end wall is obscured with growth, but there is the scar here of a possible stairwell, which reuses dressed stone. There appears to be a significant amount of reconstruction here- the lower courses are of large rectangular stone, while the middle and upper levels are collapsing.

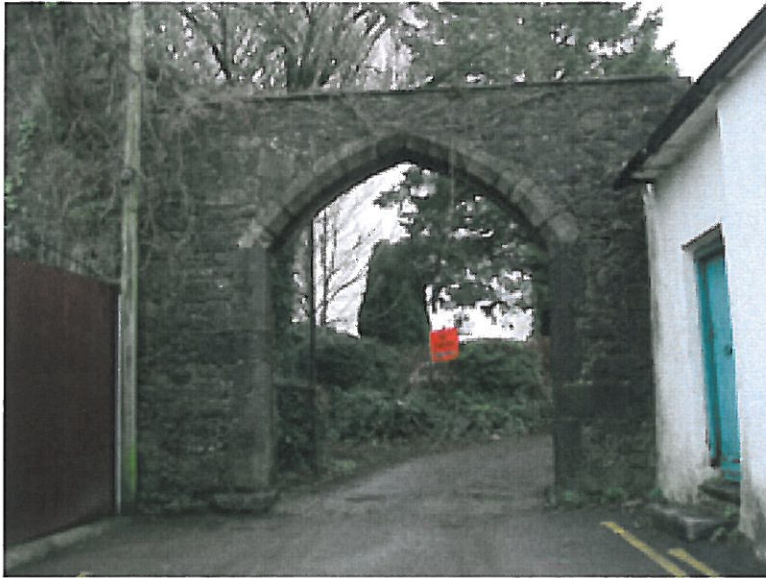
Plate 39. Gate arch at Barrack Lane, three phases of construction evident.

Barrack Lane is shown on Rocque, and is doubtless the original entrance to the priory complex from the town. The entrance arch is 3.05m in width, and the wall to the west is 1.60m in width while that on the east is 900mm in width. The entrance jambs are large chamfered limestones, and the stones of the segmented arch are fine sandstone; these are similar to the sandstone quoins in the chancel of the church, and are probably reused from the church. The inside of this arch is concrete.

The masonry of the exterior of the wall to Barrack Lane suggests three phases of building, visible in plate 39.

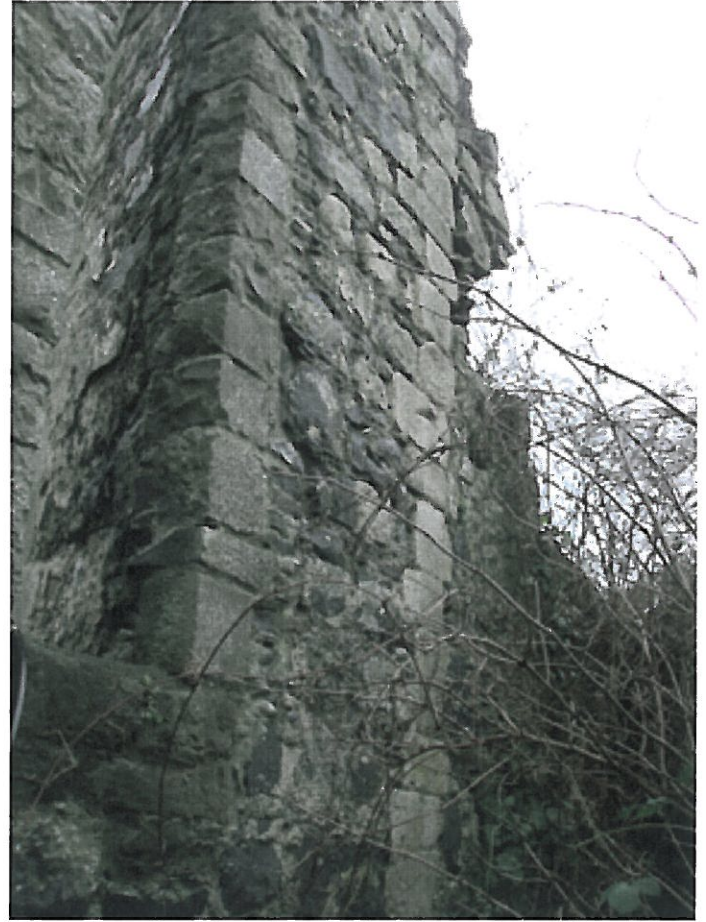
Plate 40. Sandstone quoins in north wall at south end of chancel.

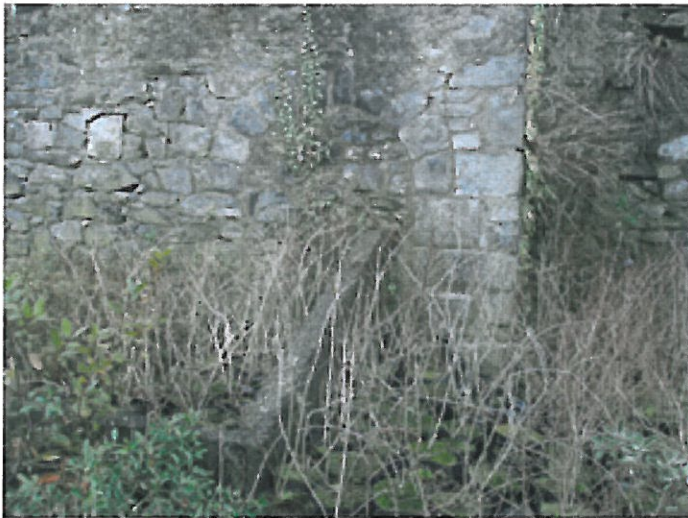
Plate 42. Round headed arch in late 18th or 19th century east site boundary wall.

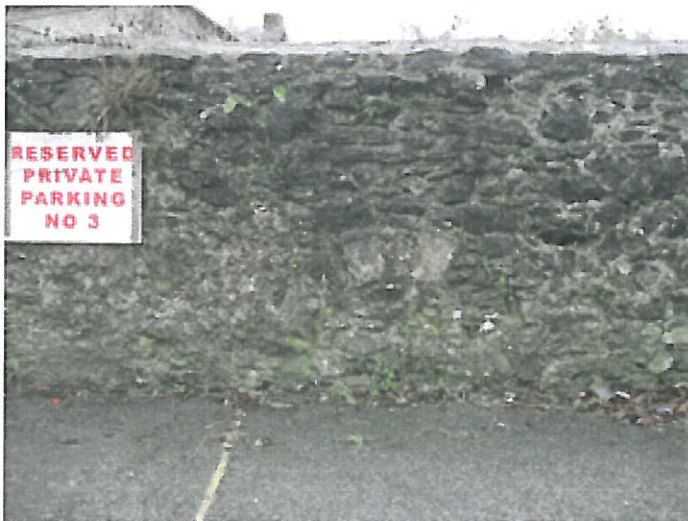
Plate 43. Blocked round headed arch in exterior of east boundary wall.

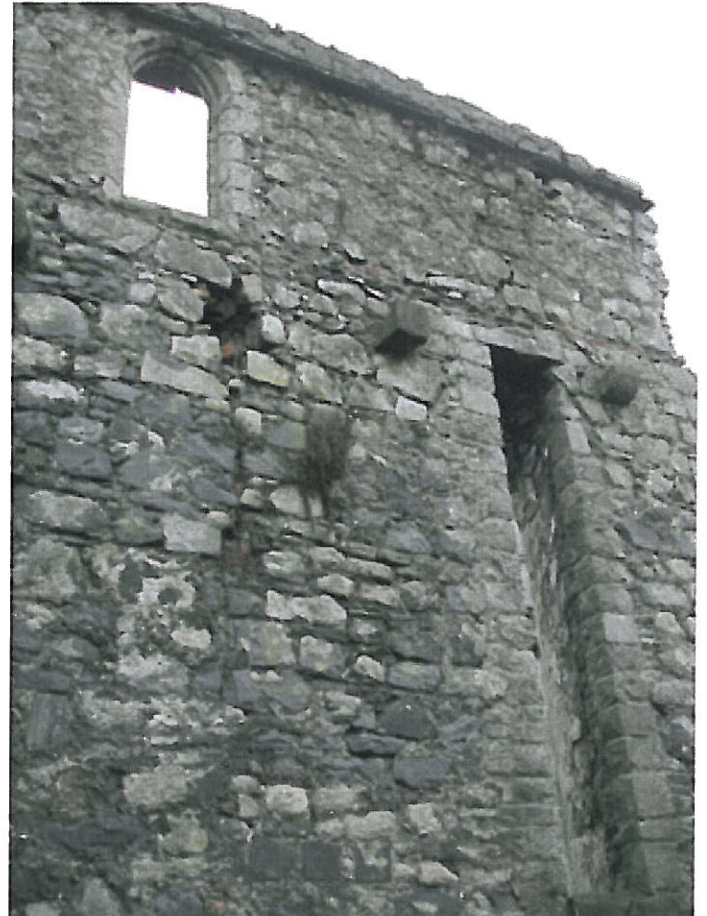
Plate 41. Patched wall of chancel, where it forms site boundary. Upper levels appear intact.

All of this walling appears to be of recent date, and much is obscured with growth. The north wall of the chancel is accessible from within the southern closet: the masonry is patched and infilled, but a line of sandstone quoins on the north-west wall of the chancel appears in situ (plate 40). Interestingly, Rocque's map shows a building to the north of the church, which appears to be the north transept of the church. Part of this wall may be extant in the east boundary wall of the site.
