Recording of buildings along
Wolfe Tone Street and Vicar Street,
Kilkenny
for the
Kilkenny Central Access Scheme

Rob Goodbody
Historic Building Consultant
March 2013

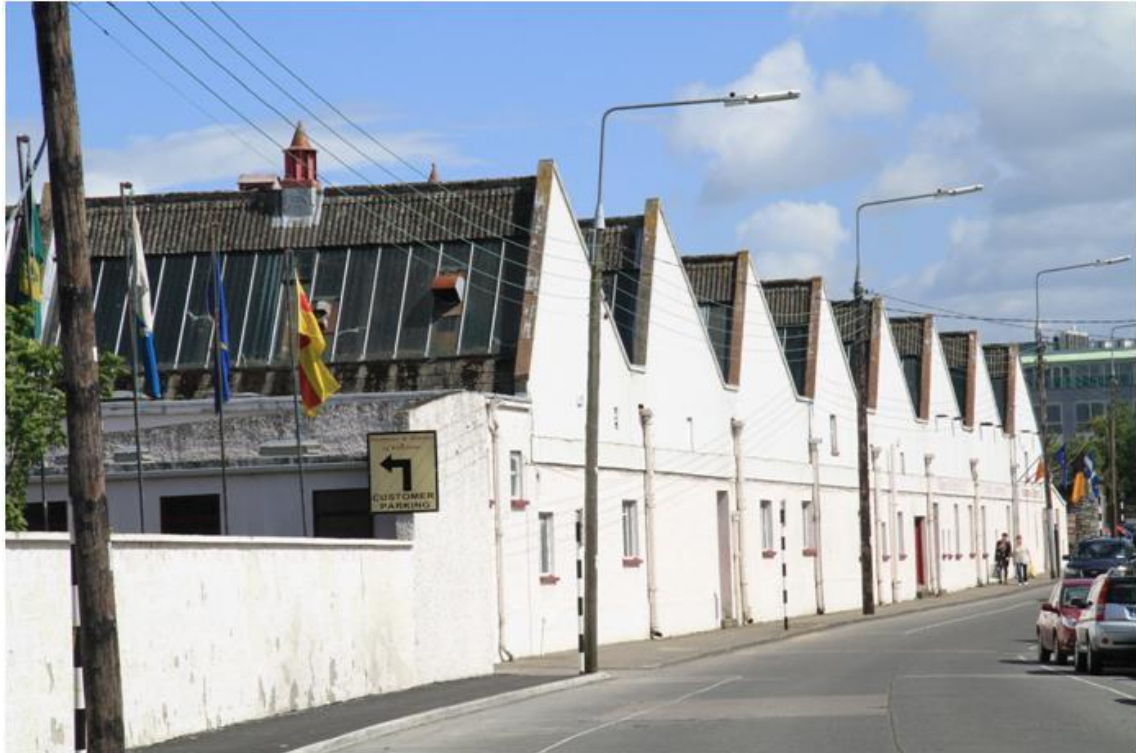
Plate 1: Padmore and Barnes' premises with wall at site AH 2 on left

The boundary wall to the west of the factory building at Padmore and Barnes is seen at left in the photograph above, with the factory building running to the east of the wall.

Seen from the road, the wall appears to be of concrete construction, faced with roughcast render or pebbledash, and capped with precast concrete copings. Immediately to the west of the main factory buildings there is a single-storey, flat-roofed extension to the factory, and the boundary wall rises to form the side wall of this structure. The wall rises higher than the extension and is faced with a similar roughcast render, though without the precast concrete capping that is seen on the boundary wall.

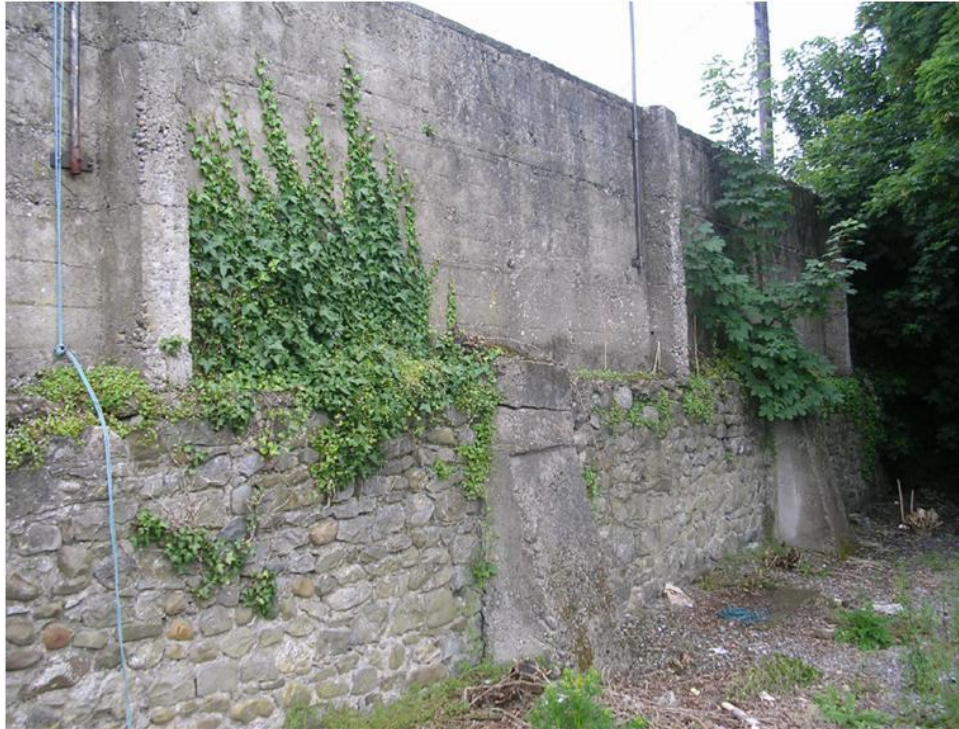
Plate 2: Northern face of wall at AH 2

Seen from the property at Padmore and Barnes, the northern side of the boundary wall is of two-stage construction. The upper portion, corresponding to the wall seen from the road, is of mass concrete, plank-shuttered and raised in three lifts, with integral mass concrete piers at intervals. This is perched on top of the lower section – a rubble stone wall, which is buttressed with mass concrete buttresses at intervals.

The stone wall is constructed of modest-sized stones, many of which are rounded, indicating an origin as field stones, rather than the more rounded type found was water-worn stones. The stonework is laid with a general horizontal emphasis, but without any obvious coursing.

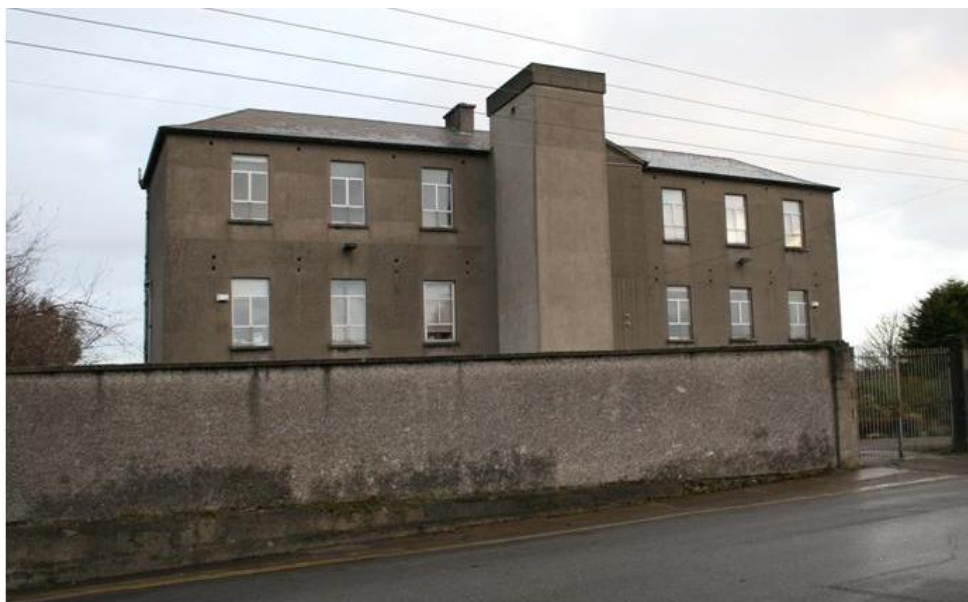
Plate 3: The former Kilkenny City and County Fever Hospital

The former Kilkenny City and County Fever Hospital is a three-storey, seven-bay building on the northern side of Wolfe Tone Street. The building has a hipped, slated roof and the facade is rendered with sand and cement. In its original form the building had a gabled and pedimented breakfront in the central bay, and while this is still in place, a rectangular structure has been built against it, running up through the height of the building to rise above the breakfront. This structure is off centre to the breakfront and the original window layout has been amended to include a window on each floor set off-centre to the building. The windows throughout the main building have been replaced with aluminium casements. There are no windows in the additional structure.

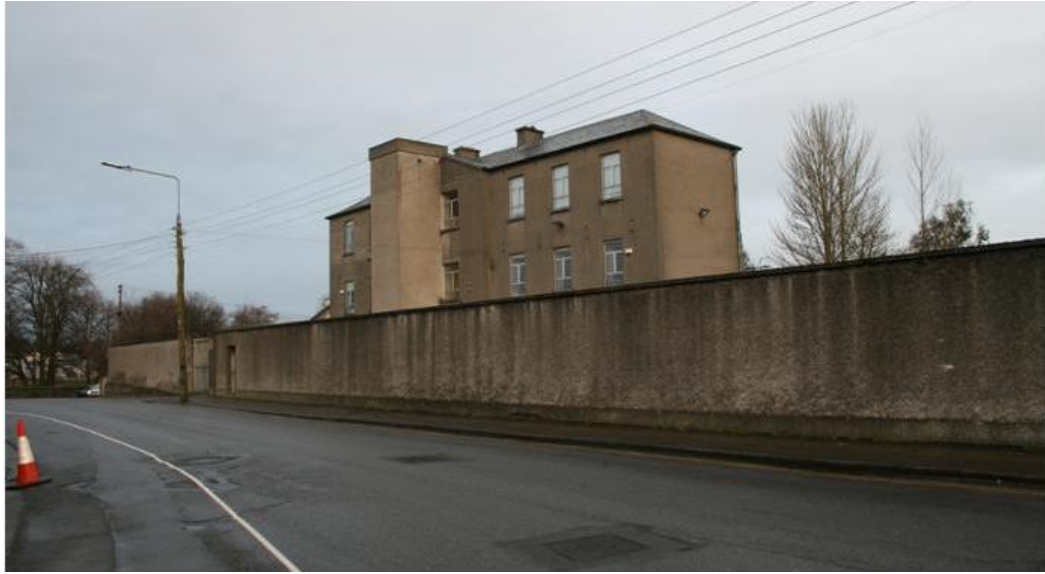
Plate 4: Front boundary wall of fever hospital

The grounds associated with the former fever hospital are surrounded by a high wall. This runs along the frontage with Wolfe Tone Street, extending almost to the junction with Greensbridge Street, before returning along the western side boundary of the property. At the eastern end the wall also returns to form the eastern side boundary.

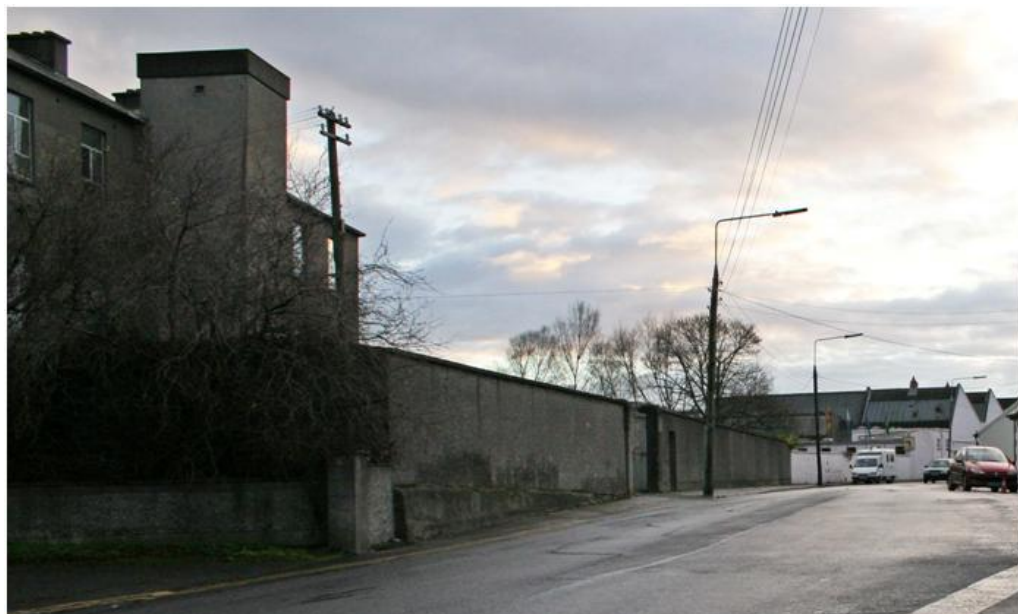
Plate 5: Boundary wall seen from the west

The top of the wall is more or less level, without any stepping, despite the slope in the road surface. Towards the western end the road level drops significantly and the lower part of the wall is rising above a plinth of mass concrete. This part of the wall is not surfaced with roughcast render to match the upper section.

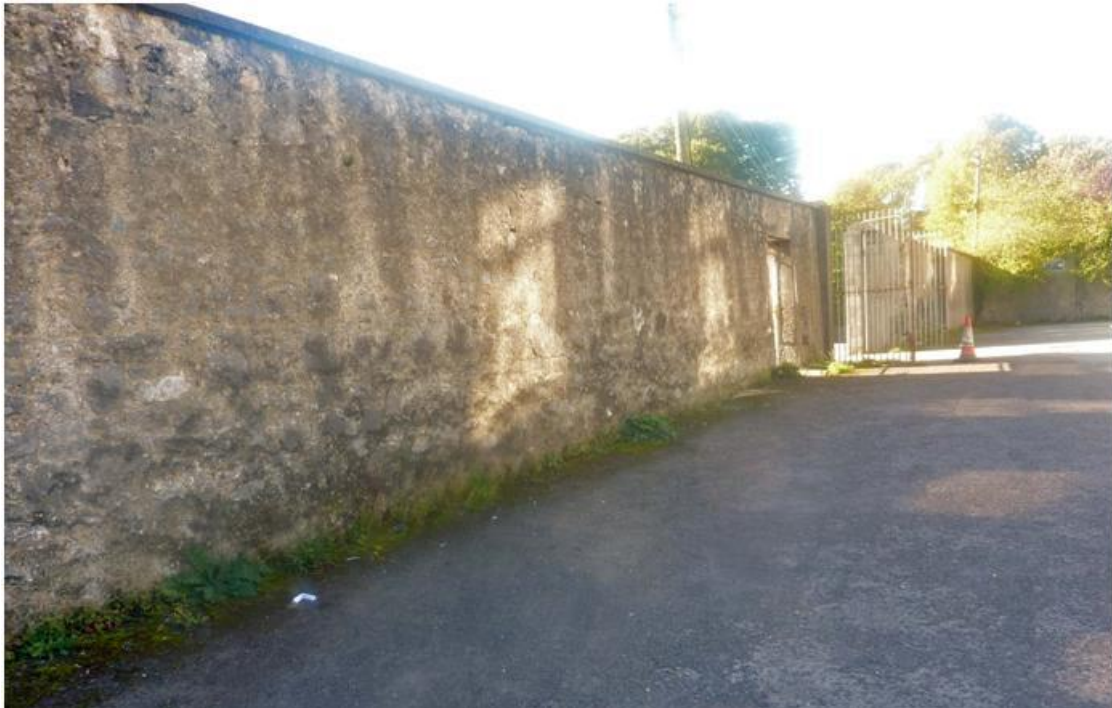
Plate 6: Internal face of wall at road frontage

Within the property the wall is faced with harling, or rough-cast render. This differs from the render on the outer face in being a lime-based harling, with small aggregate size and set in a lime-based binder. The wall beneath the render is of rubble stone.

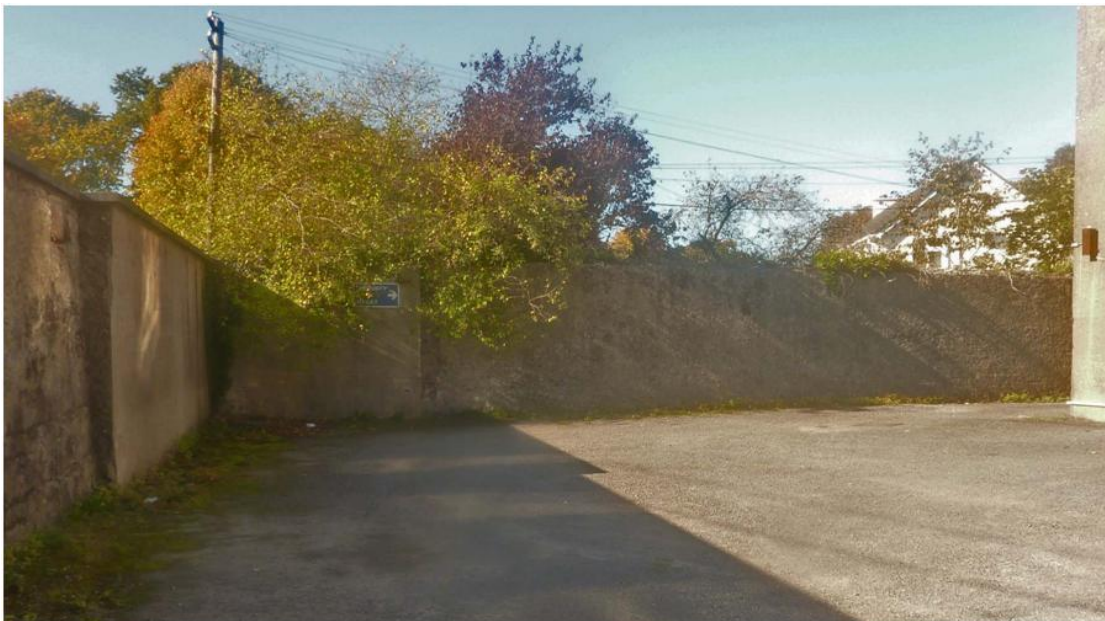
Plate 7: Northern end of front wall, and northern boundary wall

At the northern end the front boundary wall is of concrete, and rises more vertically, in comparison with the older stone wall adjacent.

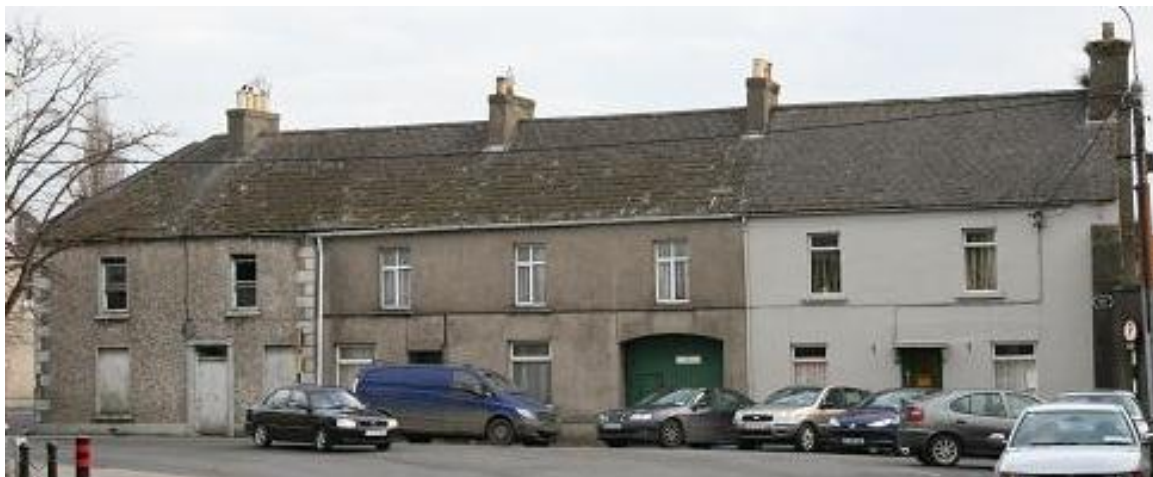
Plate 8: Numbers 20 (left) to 22 (right) Vicar Street

The three houses at 20, 21 and 22 Vicar Street form a terrace that faces directly westwards towards Dean Street. All three are two-storey houses with slate roof and rendered walls. There are other similarities between the houses including the general levels of the window heads and sills and the dimensions of the windows. While all three houses have been altered significantly such that they appear quite different, there are features that they have in common.

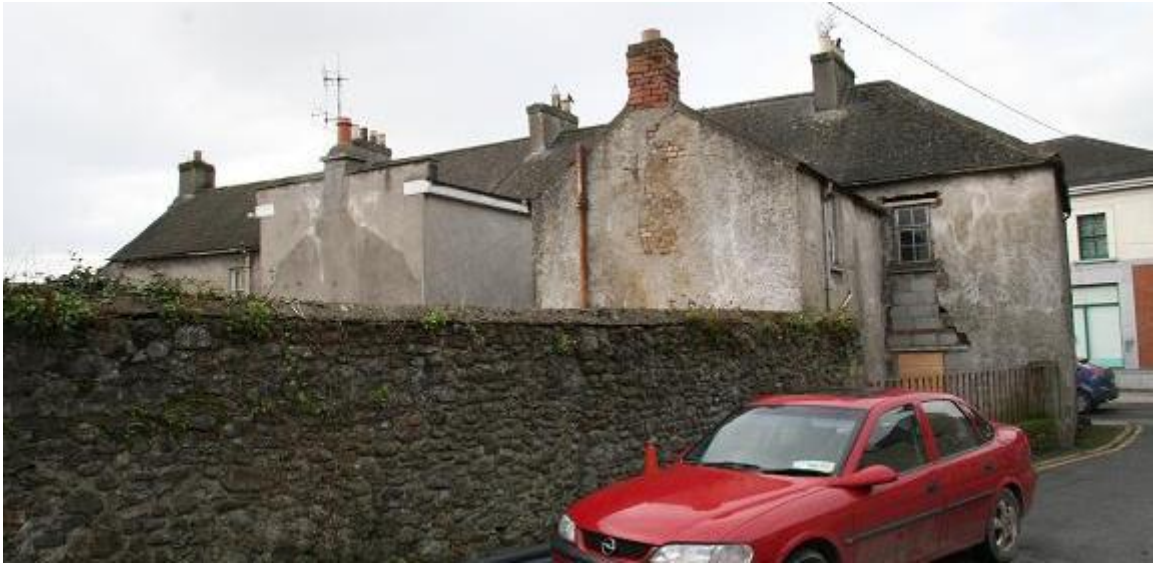
Plate 9: Rear of number 20 (right) and 21 (left)

Both numbers 20 and 21 have two-storey returns to the rear. These are extend approximately the same distance back from the front section of the house. The return on number 21 was lower than that on 22 originally, but the side walls have been built up to form a flat-roofed return.

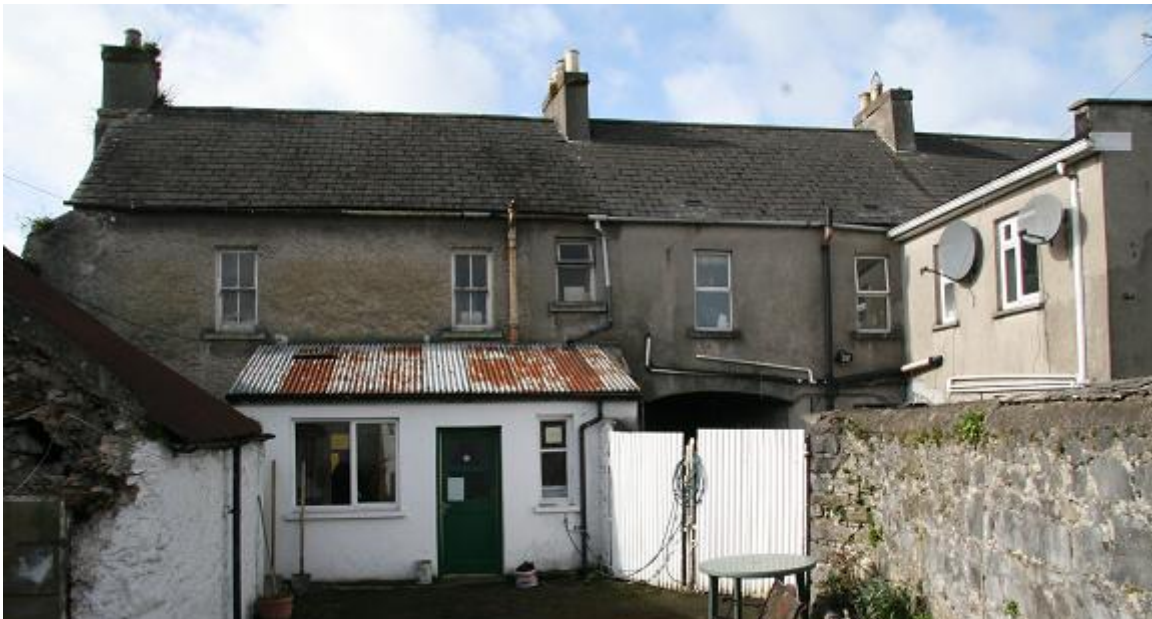
Plate 10: Rear of number 22, with number 21 on right

There is no original return at the rear of number 22. There is a modern single-storey extension to the rear built of concrete and with a corrugated iron roof.

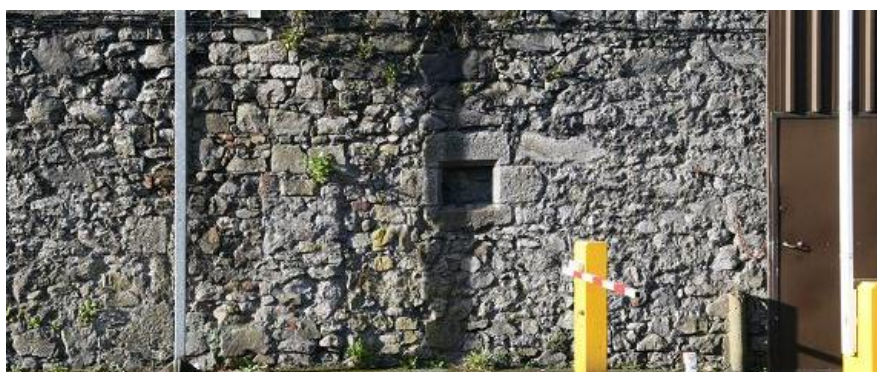
Plate 11: Medieval ope in stone wall within car park adjoining 22 Vicar Street. There is no brick in the masonry beneath or to the right of the ope. To the left, however, there is a great deal of brick fragments, indicating a later alteration or reconstruction.

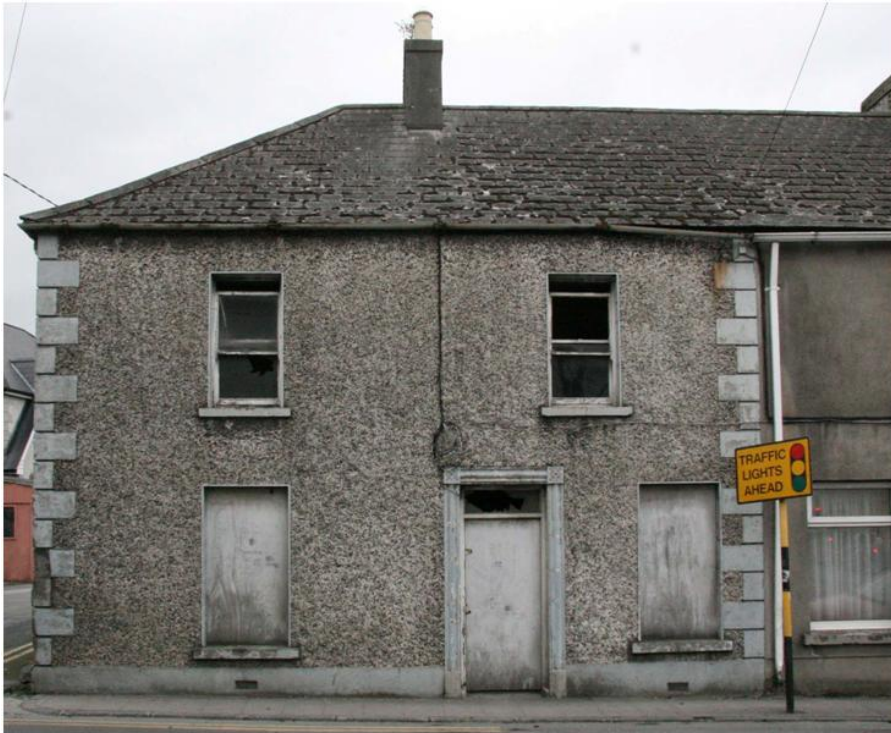
Plate 12: Front facade of 20 Vicar Street

The photograph above shows number 20 as it was in 2008. The house has subsequently been tidied up and painted externally, though the new boarding of the windows conceals the nature of the first floor windows seen in the above view.

The house is two-bay and two-storey with a roughcast rendered facade having rendered quoins. There is a smooth render plinth with cast iron vents beneath each of the windows. The front doorway has a moulded architrave and there is a rectangular light over the doorway. The original door is missing and there is a mid-twentieth century glazed door in its place, now concealed behind boarding. The first floor windows are one-over-one timber sliding sashes with simple quadrant horns. The ground floor windows are similar, though concealed behind boarding.

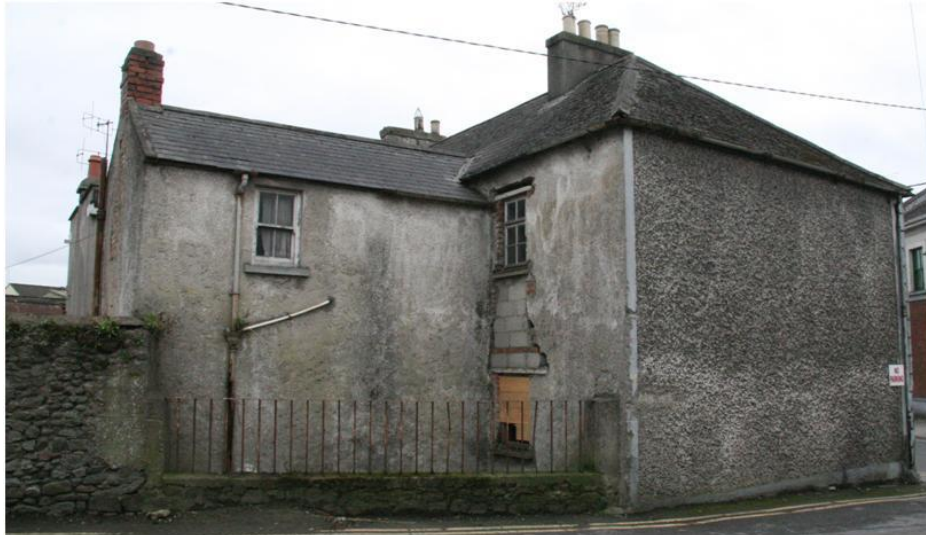
Plate 14: Side of 20 Vicar Street and its return

The side elevation of number 20 Vicar Street is pebble-dashed with no opes. The hipped roof terminates at eaves with uPVC guttering. The rear elevation on the northern side of the return is roughcast rendered and has a window ope on each floor, located close to the wall of the return. The lower window is boarded up externally at ground floor level and has a casement window on the upper floor. The area between the windows has been broken open and filled with concrete blocks, though not finished. The lintel over the upper floor window is concrete and has been inserted without the ope around it backfilled. The return is roughcast rendered and has a two-over-two timber sash window on the upper floor level and no windows at the lower level.

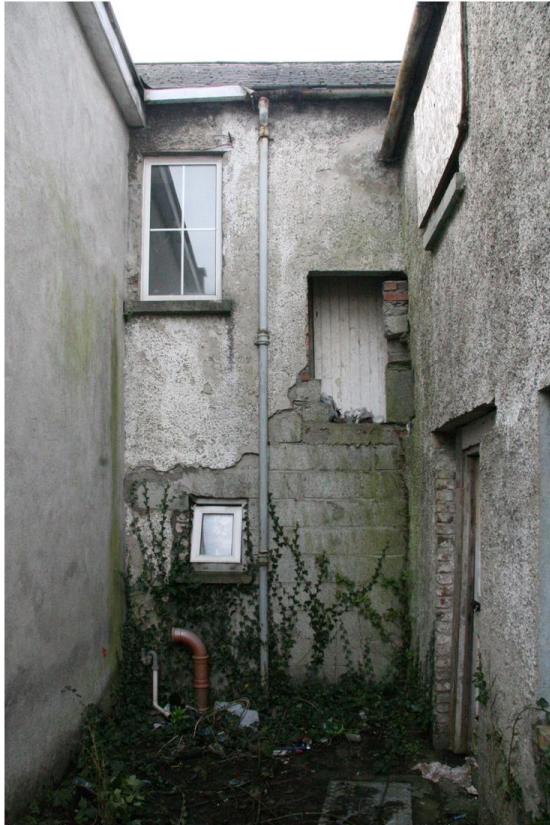
Plate 16: Rear of 20 and 21 between returns

There is a narrow section of the rear elevation of the main house visible to the south of the return, along with a narrow section of number 21. The lower part of the wall of both houses has been rebuilt in concrete block, with a small uPVC window in the rear of number 21. At mid-level there is an ope in number 20, lighting the stairs within. There is a uPVC window at the upper level of number 21.

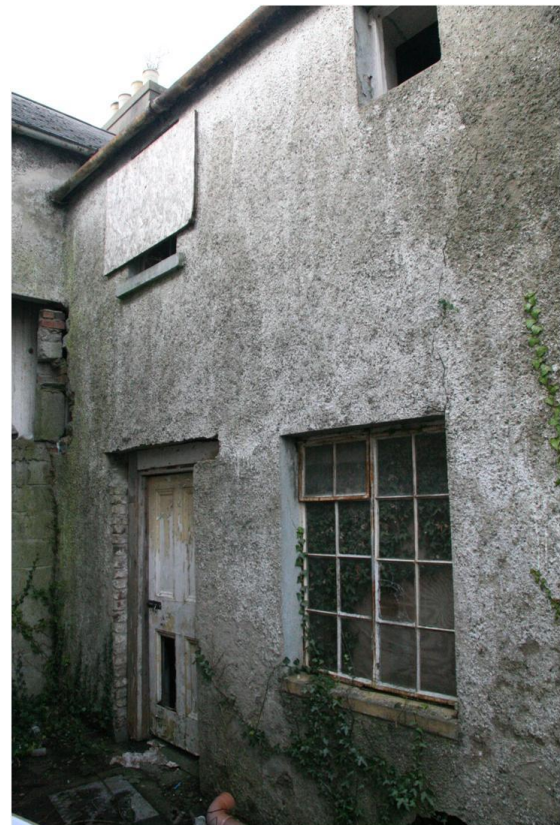
Plate 17: South side of return of no. 20

There is a steel window and a panelled door in the southern side wall of the return of number 20 Vicar Street, and two vacant window opes on the upper level. The rear elevation of the return has no opes. Both elevations are roughcast rendered, though at the rear this is breaking away to reveal the brickwork at the flue. The gable end has a red brick chimney stack with one small pot.

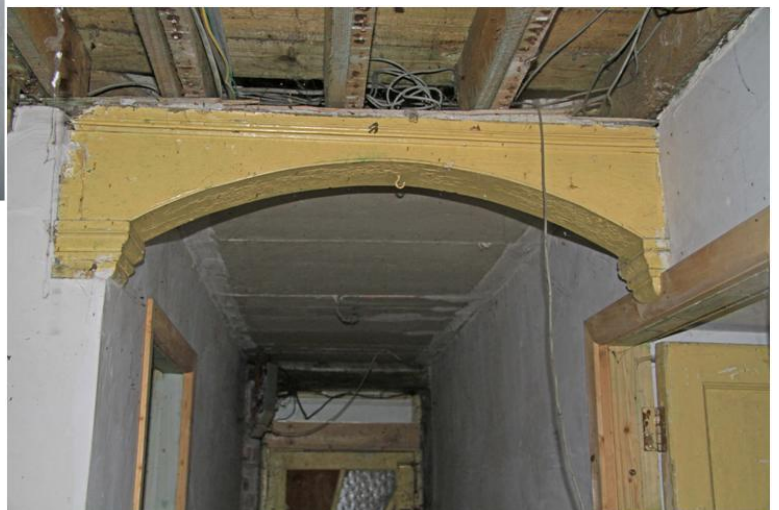
Plate 21: Timber beam over hallway

The entrance hall runs from the front door to the rear return, with doors leading off to the two ground floor rooms. The wall covering is gypsum plaster of recent date and there is plasterboard on the ceiling at the front of the hall. At the rear there is no ceiling. A beam crosses the hall in line with the rear wall of the small room, resting on the lintel over the door to the main room. This beam is shaped to resemble a segmental arch and has mouldings where it meets the wall.

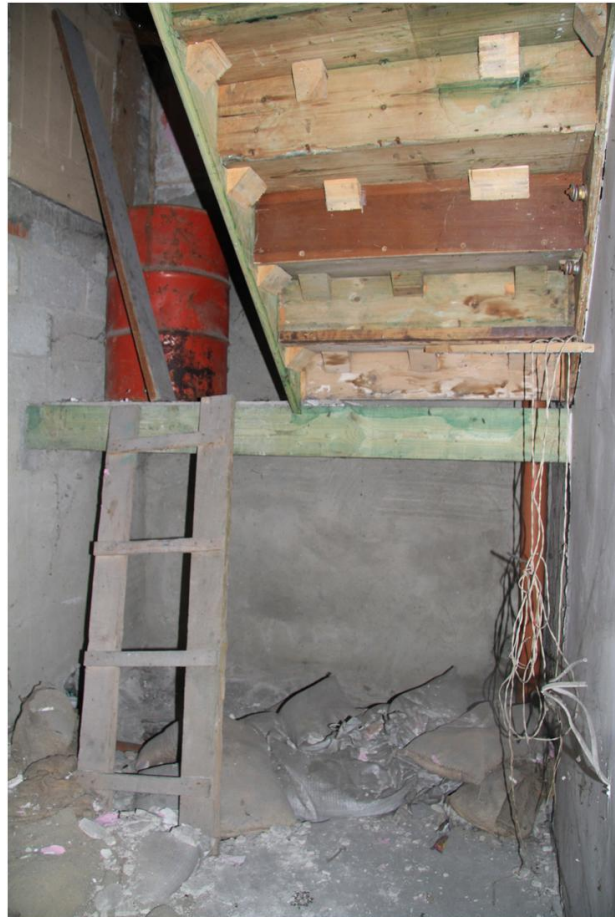
Plate 22: Stairs

The staircase is to the rear of the entrance hall, on the right-hand side, approaching from the front. There was no partition separating this from the entrance hall at the time of the survey. The lower flight of the stairs was missing and the upper flight and half-landing were of recent date, supported on a timber beam that was also fitted in recent years.

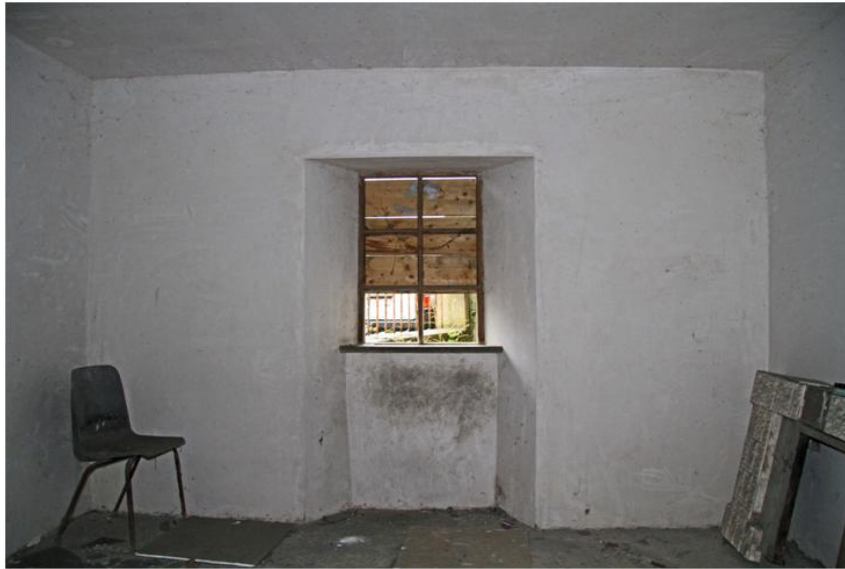
Plate 26: Rear window of large room

The rear window is a six-paned hardwood casement of recent date. The front window is a one-over-one timber sliding sash with quadrant horns.

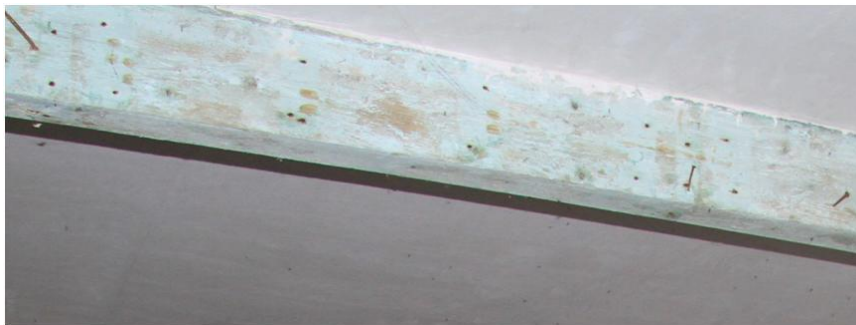
Plate 27: Detail of timber beam crossing ceiling

The timber beam that crosses the ceiling has pairs of nails driven in on the rear face. The paint on the beam has faded, leaving stronger elements of paint in line with the pairs of nails. It is clear from this that there were timber studs fixed to the rear of the beam and that this formerly facilitated a timber stud wall that divided this room into two smaller rooms.

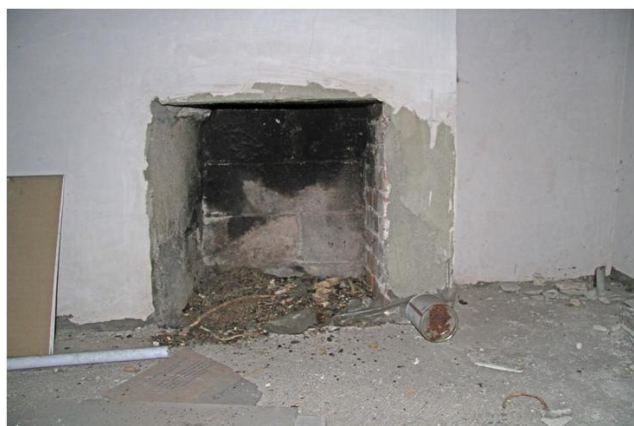
Plate 28: Hearth

The hearth is deep and rectangular, with a rear wall of concrete block. One face of the hearth is of brick, the other has a sand and cement render.

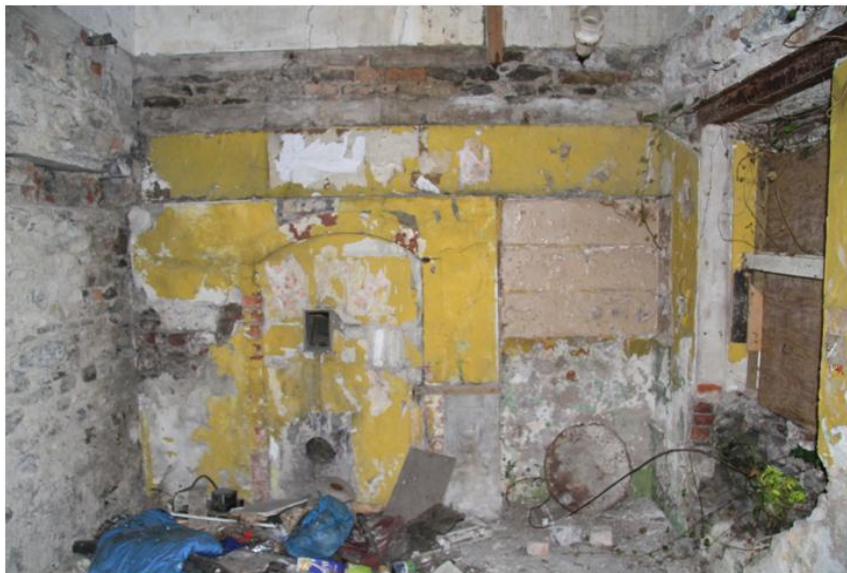
Plate 32: Rear wall of return

At the rear of the return some of the plaster remains on the wall. Part of the wall is thicker, with a blocked hearth having a segmental arch. The thicker section does not rise to the floor above.

The walls in this room are of rubble stone with a significant quantity of brick fragments amongst the rubble.

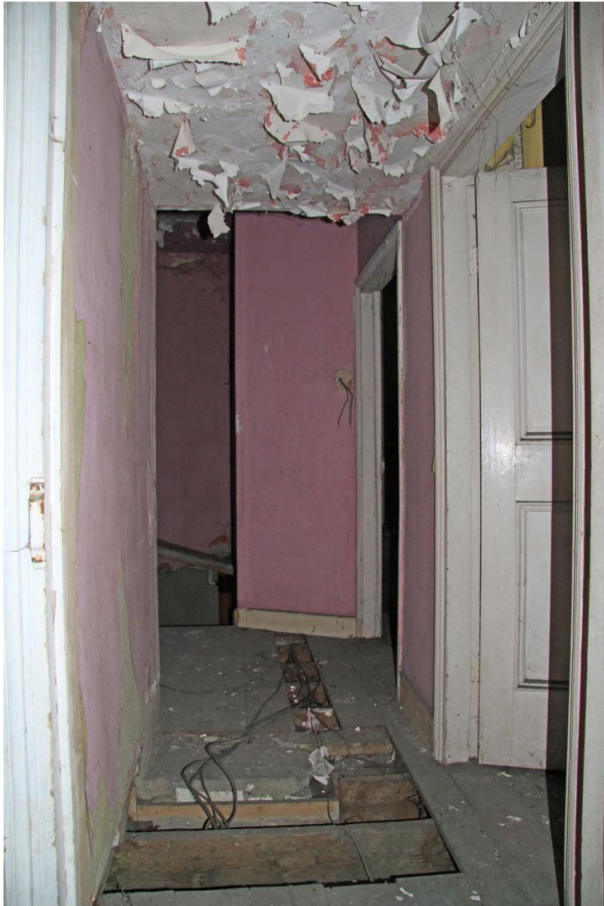
Plate 38: Landing, looking towards staircase

The first floor landing is L-shaped, leading away from the staircase to each of the three rooms in the main house. The floor is boarded, though with some of the boards missing. The ceiling is of lath and plaster, with an extensive area of the ceiling missing from over the stairs. There are no cornices at the margins of the ceiling. The doorways leading off to the three rooms have simple small timber architraves.

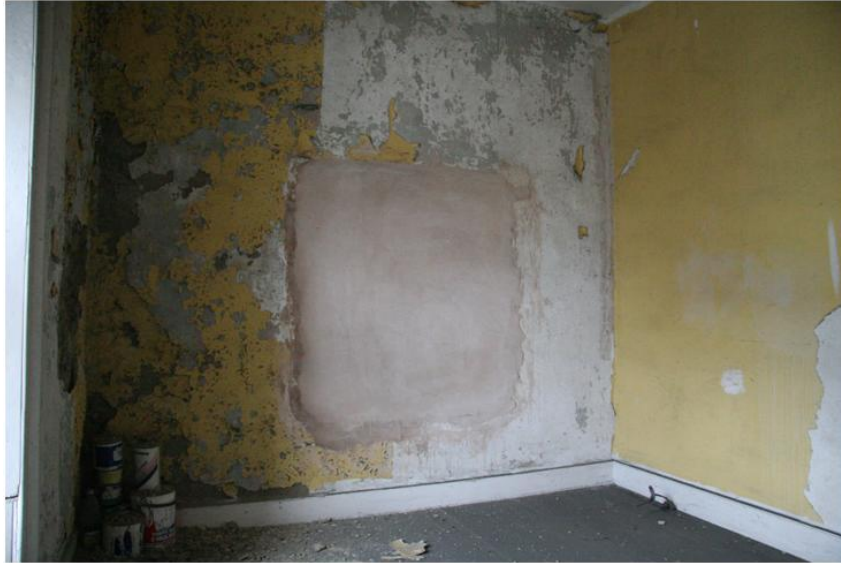
Plate 44: Blocked up in external wall of front room 2

In the external side wall of front room 2 there is an area of gypsum plaster set into the middle of the wall, surrounded by the original lime-based plaster on the walls. At the top of this area a horizontally-set piece of timber may be seen. This appears to be a blocked ope in the external wall, probably a side-facing window. It appears to have been blocked for some time, as there is no indication in the external render that there was an ope in this location.

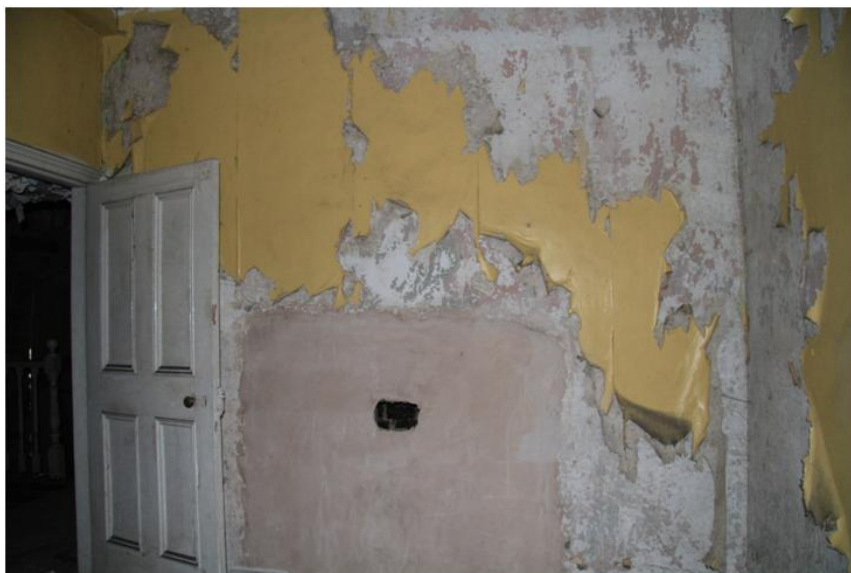
Plate 45: Former hearth in front room 2

Near the door, on the wall separating this room from the other front room, there is a rectangular area with a covering of gypsum plaster, in which there is a small hole. This is an area of plasterboard with a void at the rear and represents the former location of the hearth that provided the heating for this room.

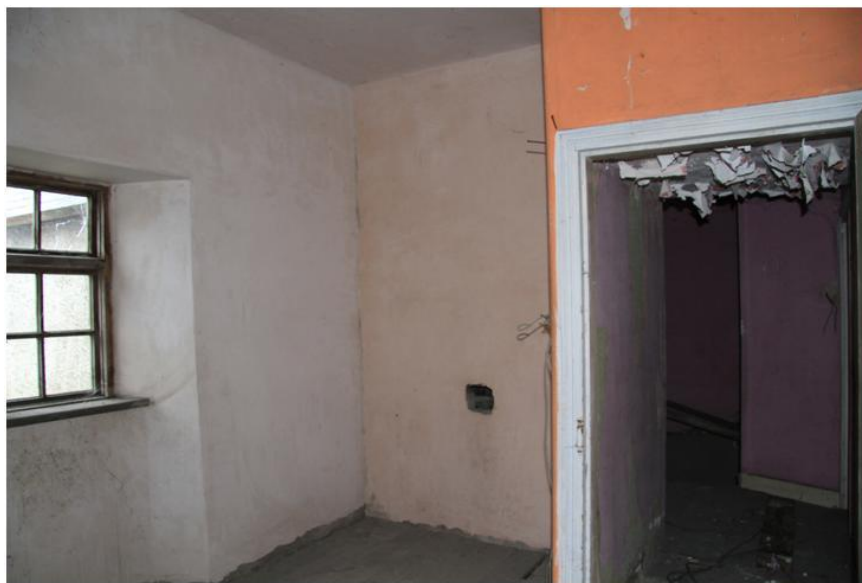
Plate 47: Window and blocked hearth in rear room

The room at the rear at first floor level of the main house has a projection at one corner to facilitate the landing outside. The door to the room is set in this projection and is four-panelled, set in a slender timber architrave. In the narrow area between this projection and the rear wall of the house there is a small rectangular hole in the wall with a void at the rear. This indicates the location of a blocked-up hearth that provided the heating for this room.

The walls in this room have a covering of gypsum plaster and a plasterboard ceiling. The window faces to the rear and is a hardwood timber casement of recent date, set in a splayed architrave without shutters or linings.

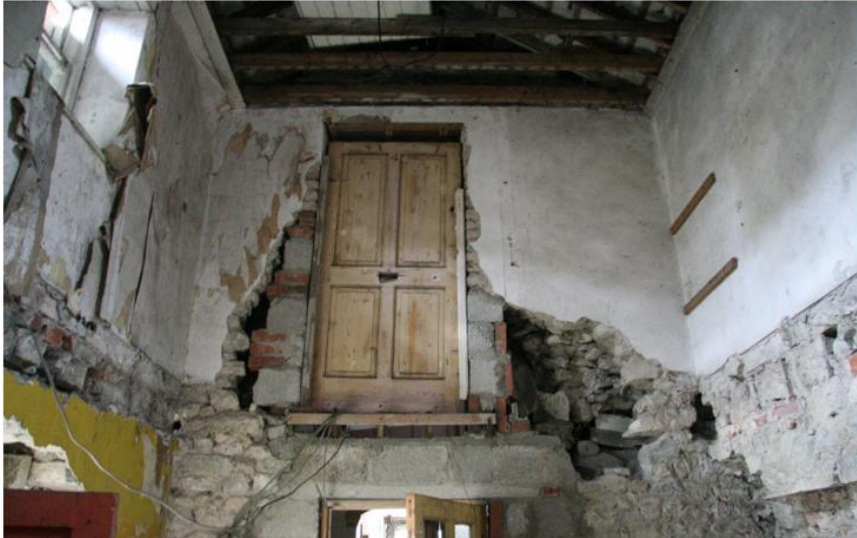
Plate 48: Return at upper floor level, looking towards main house

The lime-based plaster remains on the greater part of the walls on the upper floor of the return. The door ope has been partly rebuilt, with the upper part more or less intact, while the lower part has been reconstructed in brick and concrete block. The four-panelled door seen in the ope is probably the original door, but is now being used as a means of blocking the ope.

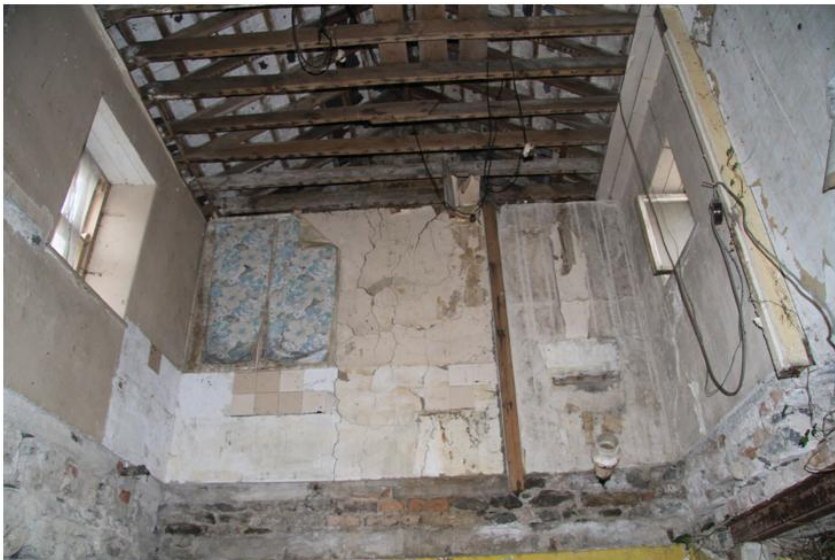
Plate 49: Return at upper floor level, looking to rear

There are no ope in the rear elevation of the return. A spar of timber fixed vertically to the rear wall indicates that there was some form of partition in this location.

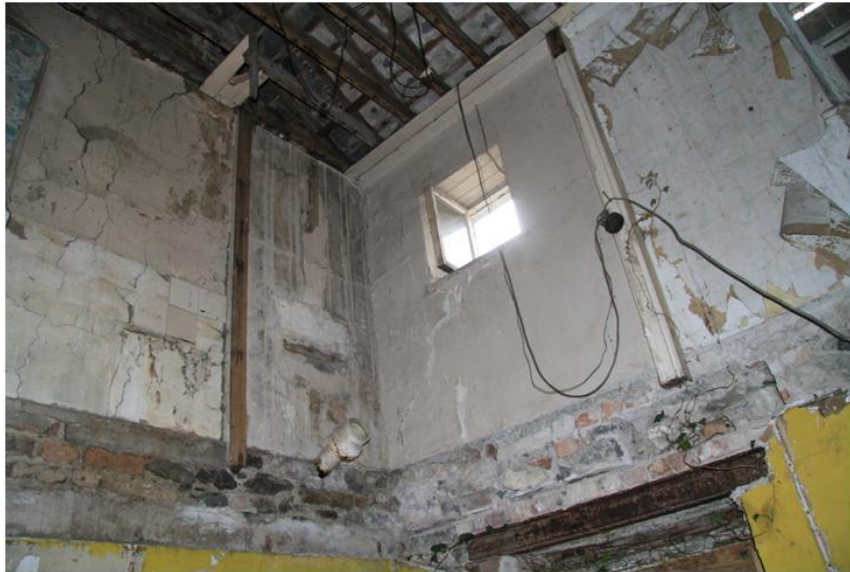
Plate 50: Corner of return at rear, with window

The remnant of the timber partition noted above is accompanied by a similar timber on the adjacent wall. A foul waste pipe through the end wall of the return denotes that there was a WC in this position and the partition walls would have provided a small partitioned space for this facility. There is a small timber casement window lighting the WC area. This window is in the side of the return that faces towards the return next door, as seen at top right in plate 16 above.

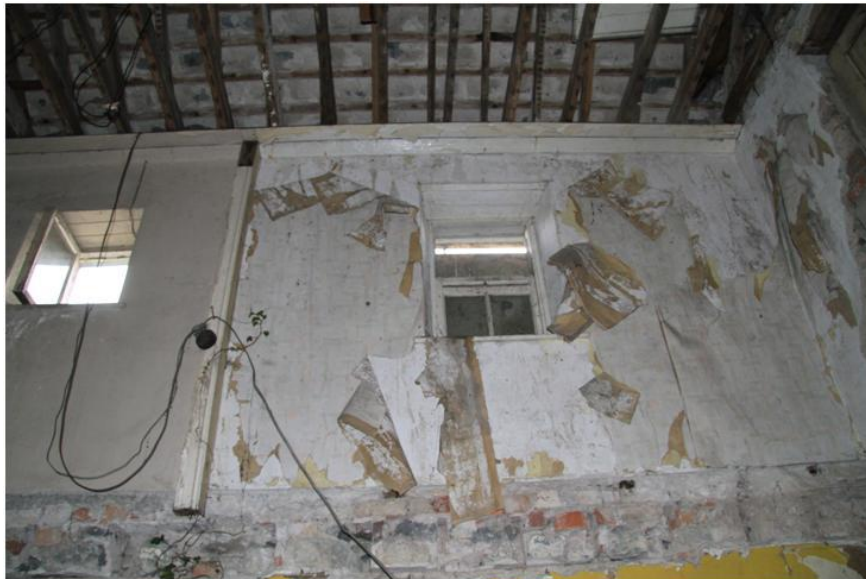
Plate 51: East-facing side wall of return

A second, larger, window in the same wall lit the main room in the return. This is a two-over-two timber sash with timber sheeting lining the soffit. This room retains its lime plaster covering, with wallpaper falling off the surface. Two timber boards at the margin of the roof above suggest that the ceiling in the return had had a covering of timber sheeting.

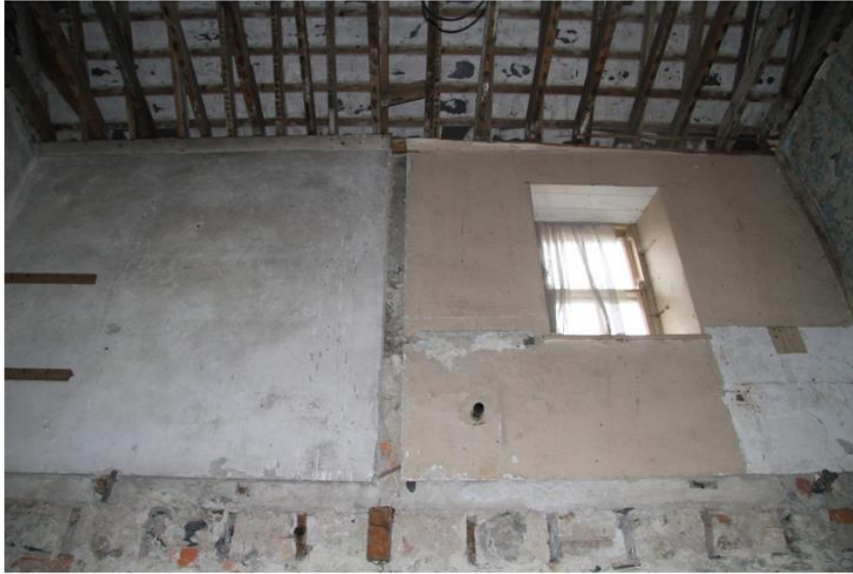
Plate 52: Western wall of return at first floor level

The western wall of the return shows evidence that the return had another partitioned area in the north-western corner, probably a bathroom, to judge by the drain pipes set into the wall, and which turn into the rainwater stack on the outer face of this wall. This bathroom area is lit by a small two-over-two timber sash window.

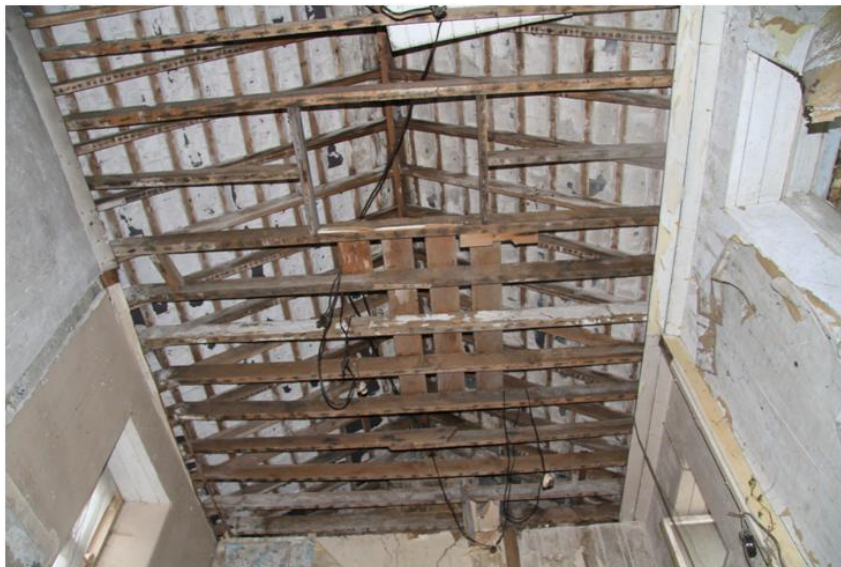
Plate 53: Roof structure in return

In the absence of the ceiling in the return the roof structure is exposed. This consists of coupled rafters set at a relatively shallow pitch and without collars, the ceiling joists serving this function. The underside of the slates has a coating of parge.

In Plate 53 above fragments of brick in the northern wall of the return and the rear wall of the main house are indicated by arrows. Near the top of the photograph the horizontal channel in the masonry marks the location of the floor, with significant quantities of brick. There are other brick fragments in these walls that are not indicated, the arrows showing a representative sample.

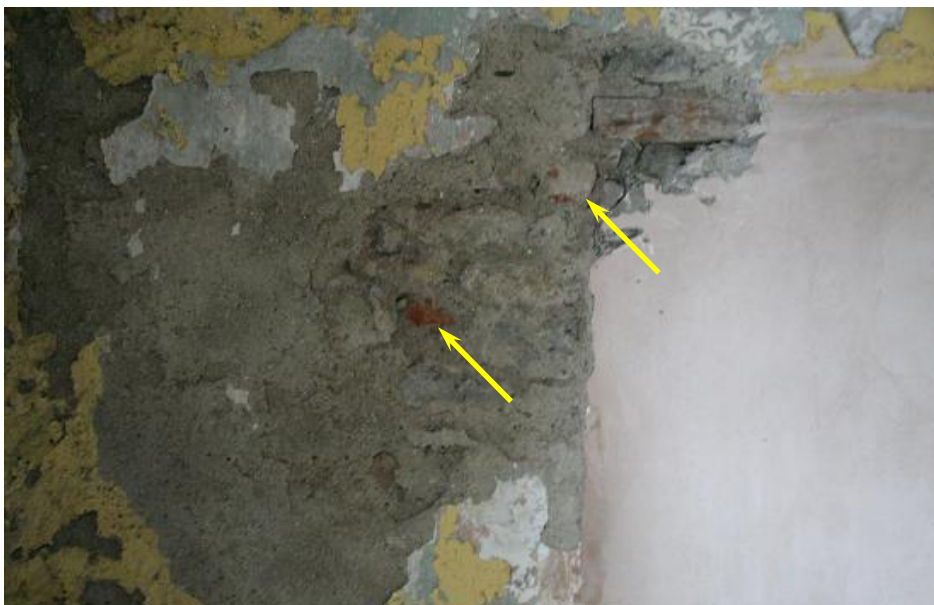
*Plate 57: Inner face of northern end wall of number 20 Vicar Street
The timber lintel is seen to the right of the upper arrow, at a higher level*

In the photograph in Plate 57 the opening in the front wall at the southern end is seen at right. Near the centre of the photo the strong vertical element is a timber stud forming the end of the party wall where it abuts the front wall. To the left of this timber stud there is brick. This wall is a timber stud wall with brick nogging.

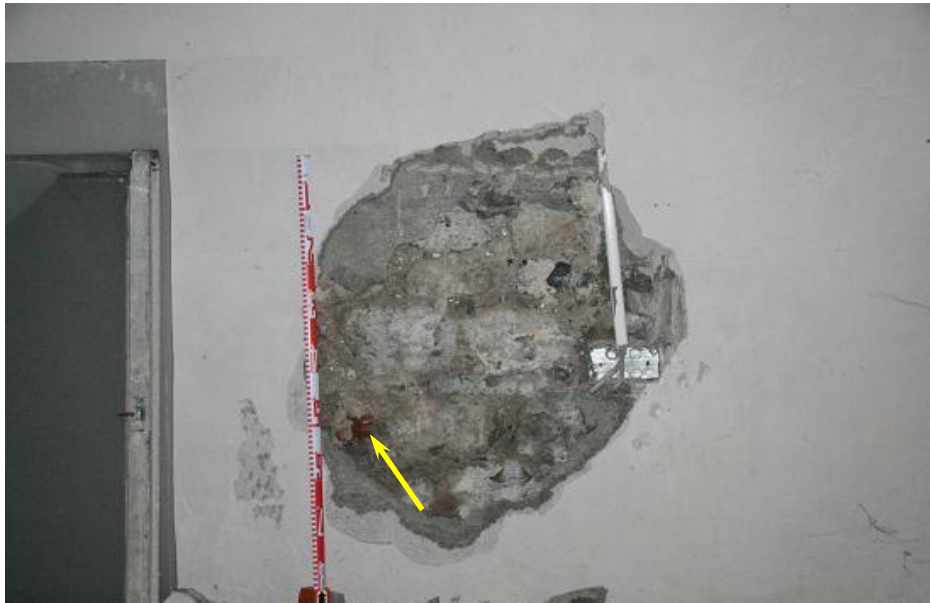
Plate 60: Opening on inside face of northern end wall, ground floor

Plate 59 above shows an opening in the northern wall in which brick appears again, forming part of the original masonry.

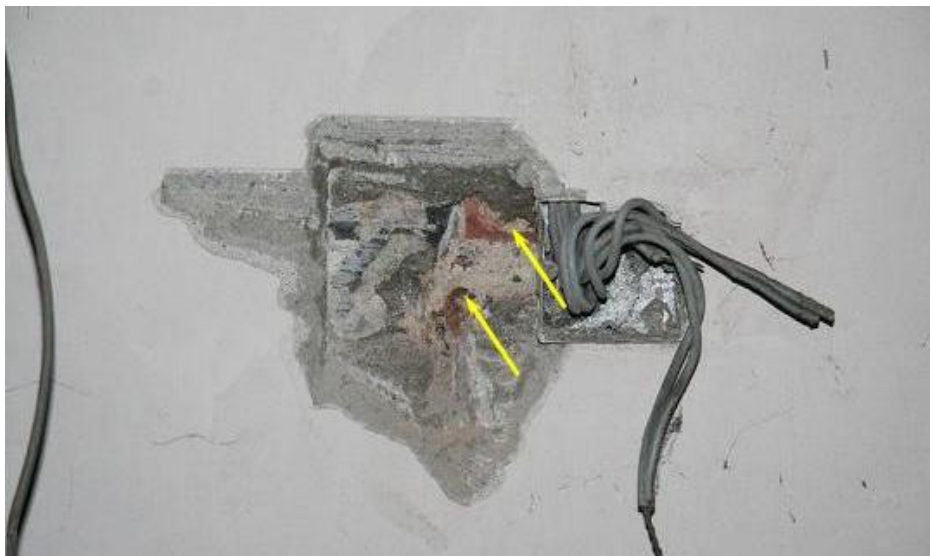
Plate 61: Opening on internal wall between hall and main reception room

The photograph in Plate 60 shows a small opening in the face of the internal wall between the corridor or entrance hall that leads through the house and the main room to the left, or west of it. This wall appears to be built of brick. An opening at the door jamb of this room found to be formed with concrete blocks.
