Recording of buildings along
Wolfe Tone Street and Vicar Street,
Kilkenny
for the
Kilkenny Central Access Scheme

Rob Goodbody
Historic Building Consultant
March 2013

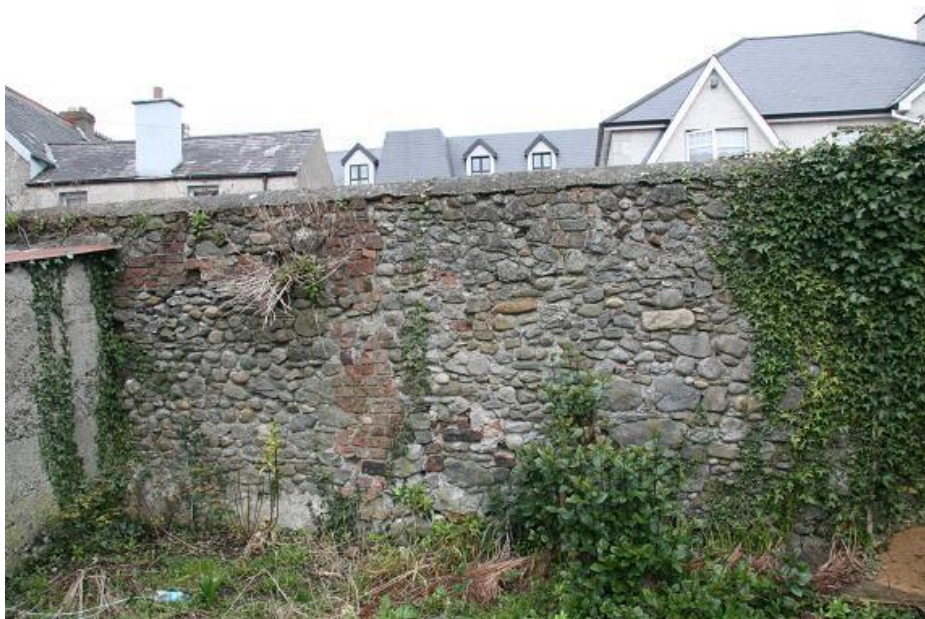
Plate 64: Part of northern boundary wall, close to house

The western section of the northern boundary wall is seen in Plate 63 below. This is built of poor quality masonry with a large proportion of water-worn stone and a significant amount of brick, both whole and broken.

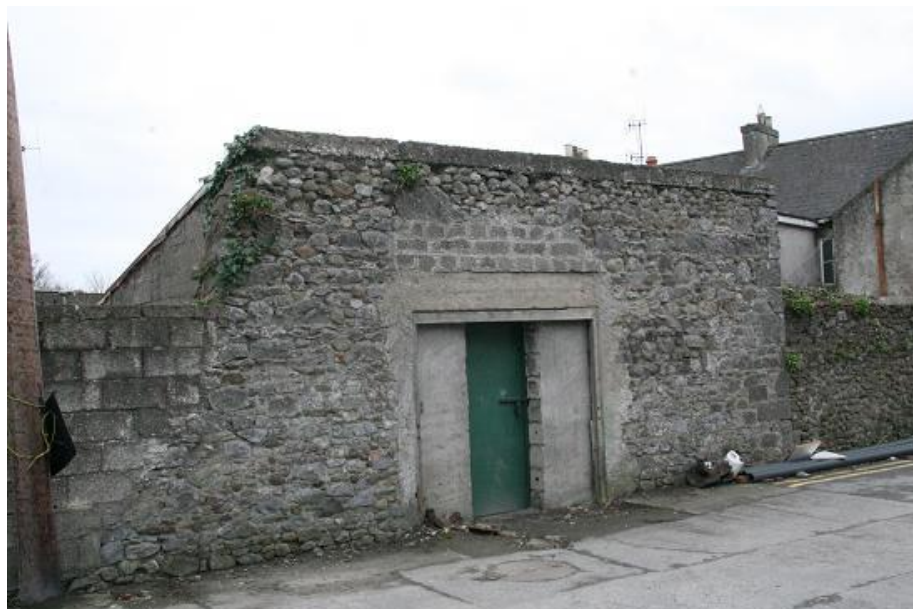
Plate 65: Shed at rear, northern face, to Mill Lane

The eastern end wall of this building is of concrete, seen at left in the photograph below. The front wall, facing onto the adjoining Mill Lane, is of mixed quality. The bulk of the wall is of similar type to the walling of the main house, with rubble limestone incorporating the occasional fragment of brick. The top section is of the poorer quality stonework with smaller water-worn stones and some brick. To the east the stone wall is broken and grafted into a concrete boundary wall and in the centre a large ope has been created in a mix of concrete blocks and mass concrete. At the western end of this wall there are quoins of a better quality than is found elsewhere in the wall. These are squared, but not dressed, and appear similar to the portion of the quoin revealed in the front of the house and seen in Plate 61 above.

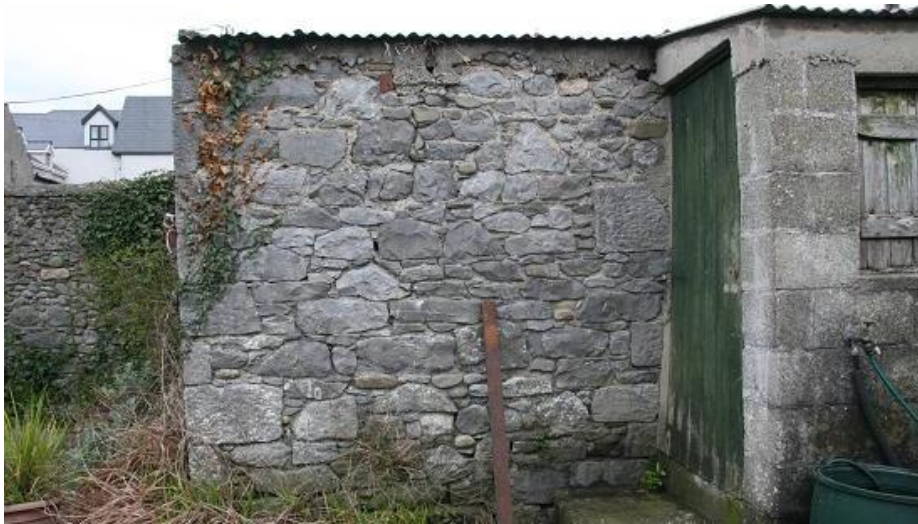
Plate 67: Southern wall of outbuilding

The two sides of this outbuilding that are within the grounds of the house are of a different quality. The southern wall is built of better quality masonry than has been seen elsewhere in the building, with larger stones of split limestone interspersed with smaller stone. On the right-hand side as seen in the photograph there is what appears to be the remnants of a doorway, with hammer-dressed squared stones, and with the skewback of an arch at the top, now with concrete in place of the adjoining voussoir. The quoins at the left hand side of the wall are also hammer-dressed.

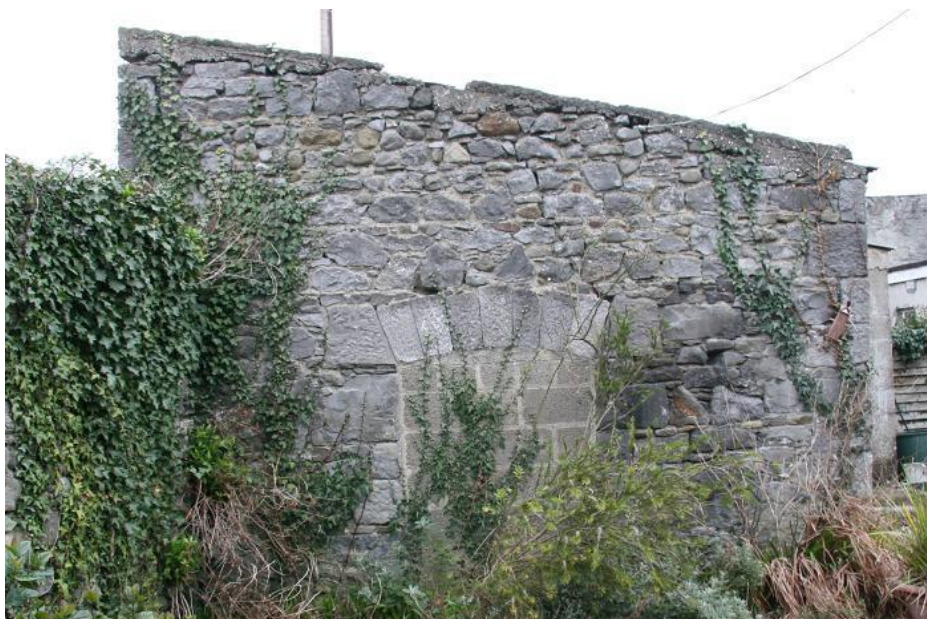
Plate 70: Western wall of outbuilding

The western wall of the outbuilding is of masonry that is not as well built as that on the southern face, though still of reasonable quality. The top section is of the poorer quality work seen in the main walls of the house, with smaller stones and some brick. The striking feature of this wall is the arched doorway in the centre of the façade. This is formed with hammered limestone both in the jambs and in the arch, executed to a good quality. The arch is segmental and formed of seven voussoirs between the skewbacks.

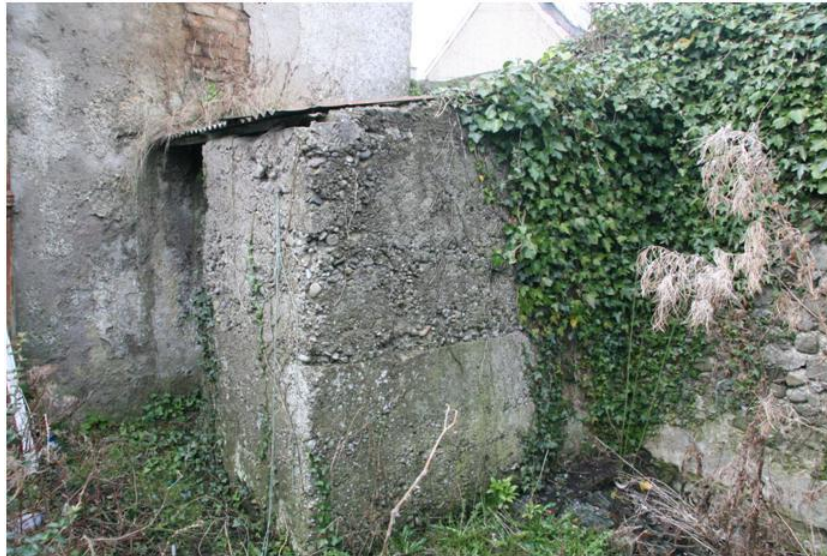
Plate 77: Concrete structure at rear of 20 Vicar Street

Attached to the rear of the return at 20 Vicar Street there is a shed formed with mass concrete. This consists of two walls of mass concrete attached to the boundary wall on the northern side of the property, which acts as the rear of the shed. The fourth side is the rear wall of the return. This shed was crudely constructed in shuttered mass concrete and has a shallow pitched roof of corrugated iron.

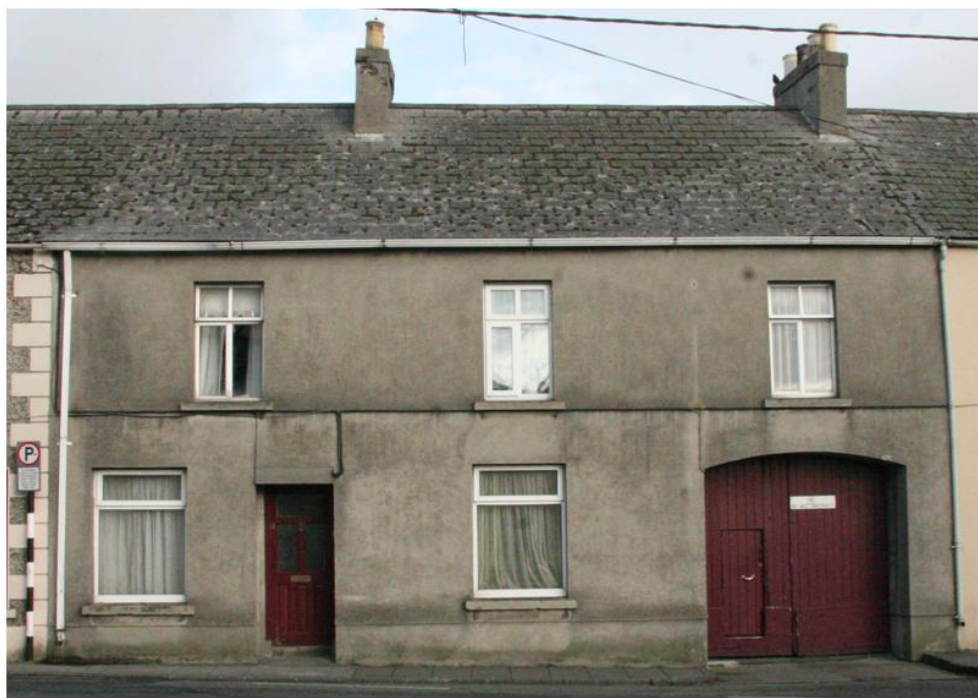
Plate 78: Front facade of 21 Vicar Street

The front facade of number 21 Vicar Street is two storeys in height, three bay on the upper floor and four bay on the ground floor. At the right-hand side of the elevation is a vehicular archway through the building, closed with a pair of timber-sheeted doors, with a timber wicket gate in the left-hand door. The facade is cement rendered without ruling or lining. There is a recessed plinth in smooth sand and cement render.

The front windows are uPVC casements. Those on the upper floor are divided vertically and horizontally with opening sections at the top and on one side of the lower section. At ground floor level the two windows have an opening top light and a single undivided light in the main section.

The front door is of mid-twentieth century date with a top glazed panel above a pair of glazed panels, below which are three timber panels.

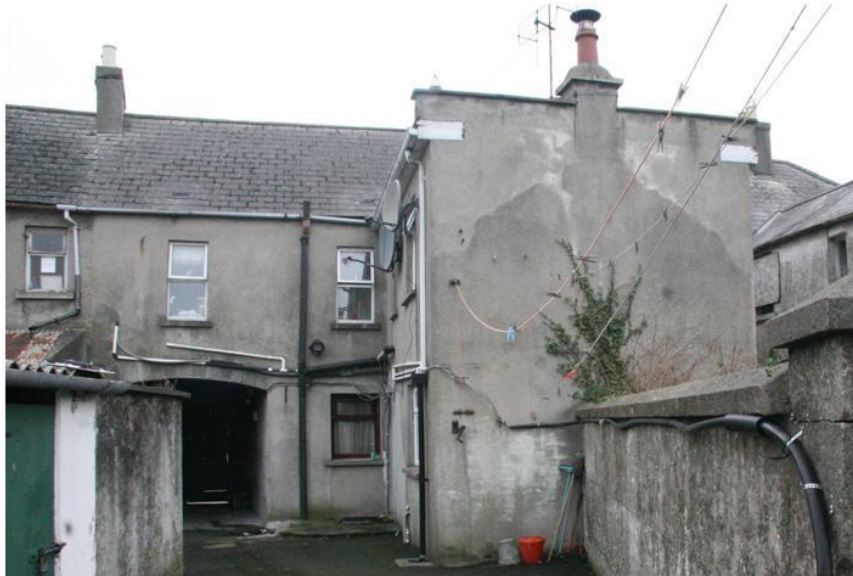
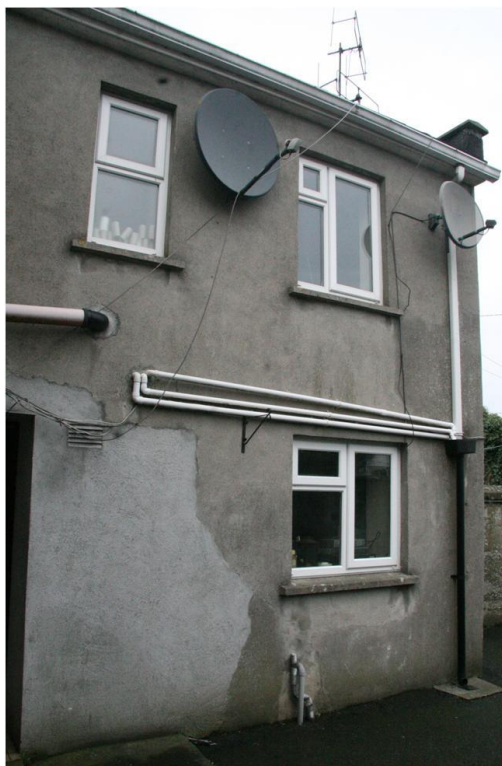
At the rear the house has a single bay to the side of the rear arch and a two-storey return projecting to the rear. The return has been raised in height, as is seen by the markings on the rear wall. The rear facade is sand and cement rendered. The roof is of fibre cement, with uPVC rainwater and drainage goods. The windows are uPVC casements except for the one window at ground floor level in the main house, which is a timber casement. The doorway to the return has been moved, as seen in the markings in the render.

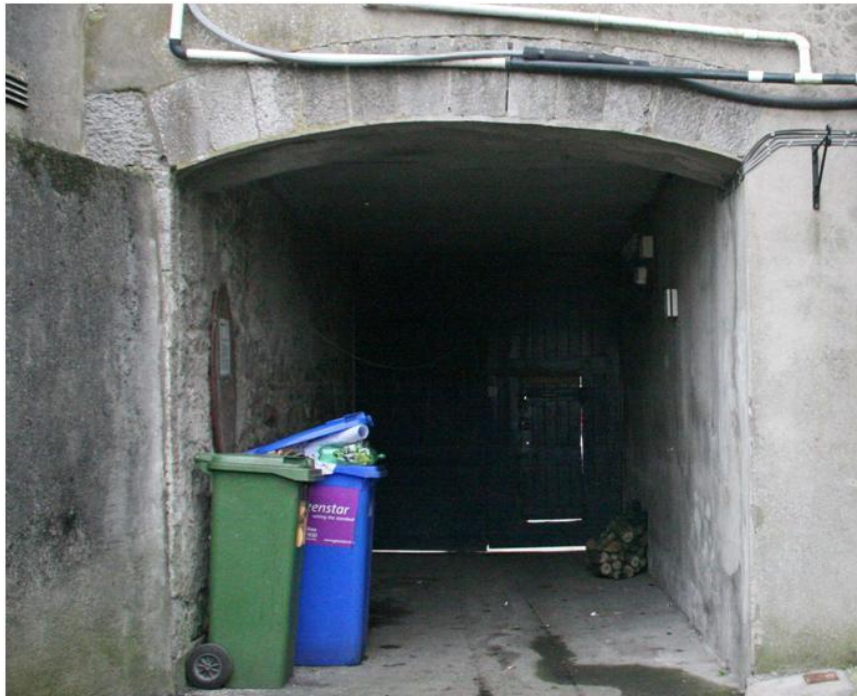
Plate 81: Rear of arch at 21 Vicar Street

At the rear of the vehicular entrance through number 21 Vicar Street is a segmental arch formed of hammer-dressed limestone voussoirs. On the left-hand side a hammer-dressed skewback is visible, while the right-hand spring is plastered over and not visible. A small part of the wall beneath the spring of the arch is visible on the left-hand side and this shows hammer-dressed quoins. The inner face and soffit of this arch are not visible as they have been plastered over. The arch to the front of the building is also plastered and its construction is unknown.

The arch at the rear of the carriage entrance that runs through 21 Vicar Street has been described above and shown in Plate 80. It is likely that there is a similar stone arch at the front of the carriage entrance, though not visible beneath a covering of render.

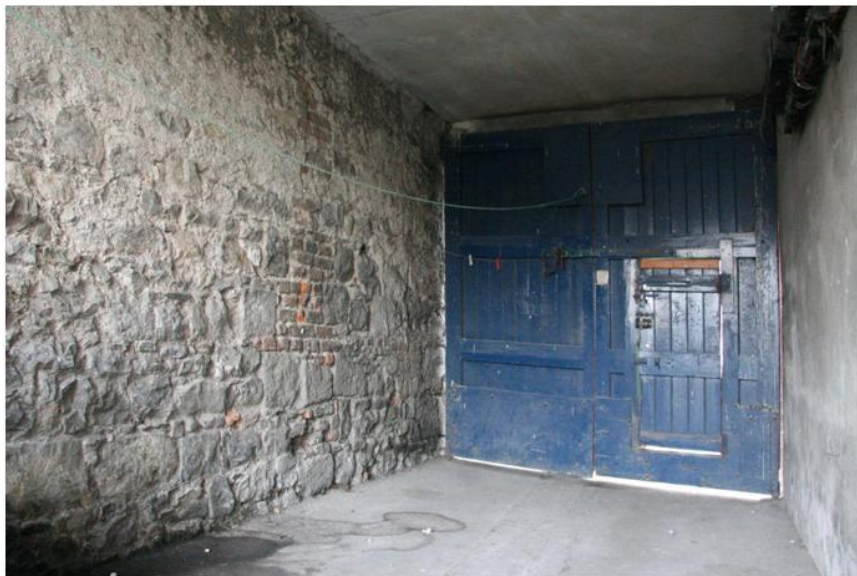
Plate 83: Interior of access through 21 Vicar Street

The interior of the vehicular access through number 21 Vicar Street has masonry walls on either side. The northern side, at number 21, is cement rendered. The southern side, abounding number 22 Vicar Street, has a masonry wall originally with a covering of render that has now mostly gone. The stonework is of limestone rubble, brought to courses. The stone varies greatly in size and shape, with some larger squared blocks towards the bottom and smaller stones with random shapes elsewhere. There are fragments of brick throughout the masonry, with particular concentrations at the rear of the hearth within the house.

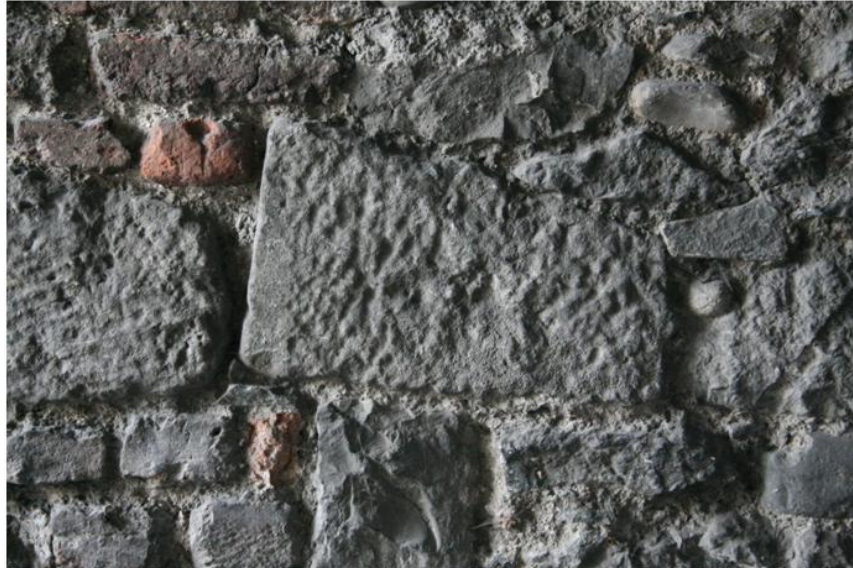
Plate 85: Detail of reused dressed stone in wall at arch

Some of the stones in the wall of the arch show marks of dressing, though in each of the cases identified in the survey the stones seen were randomly placed and did not appear to have been worked for use in their present positions. These are evidently stones that have been reused from an earlier building. Whether on this site or elsewhere is not known.

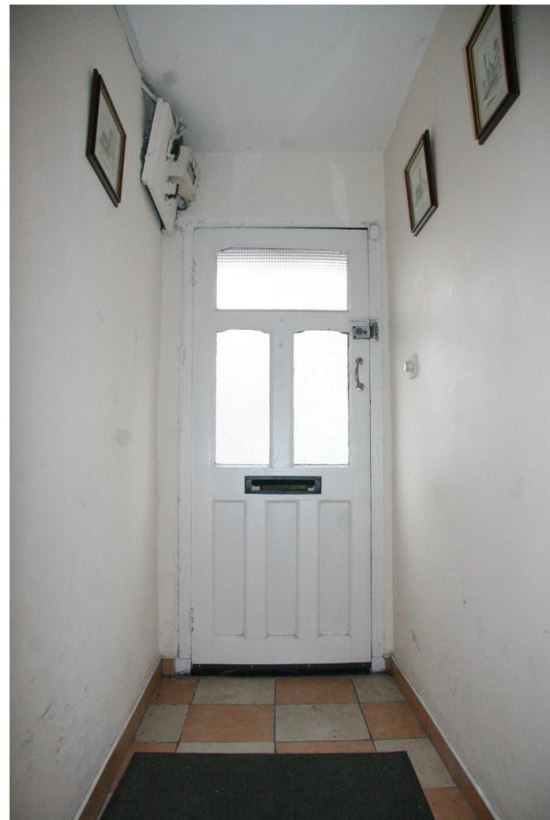
Plate 87 (above): Front door

The entrance hall runs from front to back of the main house, giving access to the rear return, before turning to exit to the rear yard. The space has been entirely refurbished, with replacement flooring and skirtings and wall plaster. The doors leading off this space are all six-panelled timber doors of comparatively recent date. The simple timber architraves are late replacements. The front door, as noted above, is a replacement panelled and glazed door. Towards the rear of the corridor a timber beam crosses the ceiling, at which point the corridor narrows slightly.

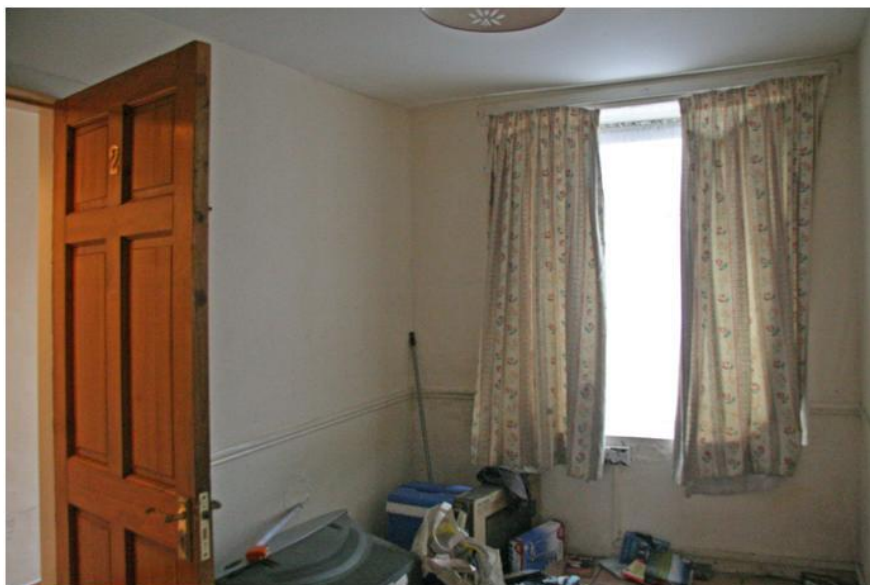
Plate 90: Front room on northern side

The room on the left-hand or northern side of the entrance hall is a narrow room with a window to the front. This is a uPVC casement without shutters or architrave. The wall plaster and ceiling in this room have been replaced, as has the door. There is a narrow dado rail, of recent date. To the rear this room is separated by a partition wall from an en suite bathroom at the rear. The doorway to the en suite is narrow and has no architrave. It appears to be a recent addition, as may be the partition wall. A timber beam crosses the ceiling at this partition.

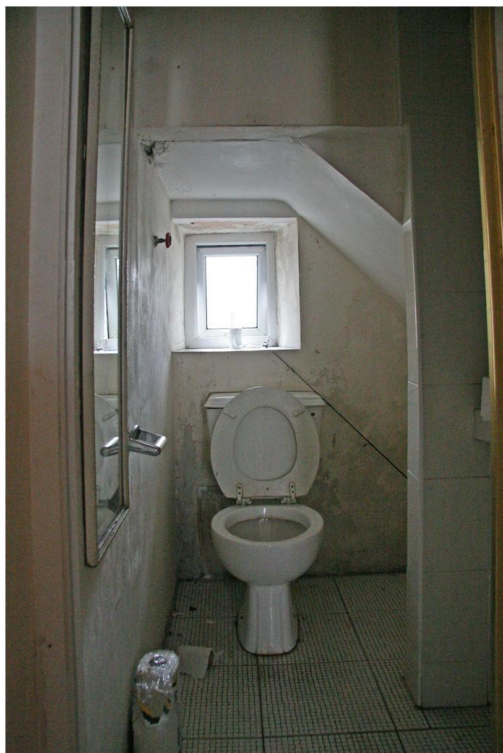
Plate 92: En suite at rear of northern room

The en suite at the rear of the front room is located beneath the stairs. The lower flight and half landing of the stairs run over the wc. A partition wall separates this from the shower cubicle, which is located under the upper flight of the stairs and the landing above. The floor in this bathroom is raised above the prevailing floor, possibly to facilitate drainage from the shower. A small uPVC casement window lights the bathroom and opens to the space between the return of this house and that of number 20, as seen in plate 15 above.

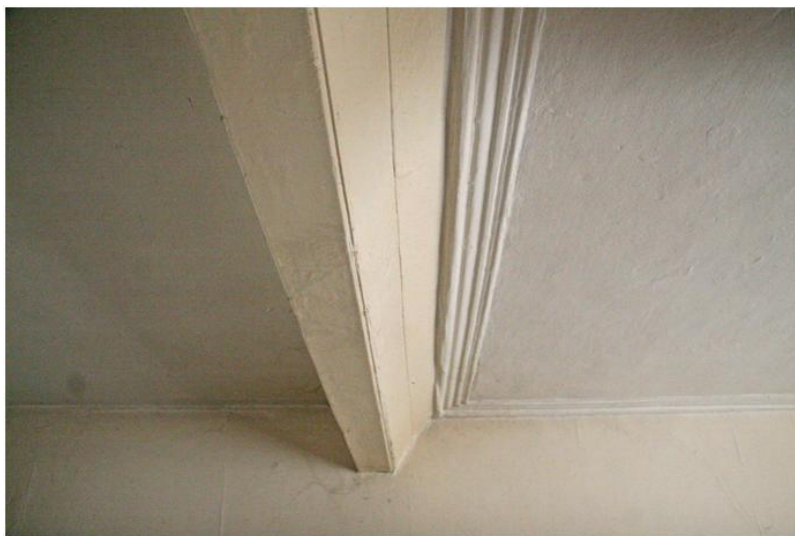
To the right of the hall is a room that runs from front to rear of the house, narrowing as it does due to the angle of the adjacent archway. The ceilings and wall plaster have been replaced in this room, though a modest run cornice survives on the ceiling in the front section of the room, to the front of a timber beam that crosses the ceiling. This room has a fitted kitchen. The room appears to have been two rooms originally.

Plate 93: Timber beam in large room, with cornice at right

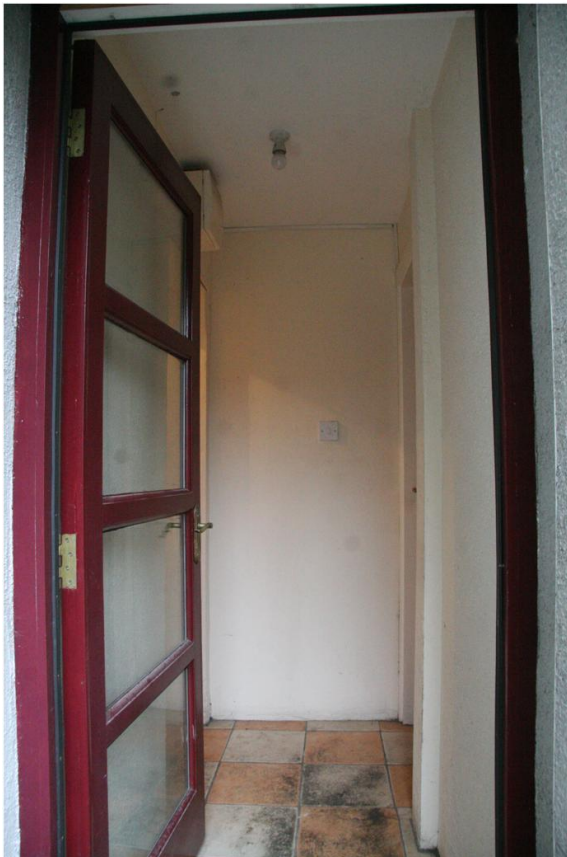
Plate 94: Rear corridor

The corridor that leads from the house to the rear yard has been partitioned off from the return and leaves the house via a doorway of comparatively recent date. This is closed by a glass-panelled door. There are no surviving features in this corridor from an earlier period, with the flooring, wall plaster, ceiling and other features all being replacements.

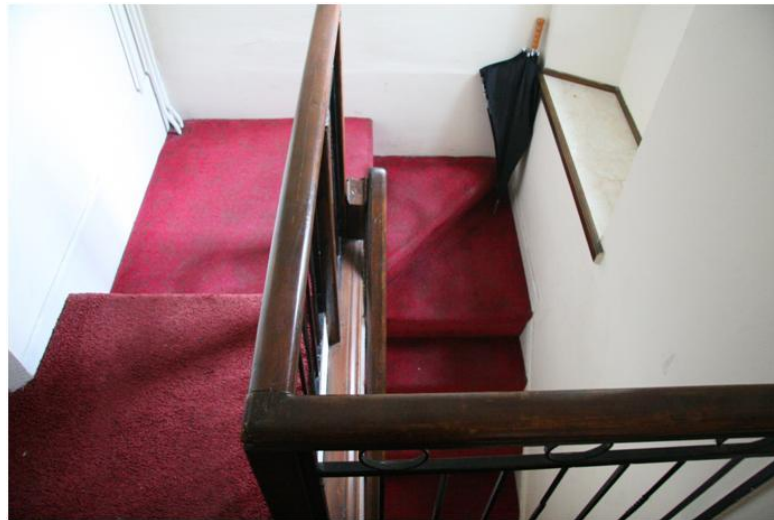
Plate 95: Upper section of staircase

The staircase is a relatively recent replacement. It rises through on major flight, through a winder and a step at right-angles to the rest of the flight, to a half landing, before climbing a final short flight to the first floor. The balustrade is a recent addition in mild steel and hardwood. The wall surfaces have been replastered and the window alongside the stairs has been replaced in uPVC, without shutters or linings.

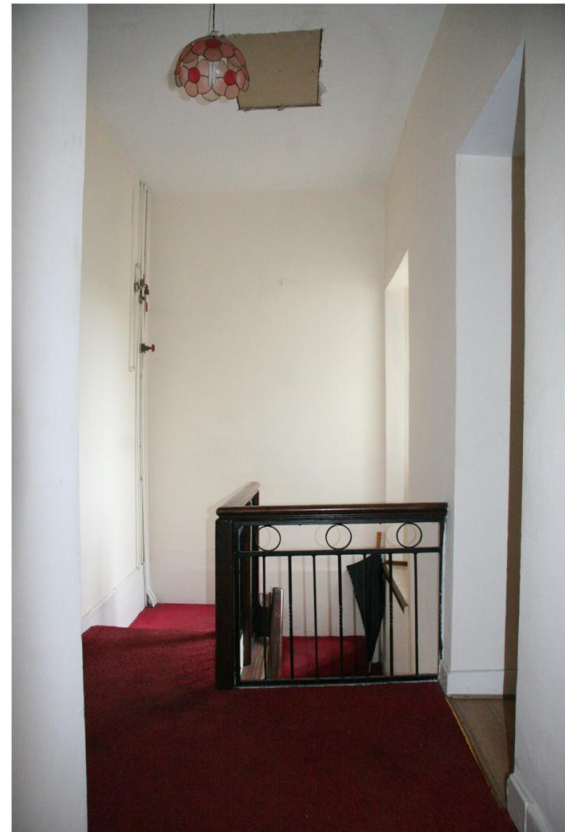
Plate 98: Landing at staircase

The landing at the top of the stairs leads to a narrower corridor across the rear of the house, giving access to each of the rooms, including the return. The entire area has been refurbished, with walls replastered and ceiling replaced. The ope through the spine wall that contains the flues is squared with no architraves or other features and no nib wall against the rear wall of the house. This suggests that the ope is a later insertion. The ope leading to the return is also featureless and has squared arrises.

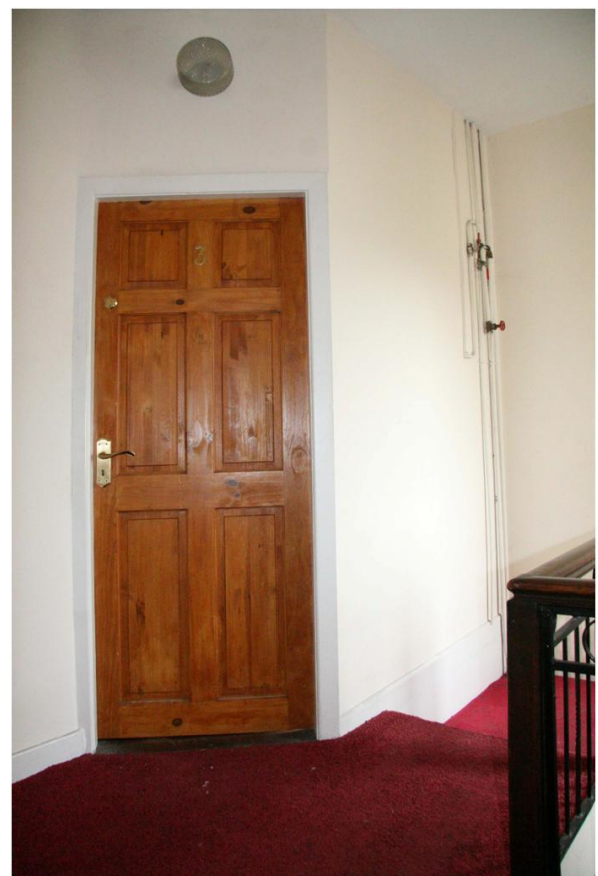
The door to the room nearest to the stairs is set at an angle in a partition that appears to be of late date. All the doors leading off this corridor are six-panelled timber doors of late date

Plate 100: Door to room next to stairs

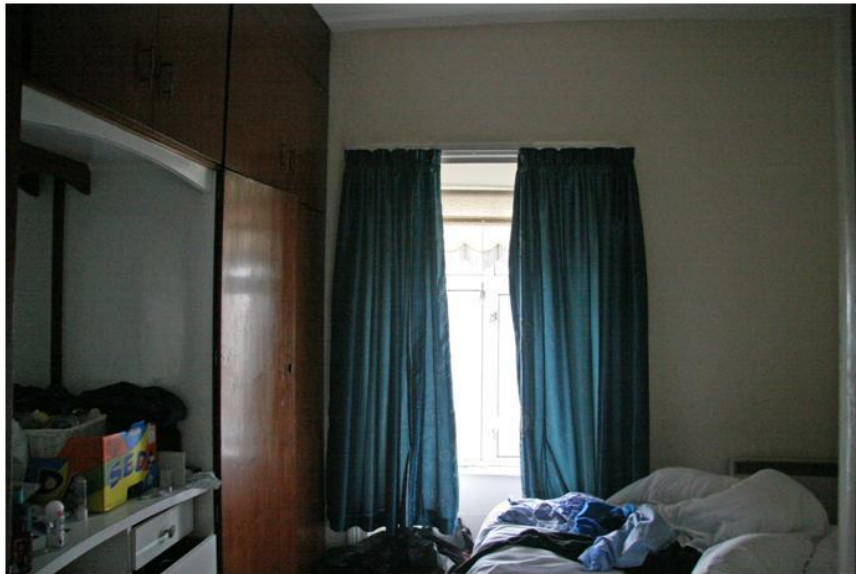
Plate 101: Room adjacent to staircase

The room adjacent to the staircase has been subdivided to provide an en suite bathroom, which is located immediately inside the door from the landing. The room has been refurbished with replacement of plaster and ceiling. One surviving feature is the architrave and window lining that surround the window. This indicates that there never were shutters in this room.

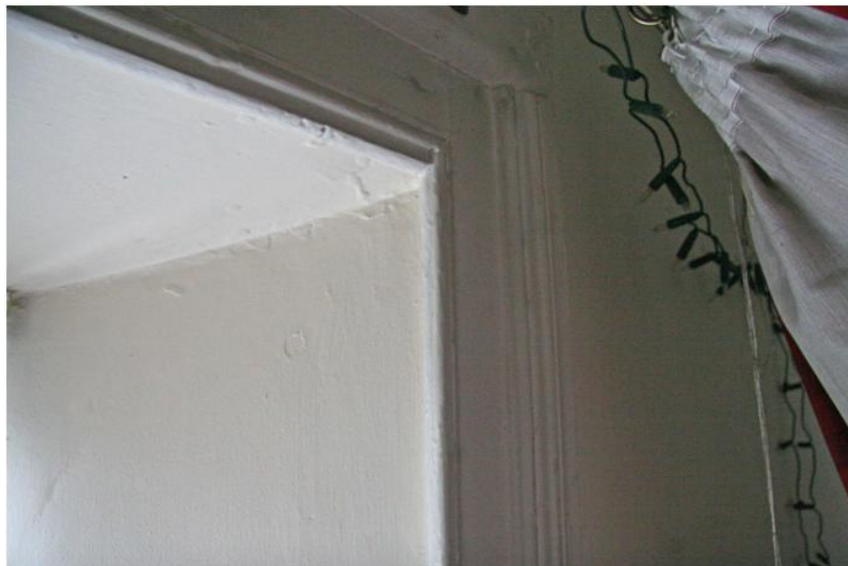
Plate 102: Surviving architrave and window lining

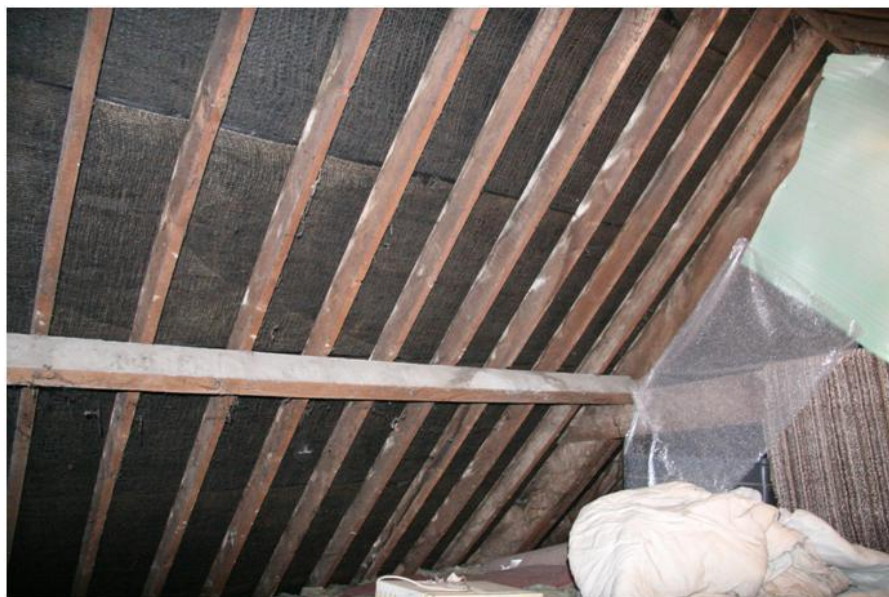
Plate 114: Underside of roof in attic of 21 Vicar Street

The owner of the property informed the present writer that the entire terrace of three houses was completely re-roofed in the late 1950s. The appearance of the fibre-cement tiles on the roof of the terrace would be consistent with their being in place for around fifty years. There is a layer of slater's felt beneath

the tiles. The roof structure consists of paired rafters supported near the mid-point by a purlin running between the spine walls. One of the walls was visible on the inspection and is a masonry wall with a rendered surface having a coating of lime-wash. This prevents any detailed inspection of the nature of the masonry.

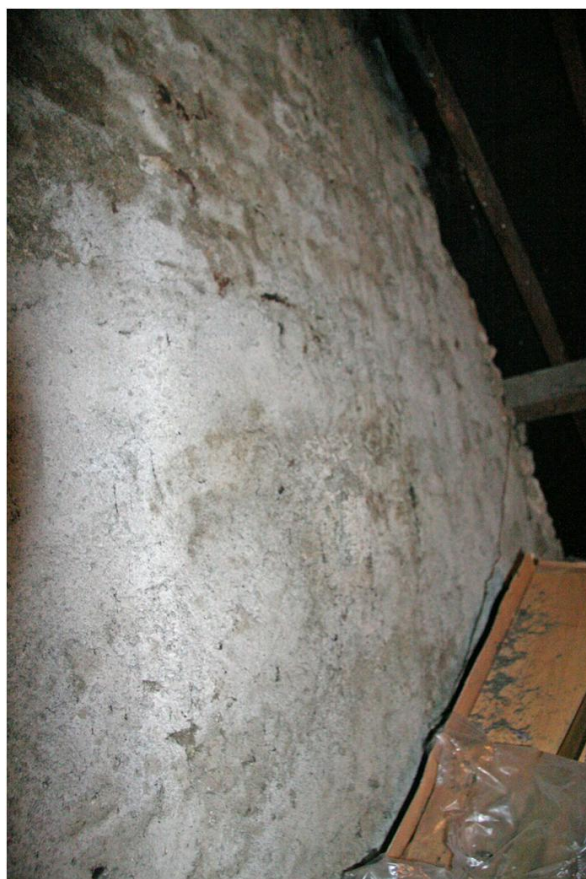
Plate 115: Face of spine wall in attic

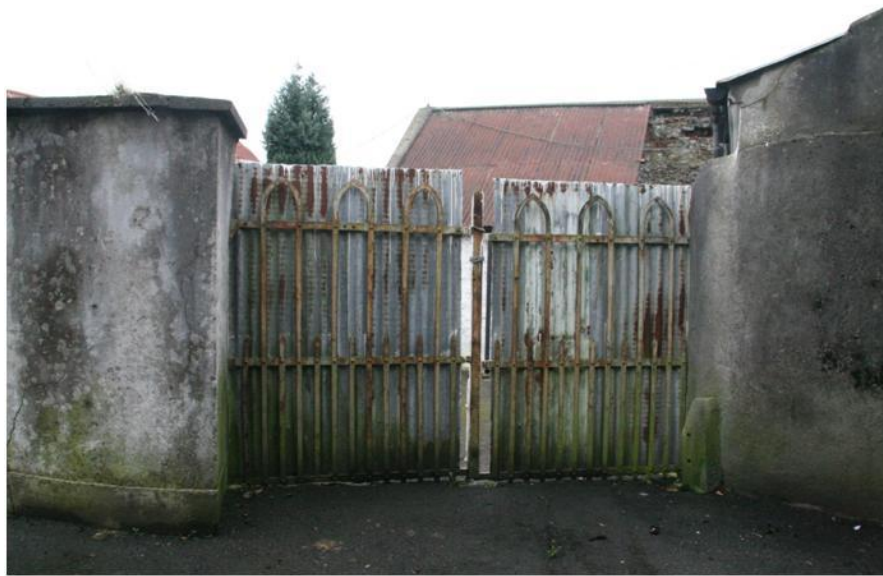
Plate 118: Gateway to rear of 22 Vicar Street

The boundary wall between 21 and 22 Vicar Street is a high masonry wall, rendered on the side facing 21 Vicar Street with sand and cement render. Immediately to the rear of the houses the wall curves splay towards the south and there are two stones set against the wall to guard against impact by cart wheels. The gateway is approximately 2.7 metres wide and is closed with a pair of wrought iron gates of nineteenth century date. These are further closed with sheet corrugated iron.

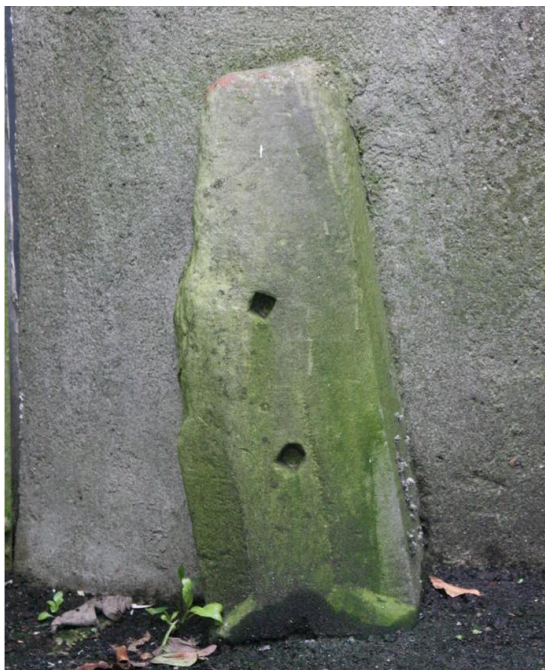
Plate 119 (left): Fender close to gateway

The fender stone close to the gates is of dressed and shaped limestone with two square holes and appears to be a reused window sill from an earlier building that had wrought iron bars.

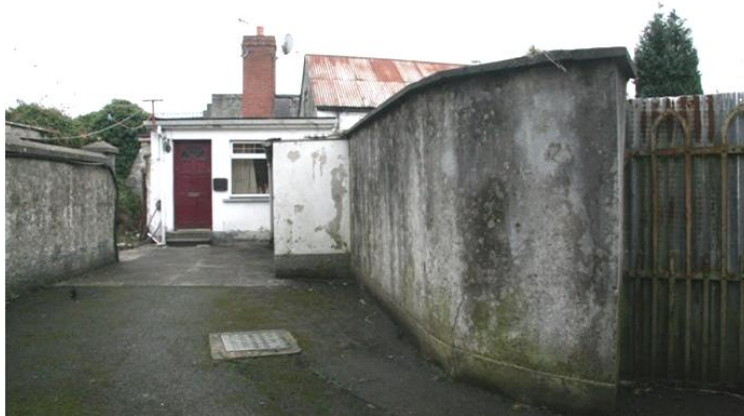
Plate 121: Southern boundary wall, at right

As noted above, the southern boundary wall is high and is cement rendered. This is seen in the adjacent photograph, with the gateway at right.

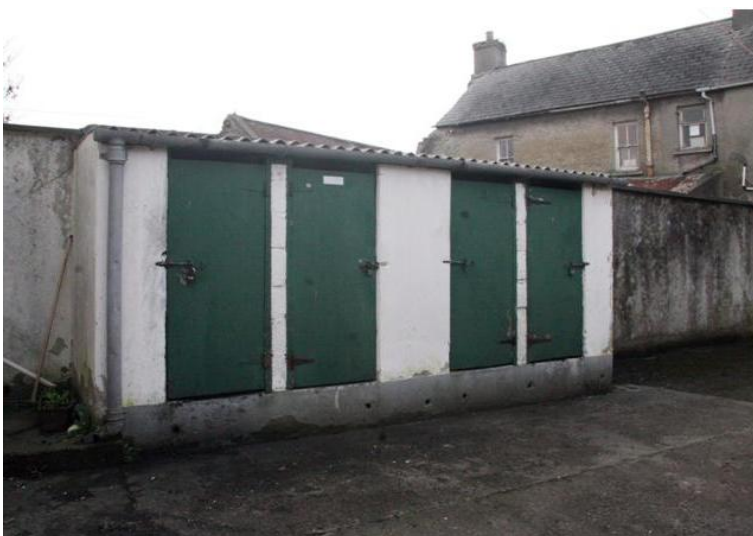
Plate 123: Storage sheds at rear of 21 Vicar Street

There is a group of four storage sheds built as a lean-to against the southern boundary wall. These are of concrete construction with timber doors and a corrugated roof.

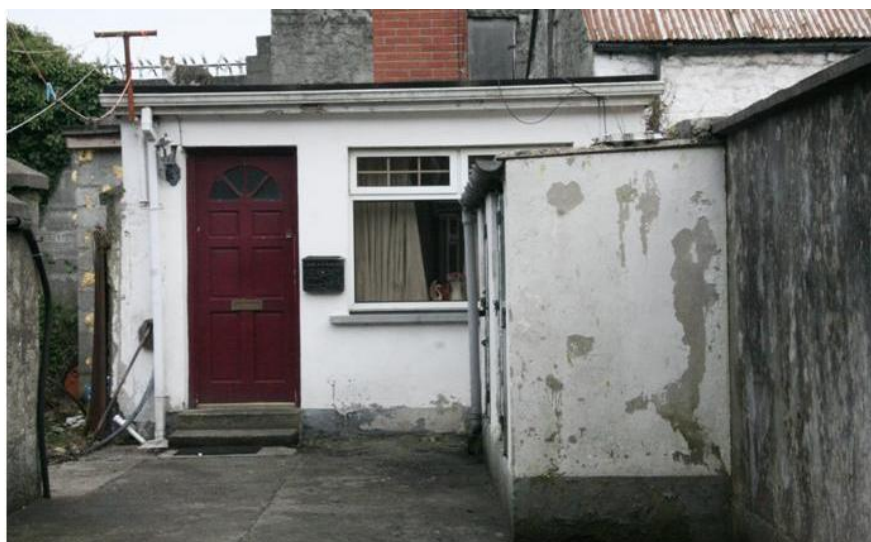
Plate 124: Western front of flat-roofed building

At the rear of the property at 21 Vicar Street there is a flat-roofed building that is in use as a residential apartment. This has a front door and a large window facing west towards the main house. The northern side wall is built off the continuation of the mass concrete boundary wall that was shown in plate 121 above, while a utility room extension projects northwards at the rear of this building. A small window faces north near the utility room.

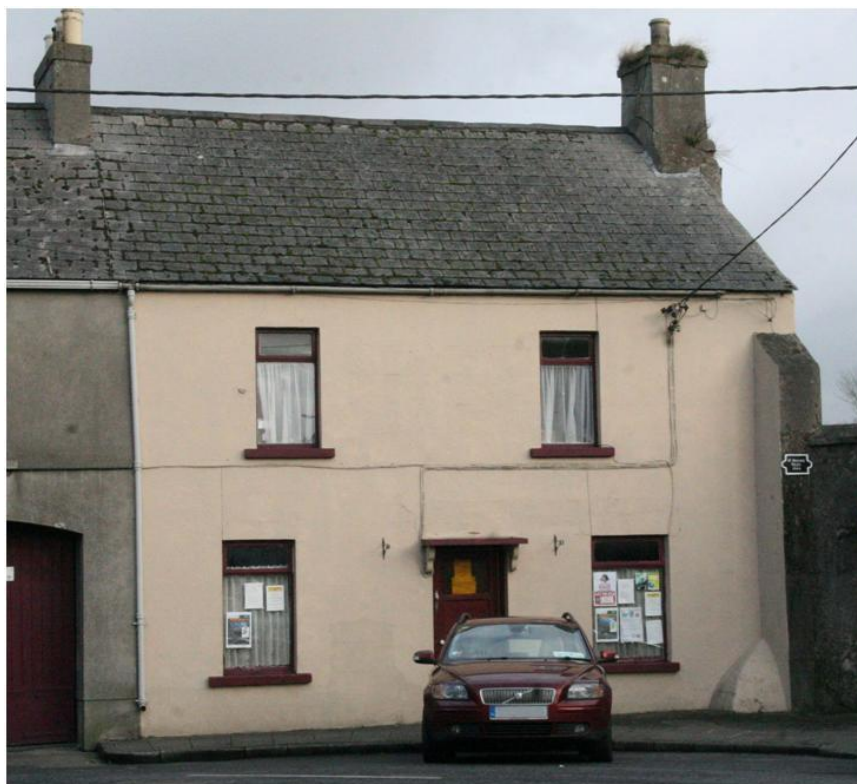
Plate 126: Front facade of 22 Vicar Street

The front facade of number 22 Vicar Street is rendered, ruled lined and painted. The facade is two-storey and two-bay on the upper floor and three-bay below. At the left-hand, or northern end, of the facade it is attached to the house at 21 Vicar Street. At the southern end a high wall projects from the corner of the facade, and at an angle to it, before stopping at a short distance from the corner. Beyond this stub wall are the double gates leading to the adjacent yard. In the corner between the facade and the stub wall there is a sub-pyramidal feature of the type that was used to prevent loiterers from lounging in corners.

It is noted that the facade of this house is not aligned with that of its neighbours to the north, and is offset at an angle of approximately 4 degrees.

The windows are of uPVC with fixed principal lights and top-hung casements above. The front door is a twentieth-century panelled door with two glazed panels and one timber panel. Above it is a small porch roof supported on moulded brackets which appear to be of cast concrete. The roof is gable-ended with a covering of fibre-cement tiles and there are chimney stacks on the end gable and on the party wall. The rainwater goods are of cast iron, with a half-round gutter that is missing the southern end.

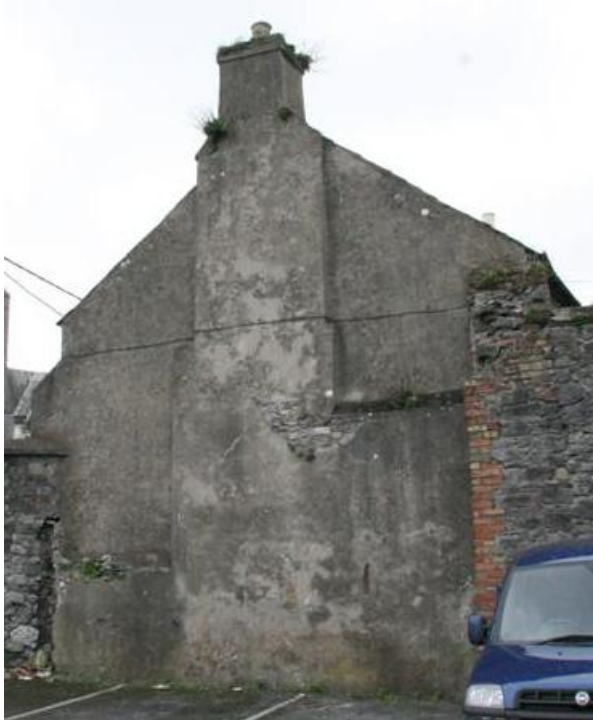
Plate 127: Southern gable end

The southern gable end of the house is rendered, though with the render damaged in places. The chimney stack projects beyond the face of the gable and becomes narrower in stages towards the top. Below the approximate level of the first floor the facade is thicker to the rear of the chimneybreast. To the front of the chimneybreast there is a small area that is thickened near to the base.

A wall projects to the front of the gable, while the boundary wall to the east meets the wall but is not aligned on it, projecting further into the adjacent property. This is discussed further in the opening up survey below.

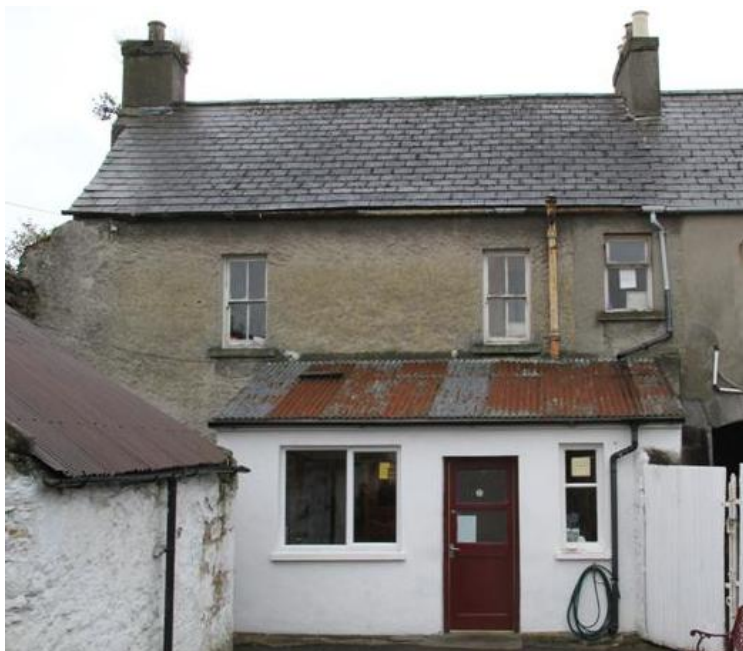
Plate 129: Rear facade of 22 Vicar Street

As noted above, the rear wall of number 22 Vicar Street has a modern extension attached and there is no return. The rear of the main house is roughcast rendered. The roof covering is of fibre-cement tiles and the rainwater goods are of cast iron. The original windows remain on the upper floor of this facade, both being two-over-two timber sashes with semi-revealed weight boxes. A third window at top level is a timber casement, as is the one window at ground floor level in the original house. The later extension is smooth rendered and painted with a corrugated iron roof and with timber casement windows.

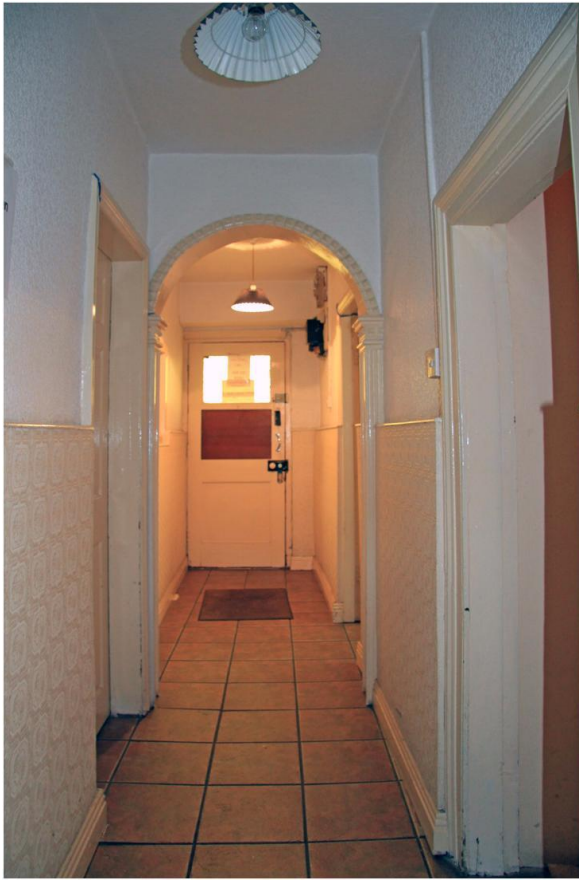
Plate 130: View to front of passageway

The entrance hall runs as a narrow passageway from front to rear in the building, where it enters the modern extension. Doors lead off to the side of the passageway into one room to the left, one to the right and to the staircase near the rear. Each of these doorways has a moulded timber architrave. The floor is tiled and the alignment of the tiles reflects the fact that the corridor is not of even width and the side walls are not parallel. A little closer to the front than half way down the passage a segmental arch crosses over, supported on timber pilasters with pyramidal mouldings at the capitals, this feature also running up the faces of the arch.

The wall above the front door is thicker than the walls flanking the door, suggesting that there is a beam at this location.

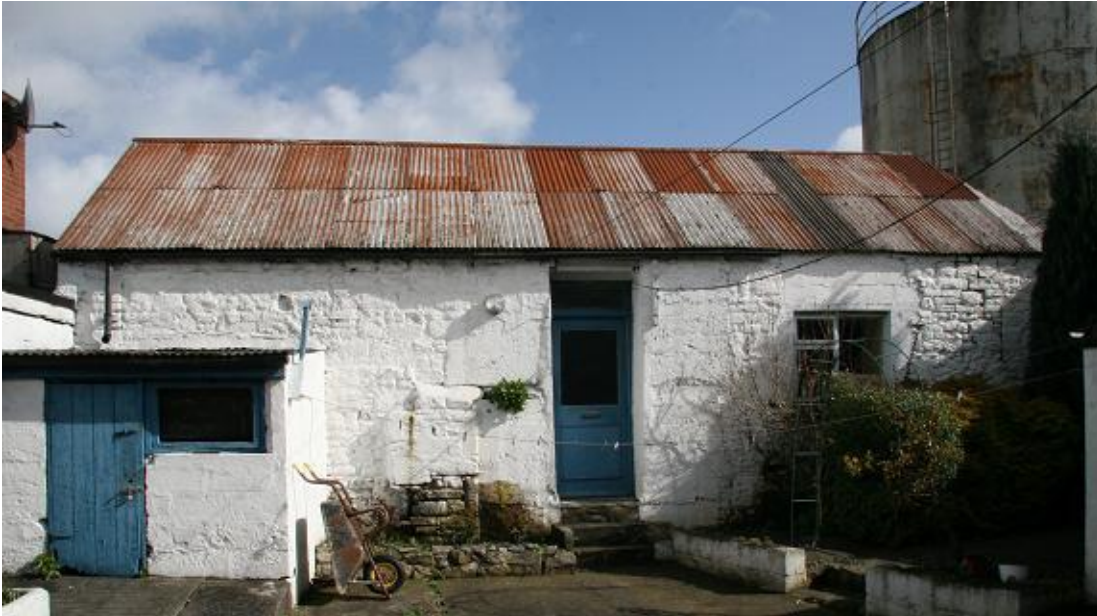
Plate 155: Shed A at rear of yard behind 22 Vicar Street

This building is shown on the 1841 Ordnance Survey manuscript map reproduced above, though the northern part of it as shown on that map is now missing. The external walls on the northern, eastern and southern sides were not inspected, as there was no access to those lands.

The interior of the building is dry lined and hence the interiors of the walls are not available for inspection. The front wall of this building exhibits a wide variety of periods and materials, making it difficult to assess how the building looked originally. The following photographs look from the left-hand side towards the right, noting the materials in the front wall.

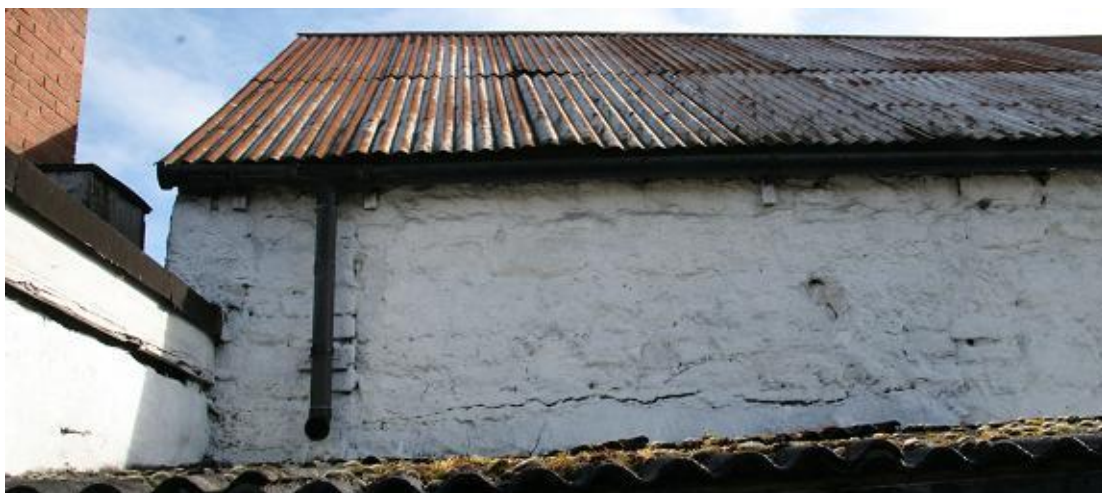
Plate 156: Northern end of building, above shed B

The front of the building is lime washed, making identification of the building materials difficult, though it is possible to be clear on this in some instances. The northern end of the building, seen in Plate 155 above, has brick built in with the rubble stone of the wall. This is particularly visible behind the drainpipe, but is also visible towards the right hand end of the photograph.

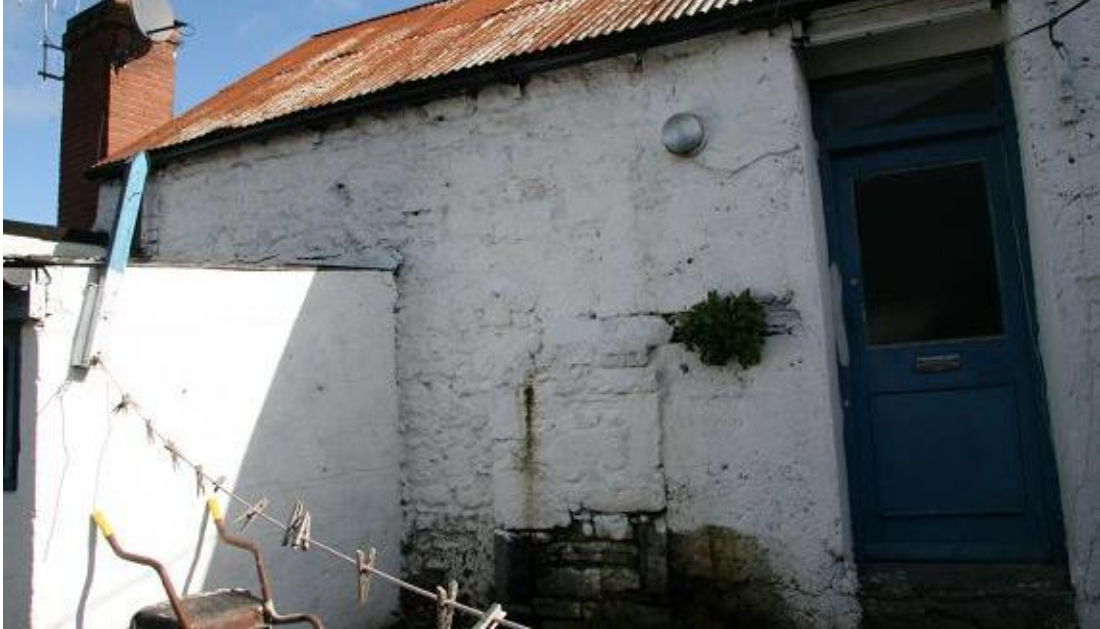
Plate 157: Wall to the left of the doorway, shed A

Immediately to the left of the door into the shed the wall is of mass concrete. There is a well-formed small buttress at the beginning of the stone wall beyond this, seen in the photograph above and in more detail in Plate 157 below.
