Recording of buildings along
Wolfe Tone Street and Vicar Street,
Kilkenny
for the
Kilkenny Central Access Scheme

Rob Goodbody
Historic Building Consultant
March 2013

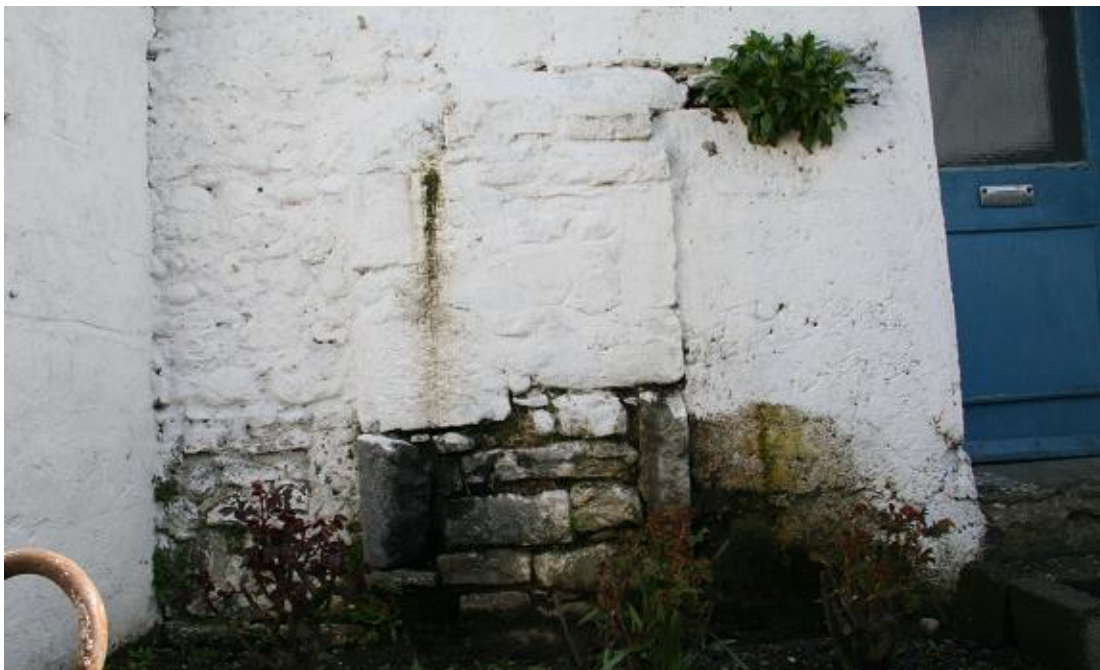
Plate 158: Buttress at front of shed A

The function of this buttress is unclear, but given that it occurs adjacent to the mass concrete area beside the door it is possible that this represents a former edge of a wider opening into the building. The buttress is also in line with the internal wall. The stonework is well formed, but does not appear to be of antiquity.

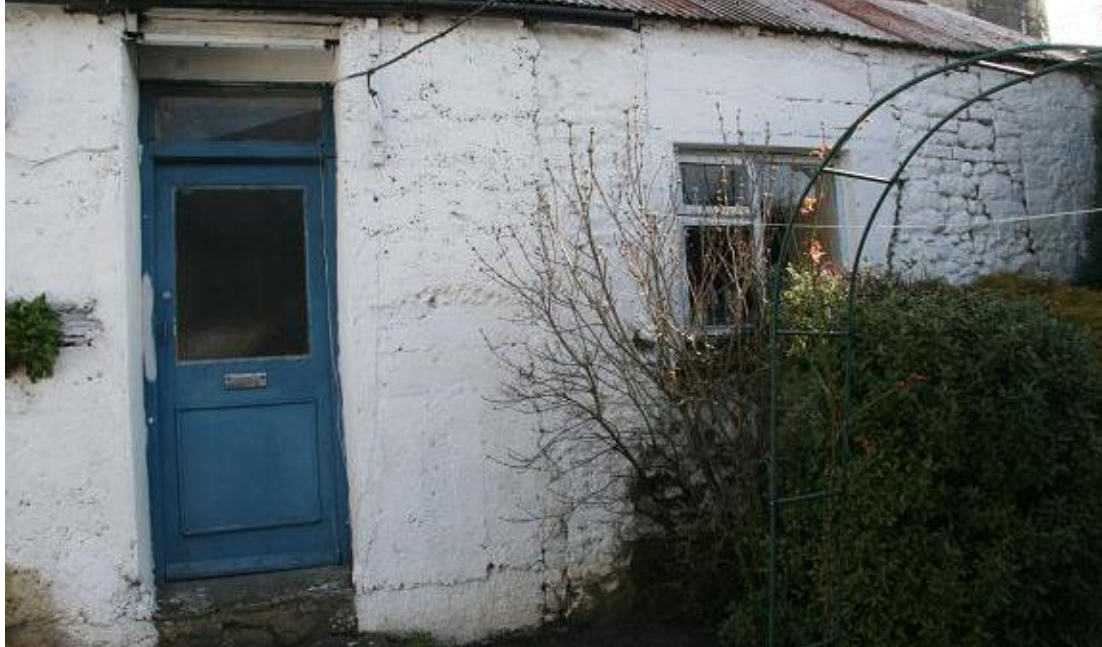
Plate 159: Area to right of door of Shed A

The door to this building is set in an area of mass concrete and this is also found around the window, which is entirely set in mass concrete. There is a narrow area of stone masonry between the door and the window, and a further area of stonework to the right of the window. This latter section has extensive amounts of brick, both whole and fragmented.

The suggestion from the masonry to this building is that while it existed at the time of the first edition Ordnance Survey it is not of ancient origin.

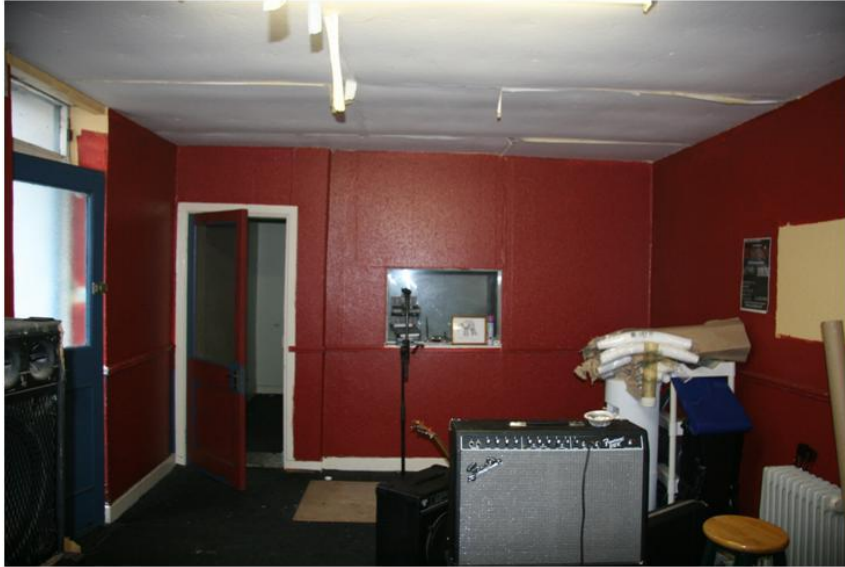
Plate 161: View northwards along larger room

The interior of shed A is divided into two unequal rooms. The building has been in use as a practice area for bands and the entire interior is dry-lined with a deep covering of insulating material. As a result, the true nature and thickness of the walls was not determined during the survey.

The larger room is rectangular, except that the southern end wall is at an angle of about 17 degrees away from the norm. The walls are dry lined with softboard or similar material, and a similar covering is found on the ceiling. These coverings are in sheets of about 2.4 by 1.2 metres in dimension. There is a light timber dado rail.

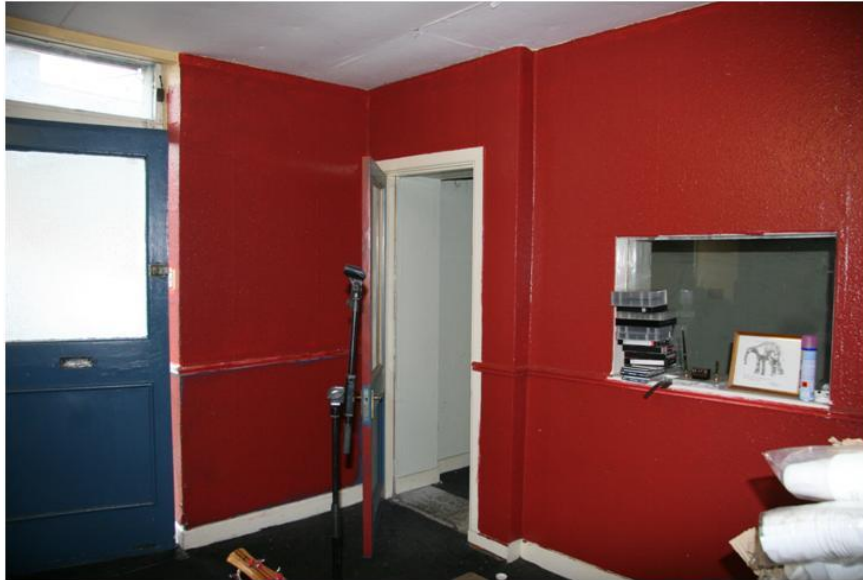
Plate 163: Entrance and door linking the rooms

The entrance to the shed is via a twentieth-century panelled and glazed door and there is a timber skirting at the base of the walls, which continues to form an architrave around the internal door.

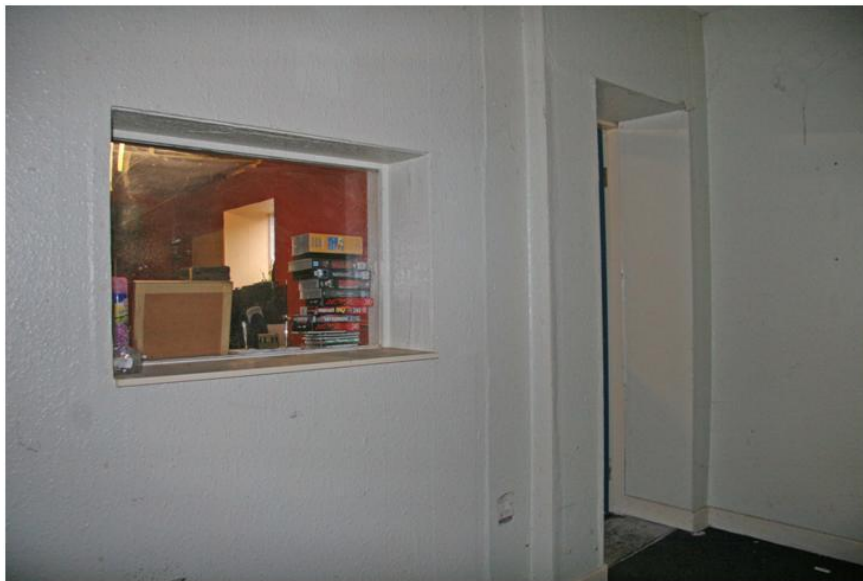
Plate 164: Window in smaller room

The smaller room is featureless except for a simple rectangular window overlooking the main room and the doorway to the other room, which lacks a door. The wall at the connecting doorway projects beyond the thickness of the remainder of the dividing wall. This room is also dry lined with softboard or similar material.

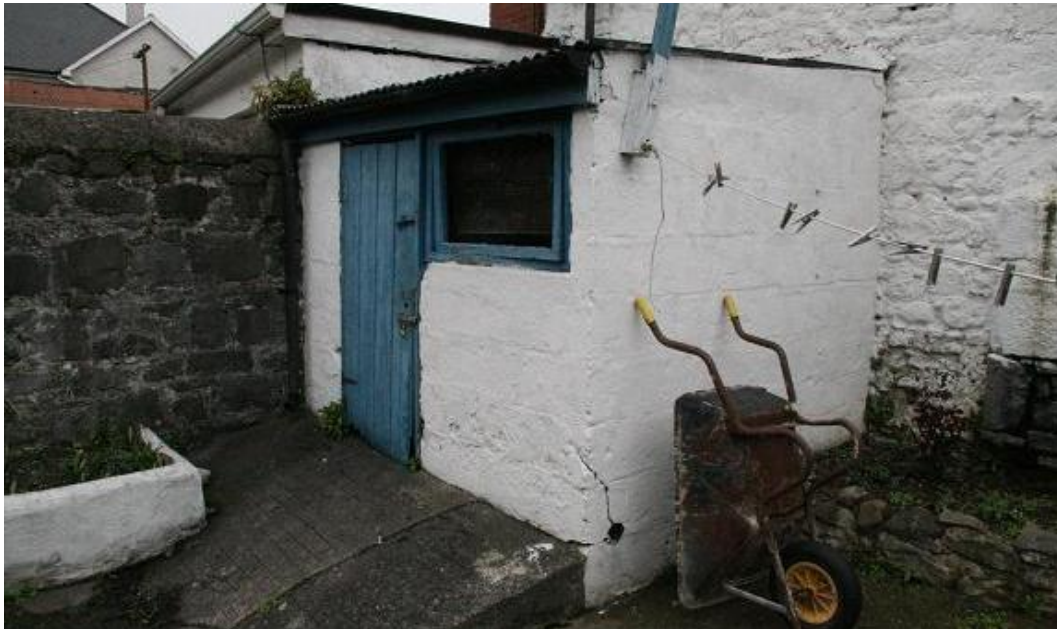
Plate 165: Shed B

Shed B is a small lean-to built against the northern end of the front of Shed A. This structure is of mass concrete and is of 20th century origin.

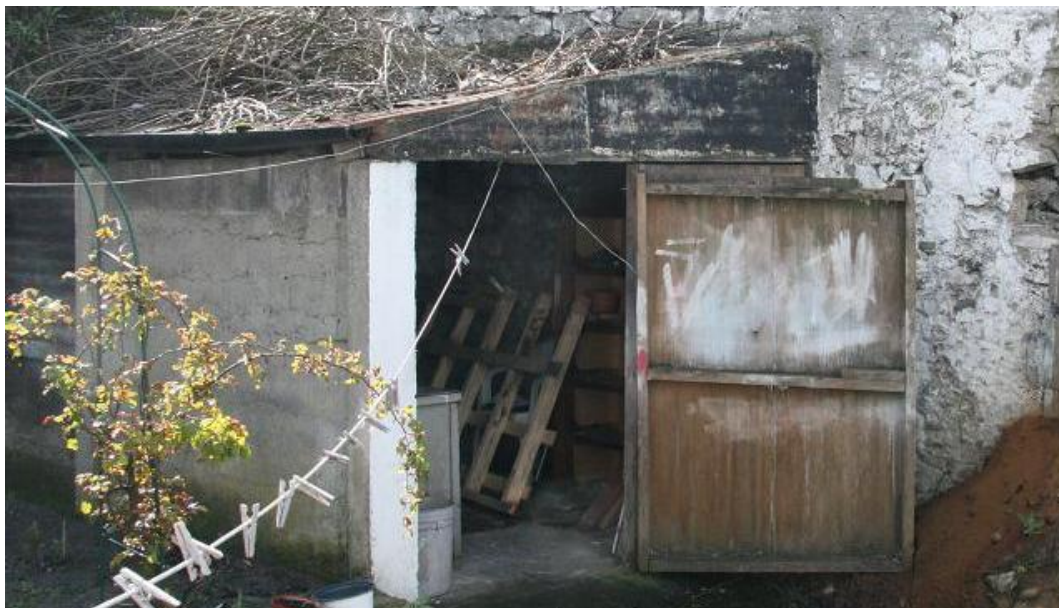
Plate 166: Shed C

Shed C is also of 20th century origin. The stone walls at the side and rear are treated separately below.

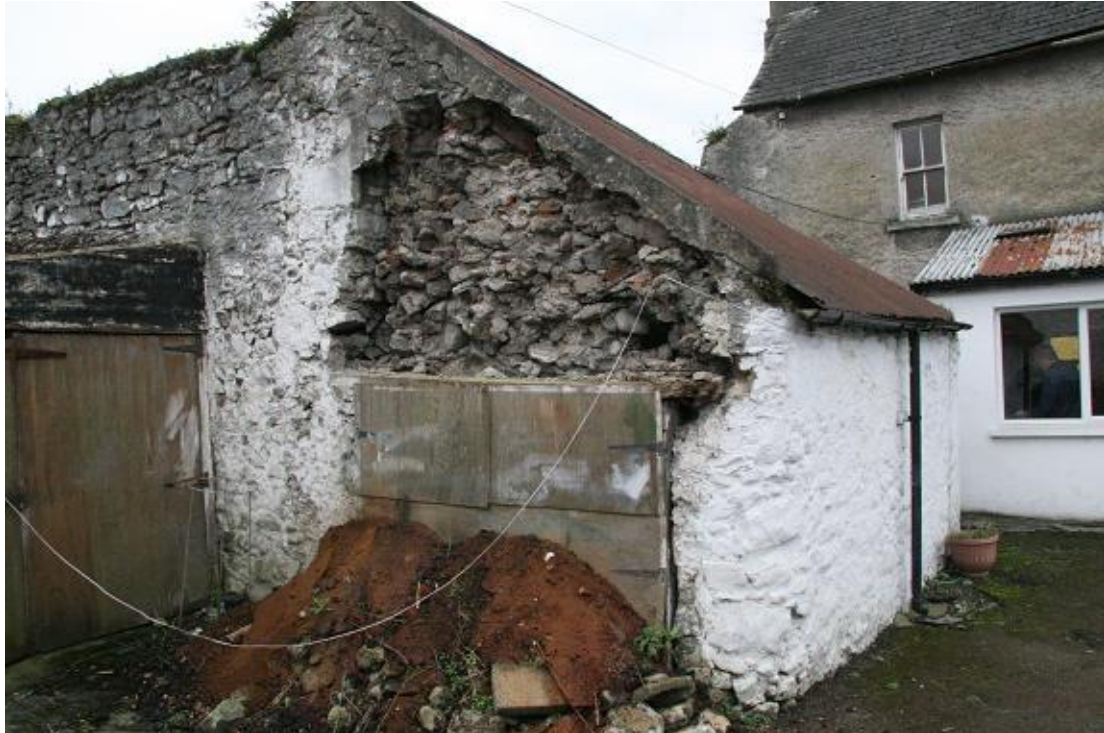
Plate 167: Eastern end of shed D

Shed D is built up against the southern boundary wall and is constructed of stone. The quality of the masonry is similar to that of the walls in the houses, consisting of small stones with a significant amount of broken brick incorporated. The gable of the eastern wall has collapsed, revealing the structure of the wall in detail.

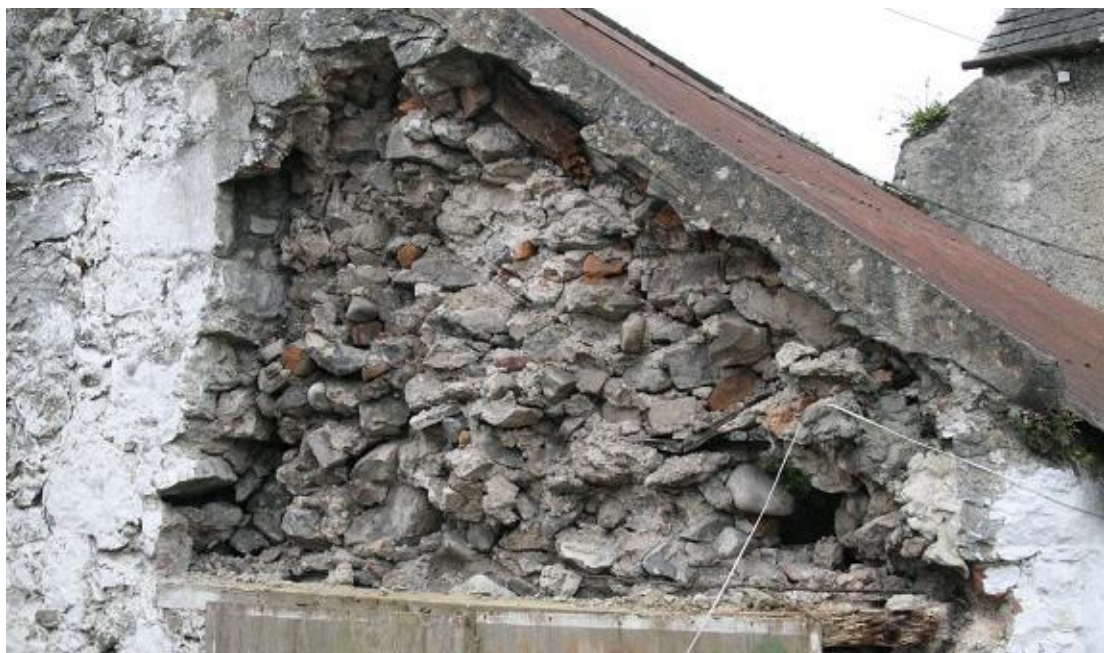
Plate 168: Collapsed gable at eastern end of shed D

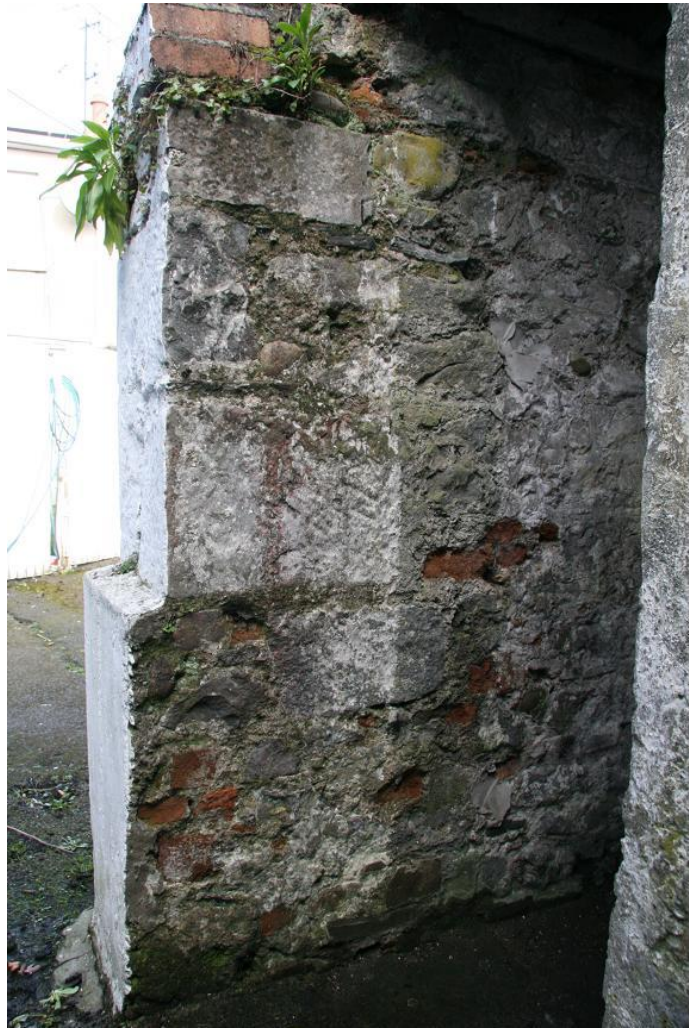
At the western end of Shed D, where it is closest to the house, there is a doorway facing the house. The end of the low wall at the doorway terminates in a pier with dressed stone in the mid section. This is seen in the photograph below where three courses of dressed stone may be seen. These rest on a plinth that includes a substantial amount of brick, showing that if this stone is of any age it has been reused in later times.

*Plate 169: Pier at end of shed D
with dressed stone in mid section*

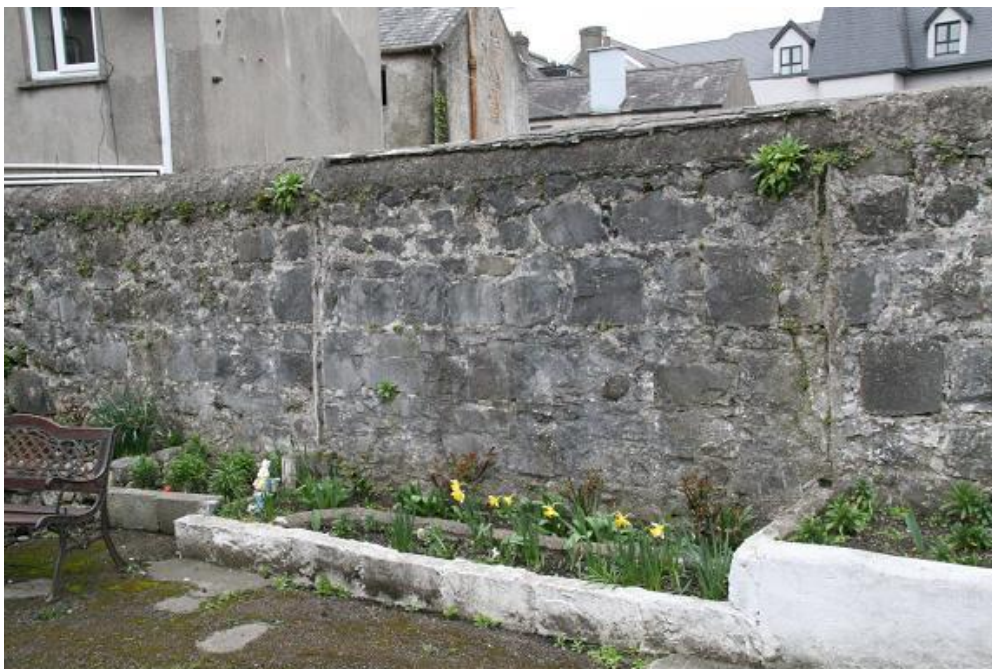
Plate 170: Northern boundary wall

The northern boundary wall consists of reasonably well-built rubble limestone masonry, brought to courses. The stones are generally of good quality and size. The wall is capped with sand and cement. The wall is divided vertically at intervals, with the courses and stonework being similar on either side of the divide. This suggests that the wall is built with Portland cement, necessitating expansion joints.

It is noted that this wall is not shown on the 1841 large scale Ordnance Survey map, though it seems to be on the valuation map of ca. 1860 and has definitely appeared by 1900.

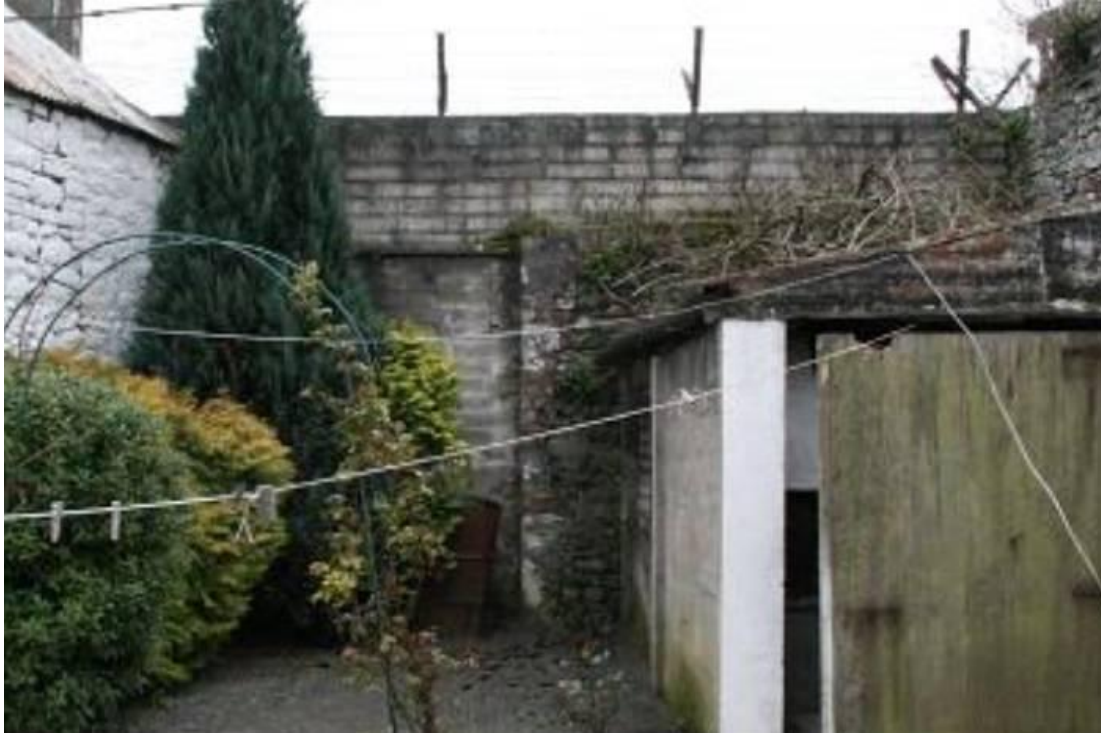
Plate 171: Eastern section of southern boundary wall

The part of the boundary wall that lies behind Shed 3 and a little above and beyond it is built of brick and stone, with a well-defined vertical stop to this part of the wall. To the east of this and running across the entire upper section of the wall the structure is of concrete blocks.

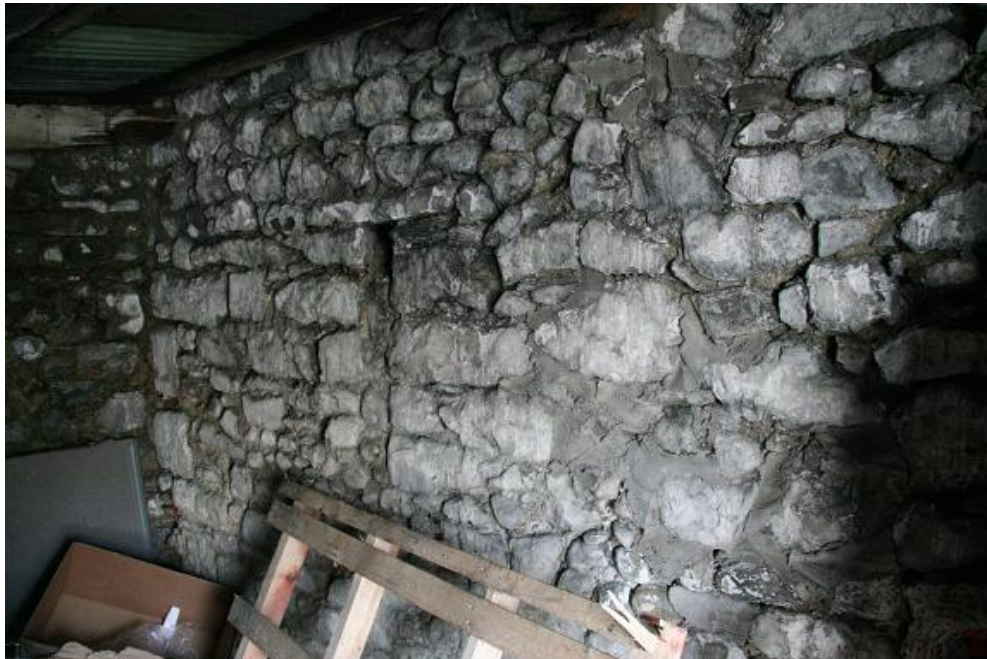
Plate 172: boundary wall, seen within shed C

The central section of the southern boundary wall lies within Shed C and above it on its eastern side, and faces into the adjoining private car park on its western side. This is a stone wall, lime washed within the shed, though the lime wash has not been renewed in a considerable time. The wall consists of small to medium sized stones and is not of high quality masonry. Mid-way along the wall there is a ventilation slit with its narrow face on within the shed. As these features would normally have the splay within the building it appears that this ventilation slit was built to serve a building on the adjoining site, now the car park. The slit is 3800mm from the corner and the equivalent distance on the other side of the wall is concealed behind a rendered section of wall.

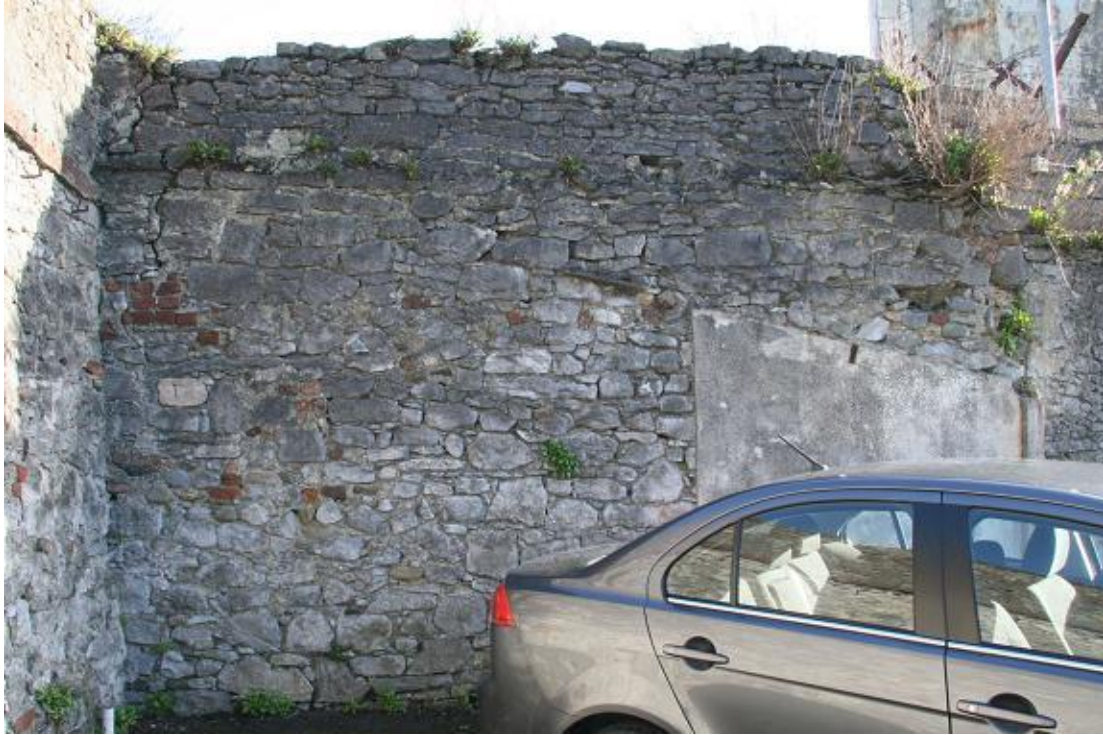
Plate 174: Central section of southern boundary, seen from car park

The opposite side of this wall, within the adjacent car park, is not lime washed, enabling closer examination of the fabric of the wall. This is seen to be of rubble stone of mixed quality, with particularly poor work at the very top. A great deal of broken brick is visible throughout this wall, suggesting that it is of post-medieval date. A small section of the wall is rendered, with a sloping upper margin to the render, suggesting that there was a structure here at some stage. As has been noted above the ventilation slit that is visible within Shed C is within the area that is rendered, preventing examination of this feature from this side.

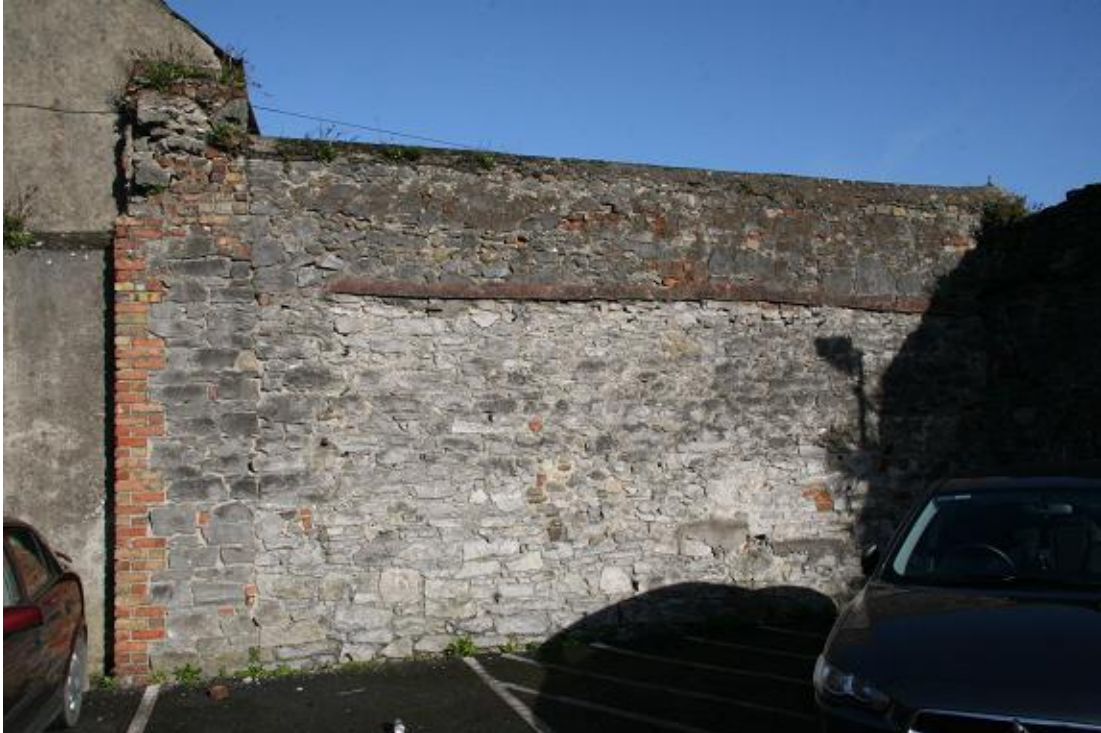
Plate 177: Southern boundary, western section, seen from car park

When seen from the car park the wall may be seen to be constructed like many of the other walls examined, with smallish, irregular stones of limestone, and incorporating a significant amount of broken brick.

The pier at the left-hand end of this section of wall is of a later date than the rest of the wall. This has been constructed to repair the broken end of the wall that is part of the feature revealed in the rear wall of the house and discussed in the opening up survey below. There is a clear break between the masonry of the pier and that of the main section of the wall, and the stone in the pier is of better quality. This is clear in Plates 173 and 174 below.

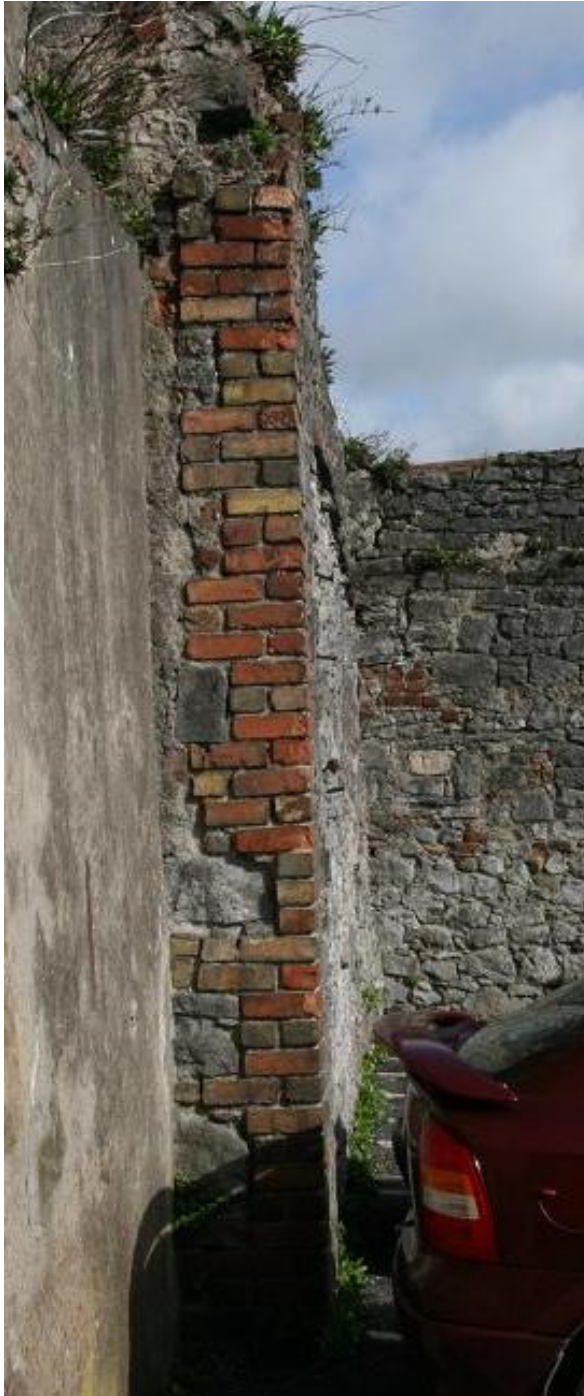
Plate 178: Western end of southern boundary wall, at rear corner of house

The south western corner of this pier is constructed of brick and the brick is of better quality than that seen elsewhere in the masonry and it is virtually the only section of brickwork encountered other than the use of odd bits of brick within the stonework of the walls.

It would appear that the boundary wall was originally built butting up against the masonry of the feature found in the rear wall of the house. The remainder of this feature was subsequently demolished and the ragged end protruding from the corner of the house was repaired, blending it in with the stonework of the boundary wall and finishing off the other end with brickwork keyed into the substantial stones of the feature, as seen in Plate 173 below.

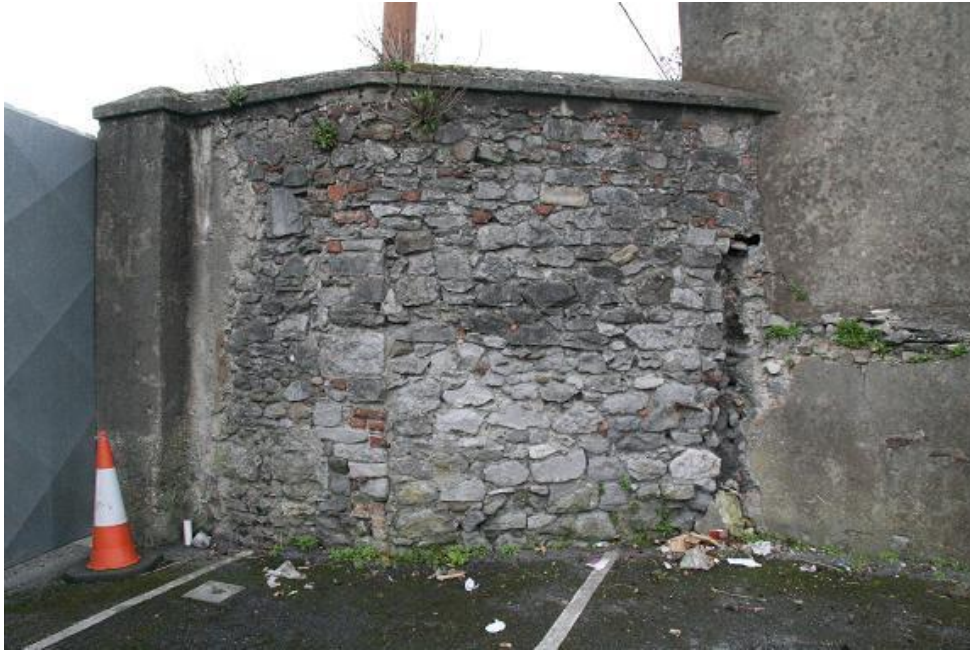
Plate 180: Wall projecting from south-western corner of 22 Vicar Street

The outer face of the wall, facing the street, is rendered and gives no clues as to its composition. The inner face, within the car park, is not rendered.

The upper section of the wall is built of the same rough masonry with smallish stones and brick fragments as is found elsewhere in the buildings. There is a vertical joint in the wall about two thirds of the way along its length from the house. The section nearer to the house has a small amount of brick built in with the stonework, while the part away from the house also has brick, some of it concentrated in the vicinity of the vertical joint.

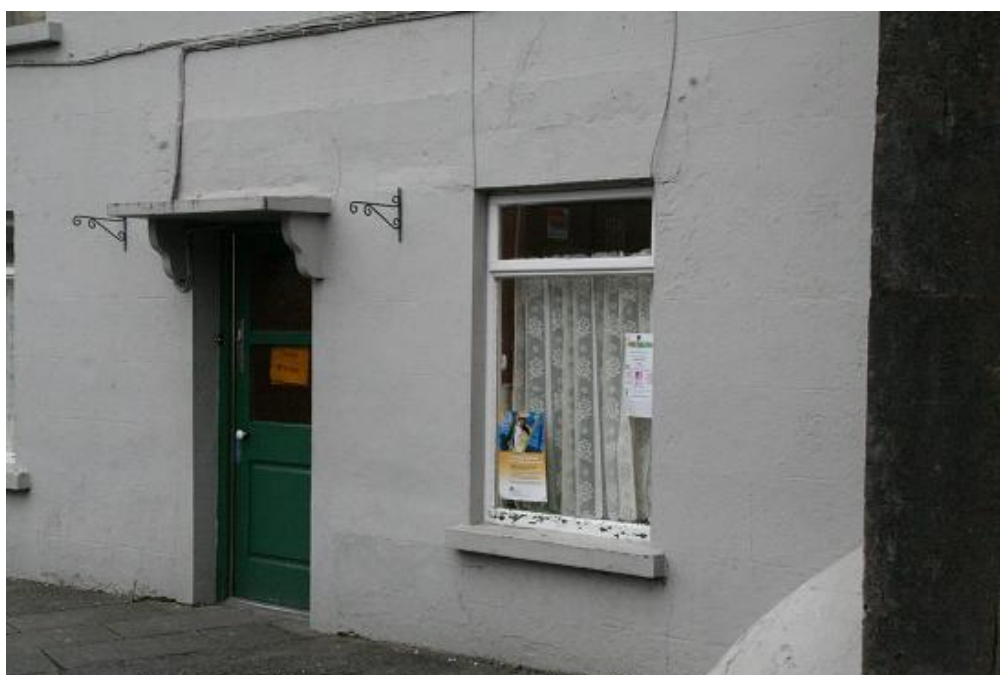
Plate 181: Southern part of ground floor facade showing shopfront

A further difference is that there are scars to suggest that there was a shopfront on the façade of number 22. This is seen in the scar that extends over the front door and the window to the right of it. This could have been a signboard, but the presence of what appears to be a beam on the inner face of the wall makes it more likely that there was a shop window here at some time in the past. This possibility is made the more likely by a further scar at sill level between the door and window, which may reflect the location of the stall-riser on the shopfront, but this is not conclusive.

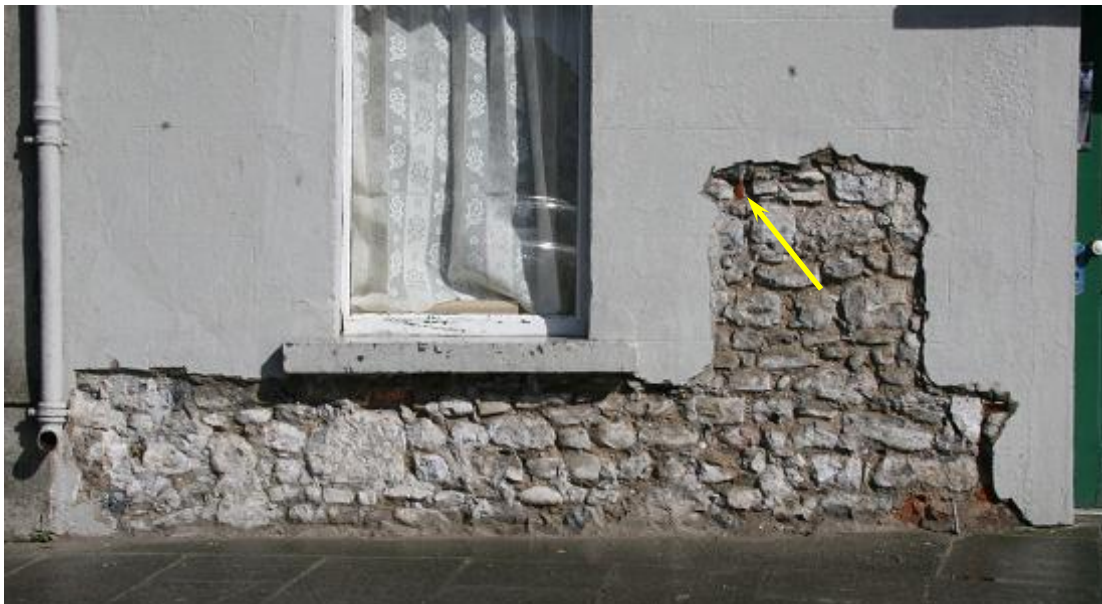
Plate 182: Opening in front facade of number 22 Vicar Street

This opening reveals a similar type of masonry to that found in the walls of number 20 Vicar Street. The masonry is generally of comparatively small stones of irregular shape. At the bottom on the right there is an area of brick, though it is possible that this is part of the brick lining of the door opening. A small fragment of brick was found near the top of the opening suggesting that this part of the wall is of post-medieval date. The lack of any change in the style of the masonry suggests that all of the stonework revealed in this opening was erected at the same time.

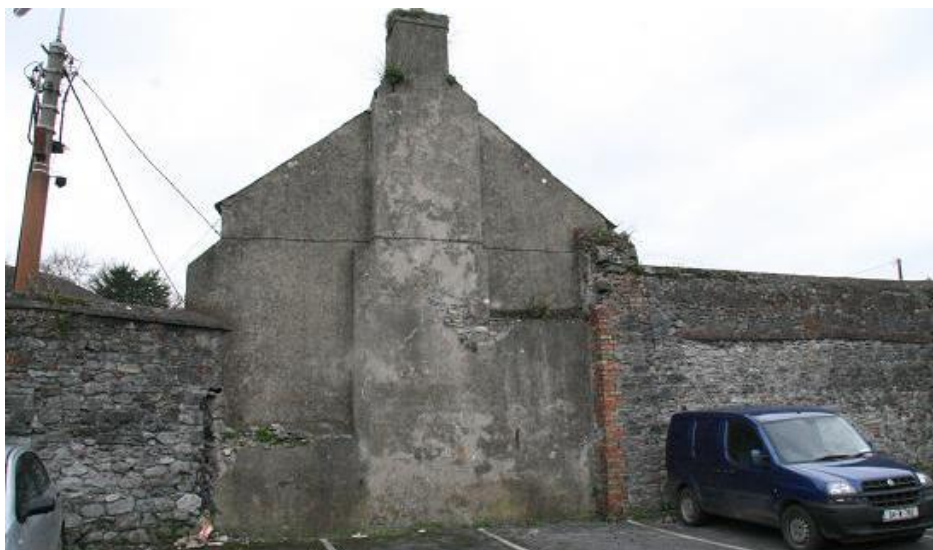
Plate 183: Southern gable end of 22 Vicar Street

As seen in the photographs below the gable end of the house is rendered. There are other walls butted against this gable, including a low section of masonry with the appearance of a buttress. The render in this additional masonry was cracked in places to reveal some brick in the walls, but the only place where this occurs on the main gable is at the chimney where brick would be expected in a building of this age.

The photograph in Plate 26 above shows the gable end with the chimneystack projecting. To either side there is a thickening of the wall that may be of a different period to the main gable wall. These abutted walls contain fragments of brick and the masonry is of poor quality. The stone walls on either side of the gable are considered separately below.

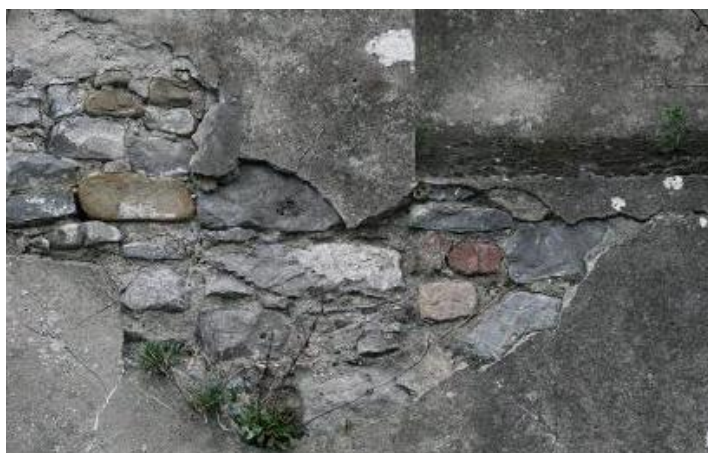
Plate 184: Masonry at chimney stack

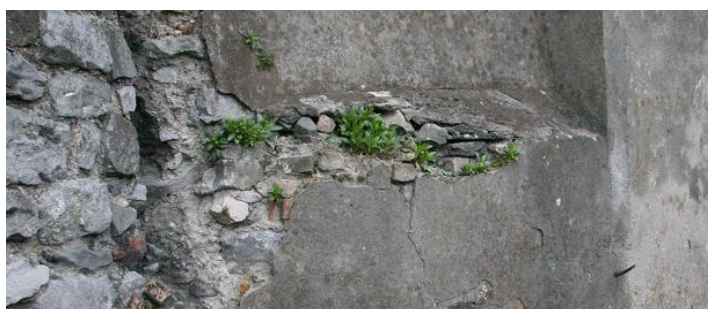
Plate 185: Masonry at base of gable wall

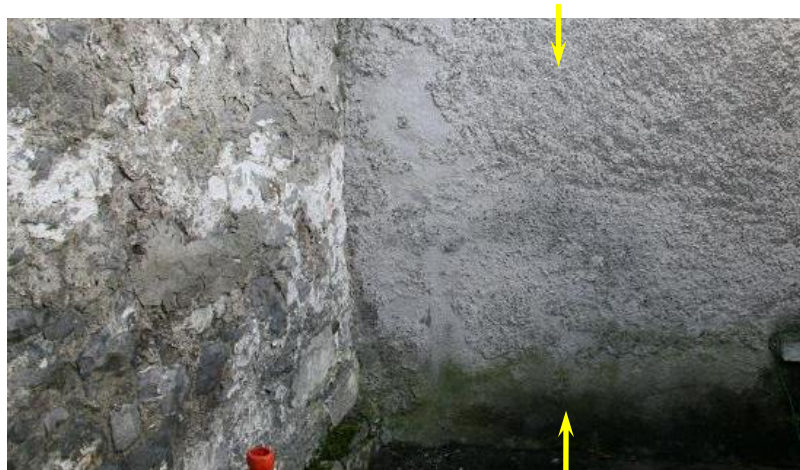
Plate 187: South-eastern corner of building with change in face indicated

The opening up of this part of the building revealed that the cause of the change in direction of the face of the building was a section of different masonry buried in the wall.

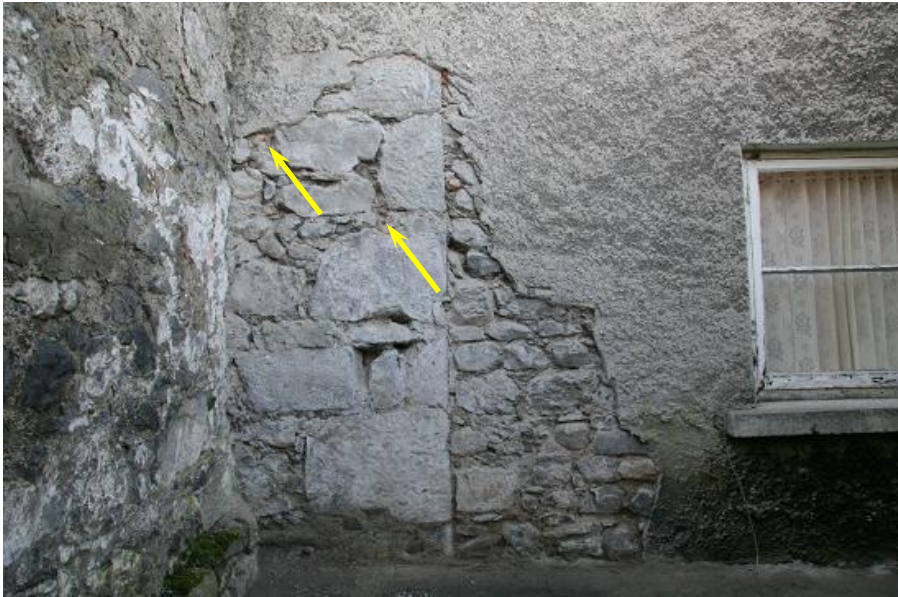
Plate 188: South-eastern corner of 22 Vicar Street

To the right of this feature the wall of the house is similar to that found at the front and in number 20 Vicar Street, with small stones making up a rough, poor quality wall. The feature itself has the appearance of the edge of a building, either a corner or one side of an opening. The firm edge is formed with what appear to be quoins, while to the left of this the masonry consists generally of smaller stones.

The feature itself is post-medieval and the better quality stones in the masonry are reused from another structure. The arrows in the above photograph indicate where fragments of brick are built in to the masonry, indicating that the wall is post-medieval. The stones themselves are of varying style, suggesting that they did not all come from the same origin, while the dressed stone that is not acting as a quoin is dressed as if to form the jamb of a door or window, complete with a dressed chamfer.

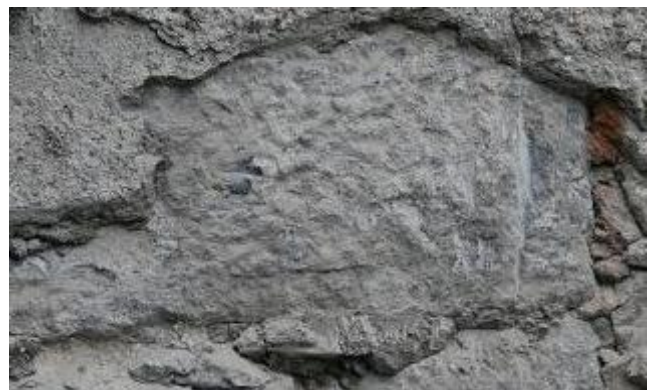
Stone 1: Only the bottom of this stone was revealed in the opening. It is hammer dressed with drafted margins ca. 50-60mm wide. The field is raised. The stone is approximately 510mm long, height unknown.

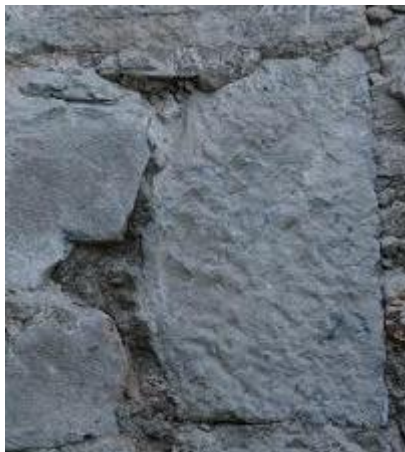
Stone 2: A vertical stone, hammer dressed with lightly chiselled, but not drafted, margin, circa 30mm wide. The stone is approximately 270mm horizontally and 420mm in height.

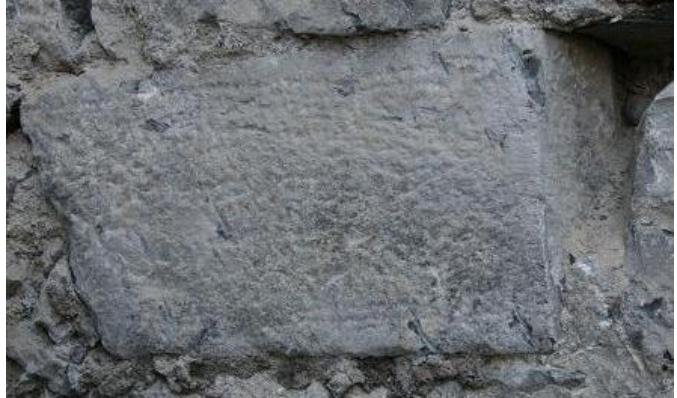
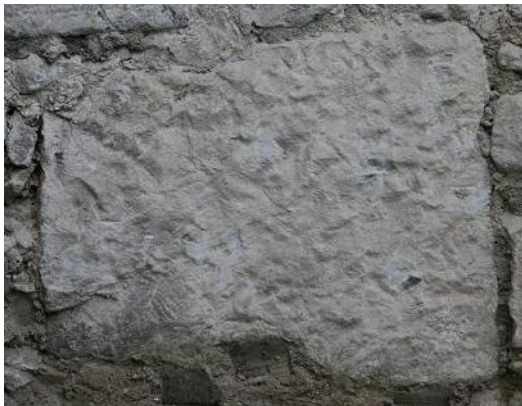
Stone 5: This is the only shaped stone that is not incorporated as a quoin, but is set back from the edge of the feature. The stone is set slightly off horizontal. The main face is finely punched with drafted margins ca. 25mm broad. The right-hand edge of the stone is chamfered, suggesting that this was the jamb stone of a door or window. The stone is ca. 450mm long and 250mm high.

Stone 6: This stone is somewhat irregular, having a well-defined right-hand edge, but otherwise poorly shaped. The surface is hammer dressed, but without any chiselling or punching. The stone is approximately 565mm in length and 480mm in height.

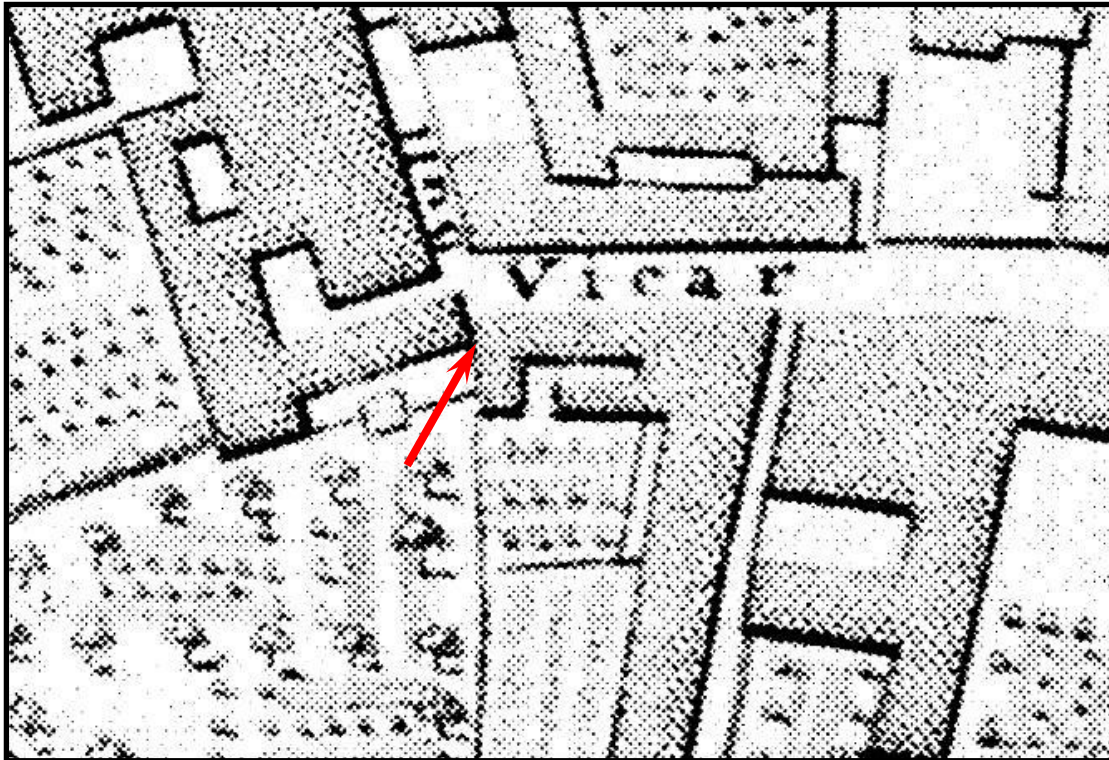
Figure 24: Enlarged detail of Rocque's map of 1758

The feature of dressed stone that emerged when the render was removed at the back of 22 Vicar Street has been seen from the examination of the structure to be an earlier feature than the houses. This is seen in the way that the rear wall of 22 Vicar Street butts up to the more substantial masonry without any keying between the two phases of wall. It has also been shown above that the feature is post-medieval, as is seen in the fragments of brick built into it, and the stones incorporated into it have been reused from elsewhere. While it is not possible to say exactly when the structure associated with this feature was built, nor when it was demolished, the evidence from maps shows that there was a building here in the mid-18th century, and it was gone before 1839.

In this greatly enlarged extract from Rocque's map a building is seen on the site now occupied by the adjacent car park. The corner of the street is greater than a right angle, such that buildings facing the street on either side of the corner do not meet square on. This scenario explains the presence of the feature clearly, and shows it to be the corner of the building that formerly occupied the adjoining property.
