Mullinavat Urban Design Study

Photographs to Accompany Text

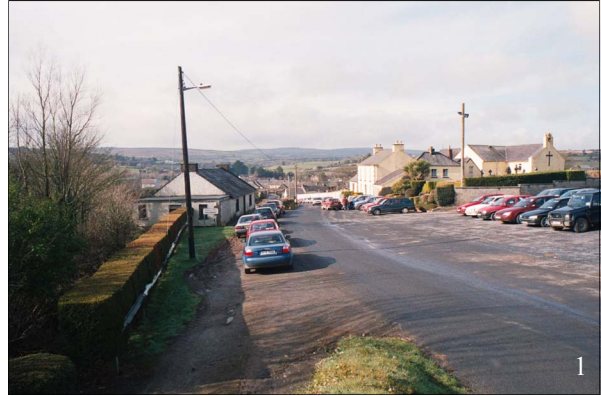
Photo 1 (top right): The elevated ground on the east side of the village, in the vicinity of the Church, provides strong views across the distant landscape.

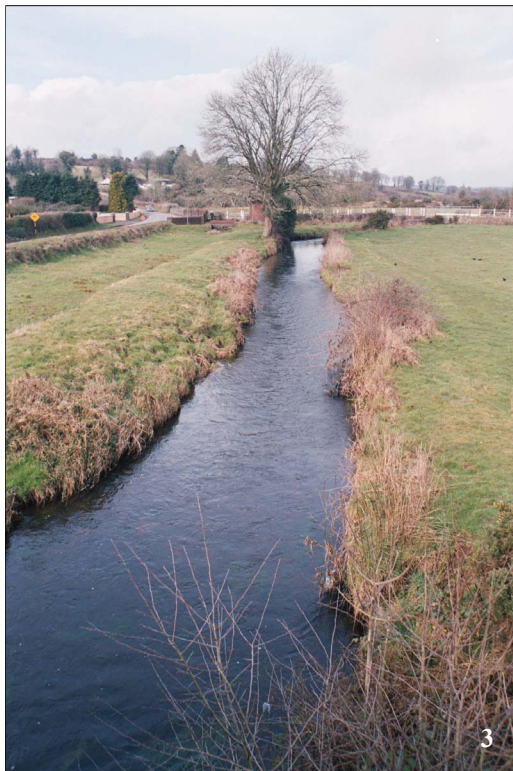
Photo 3 (Left): View of the Blackwater River—one of the areas' most significant amenity.

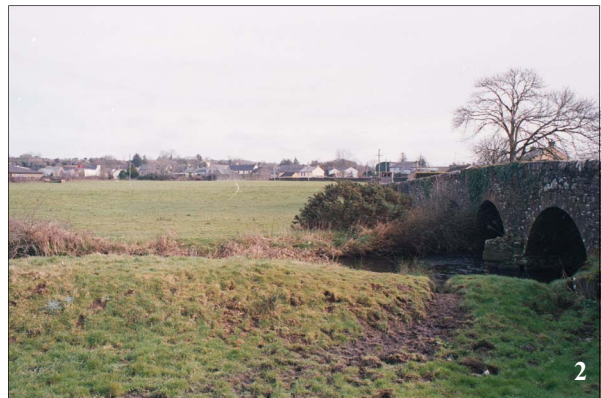
Photo 2 (below right): Immediately west of the village, the low lying lands associated with the Blackwater River and its floodplain are evident.

As evident in Photo 2 (above right), the village has remained relatively contained—in part due to the presence of the floodplain to the west and access restrictions onto the N9.

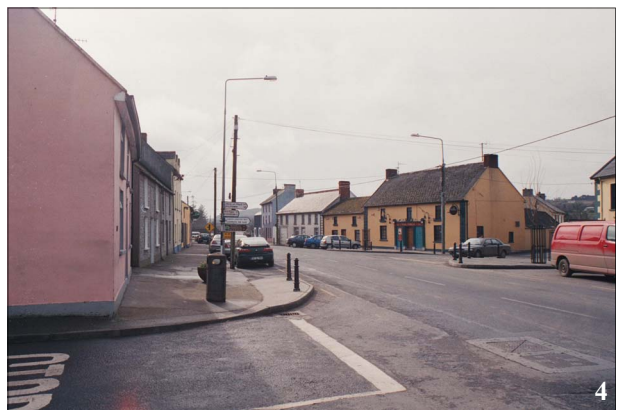
Photo 4: The village is centred on a cross-roads at a point where the Main Street broadens significantly in a splayed fashion.

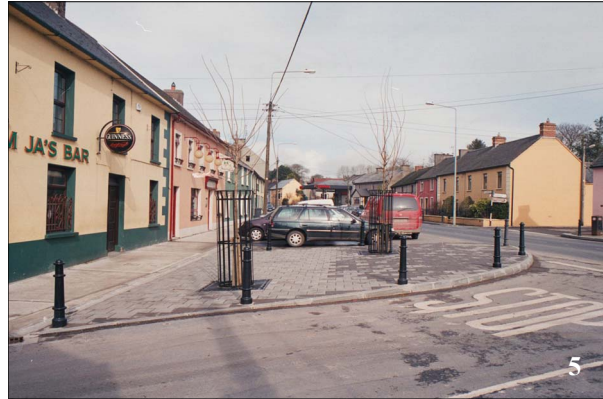
Photo 5: The splayed street pattern, which broadens in the centre of the village, permits further environmental improvements such as this one—with an extension of the pavement area, surfaced with concrete/stone settes and delineated with bollards and trees. It would also allow for a more formal delineation of car parking spaces—or their relocation to an off-street car park close by.

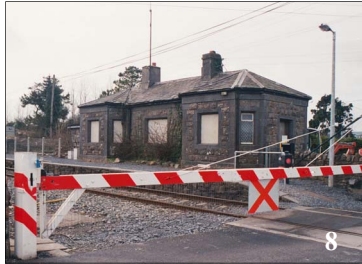
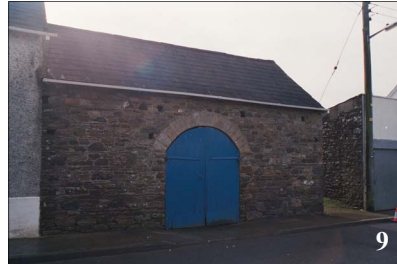
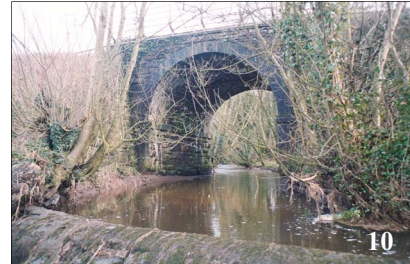
Photos 8, 9 & 10: While the number of architecturally important buildings in Mullinavat is limited, there are a number of fine stone structures including the former Railway Station (No.9); numerous stone bridges associated with the railway line (No. 10) and/or bridges over the numerous streams and rivers and some distinctive stone out-buildings (No. 11).

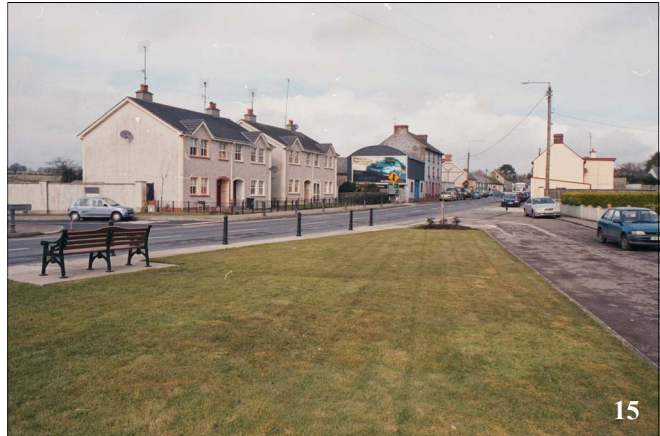
Photo 15: One of the few areas of open space in the village at Glen Crescent—fronting the busy N9.

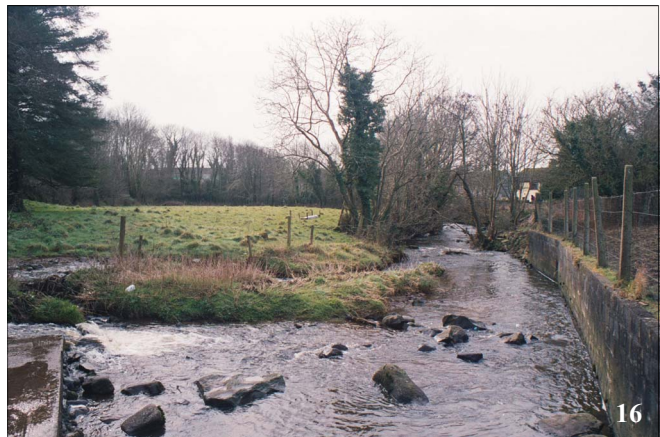
Photo 16: An enclosed area at the back of the village and adjoining Abhainn an Bhata — it presents an attractive amenity that could be suitably developed into a park.

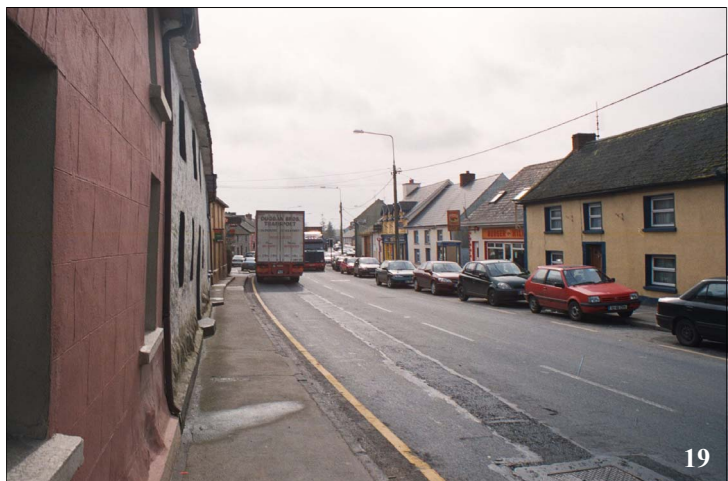
Photo 19 (Bottom right): N9 route attracts heavy volumes of heavy vehicles through the village.
