**PROPOSED NEW BUTLER GALLERY AT
EVAN'S ALMS HOUSE,
BARRACK LANE, KILKENNY**

**VOLUME 2
EXTERNAL CONDITION SURVEY
RECOMMENDATIONS**

July 2010

CARRIG
BUILDING FABRIC CONSULTANTS

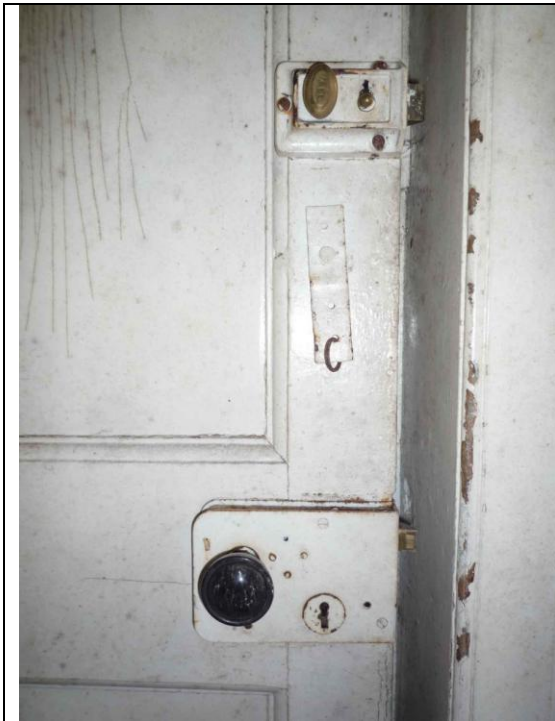
Fig.51: Door furniture to G01.
