**ARCHAEOLOGICAL TEST EXCAVATION AT EVAN'S HOME, BARRACK
LANE, KILKENNY**

FOR MC CULLOUGH MULVIN AND KILKENNY COUNTY COUNCIL

**MINISTERIAL CONSENT C414; registration number E4109; metal
detection R217.**

**CLAIRE WALSH
AUGUST 2010**

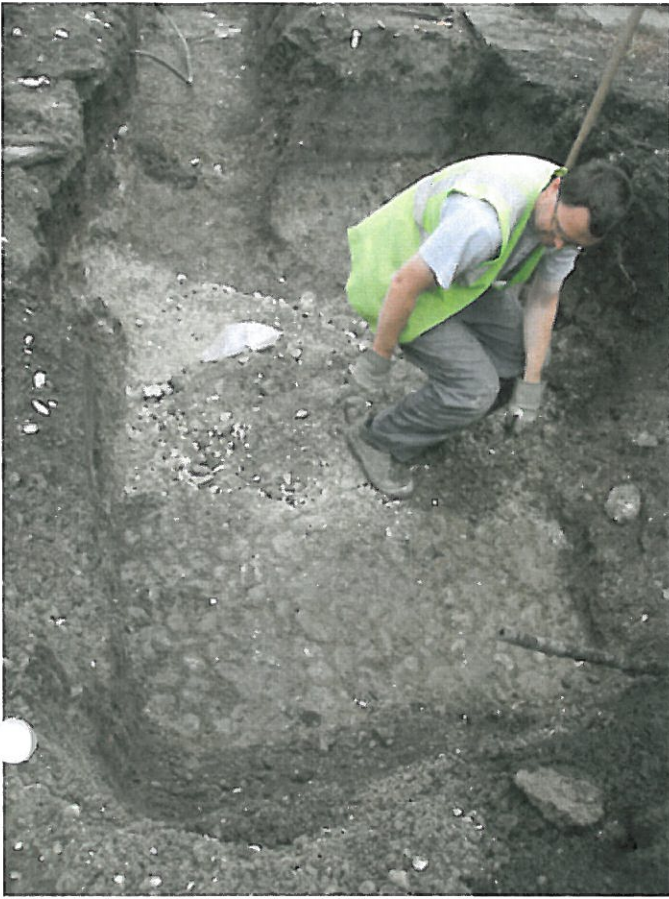
Plate 1. Cobbled surface F2 in trench 1A, looking north.

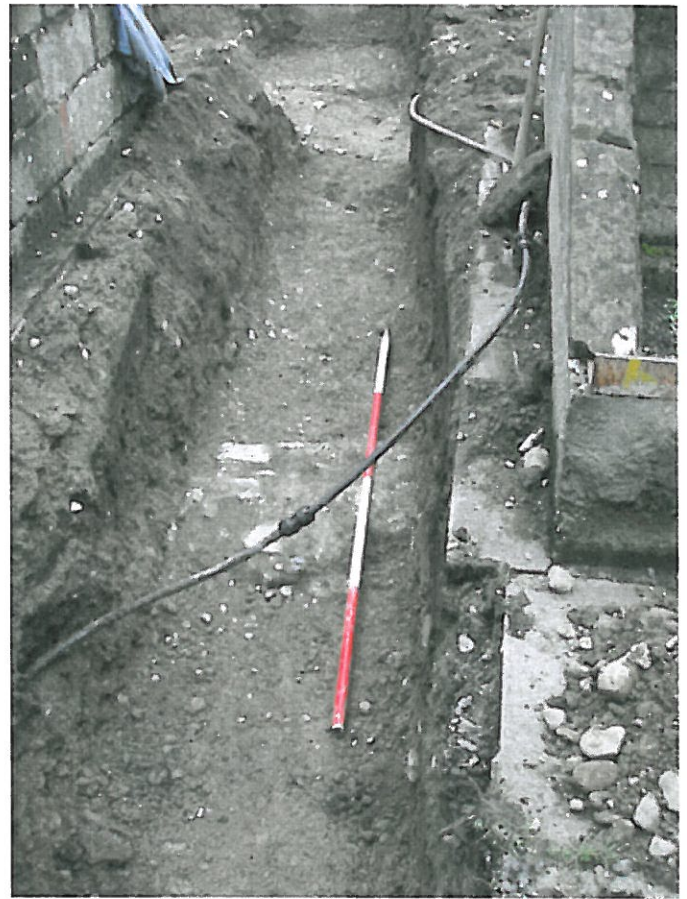
Plate 2. Wall footing F1 in trench 1A, looking north.

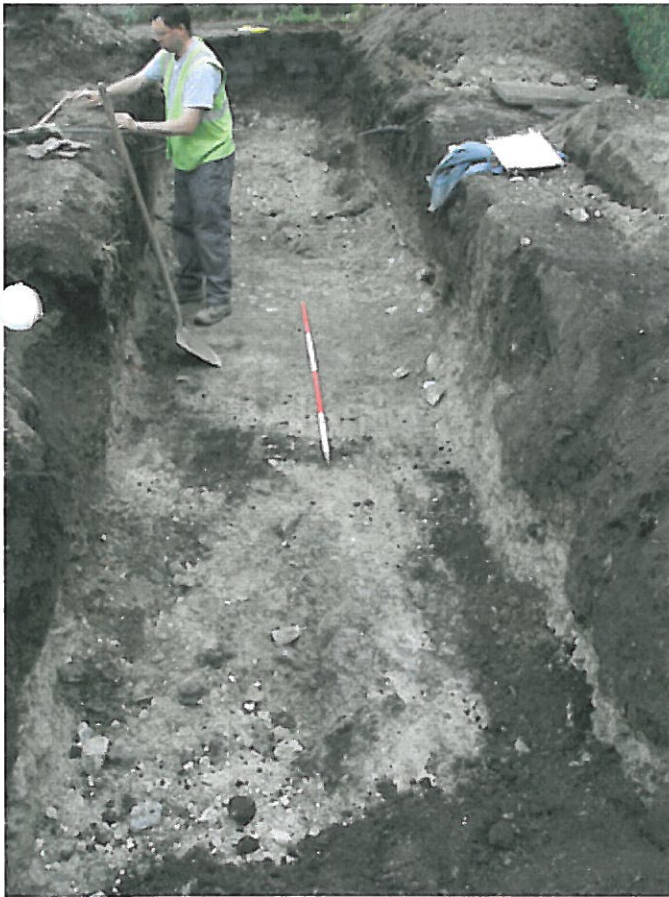
Plate 3. Trench 1B, showing cobbled surface F2, looking north.

Trenches 1B, 1c (figs 1, 2, plates 3, 4, 5, 6)

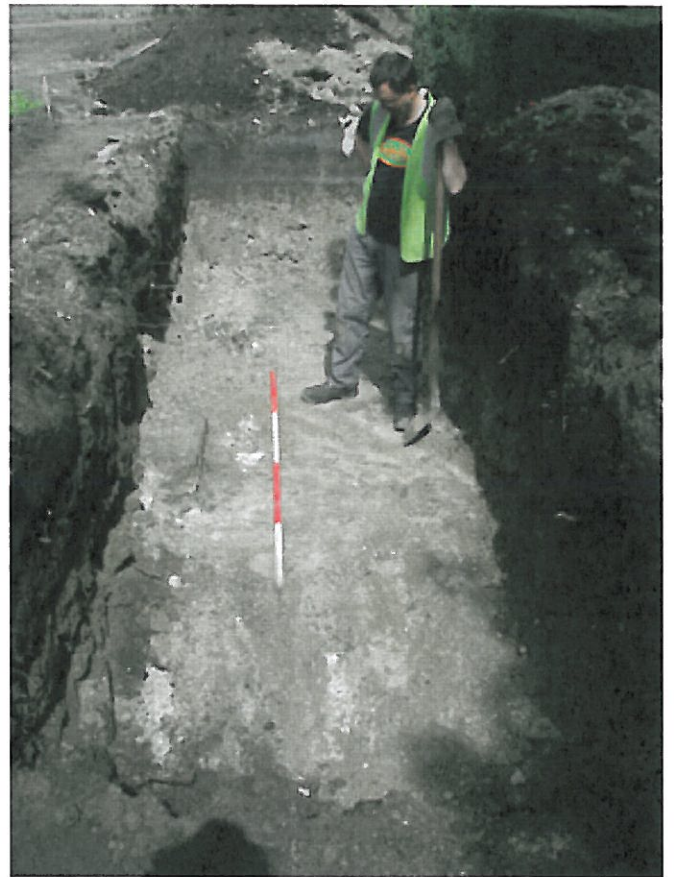
Plate 4. Trench 1C, showing cobbled surface F2, and wall footing F7, looking north.

The extension of trench 1 to the south uncovered a continuation of the horizons in trench 1B. However, a large flat limestone (F7) which was embedded in the cobbled surface, was uncovered towards the southern part of this trench (see fig.1, plates 4, 6). It is probable that this stone represents the remains of a wall. A sherd of tin glazed earthenware, late 17th- early 18th century, was recovered from F6, the yellow/ brown soil over the mortar layer.

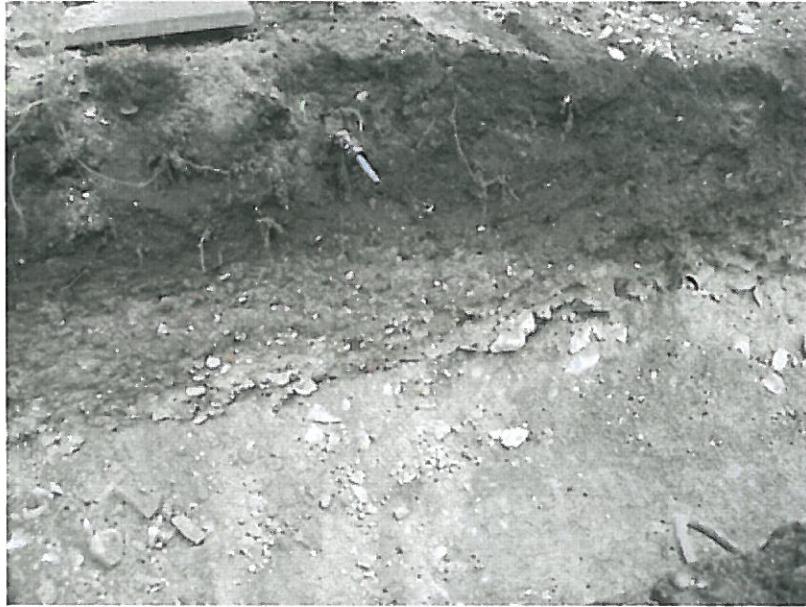
Plate 5. Section of soils in trench 1, C, looking east.

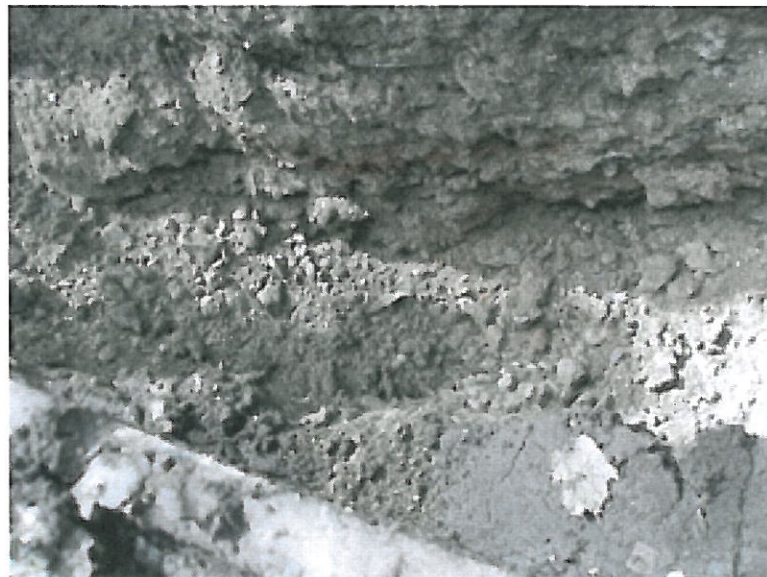
Plate 7. Base of trench 2A, looking west.

Trench 2 (Figs. 1, 2, plates 7, 8, 9, 10).

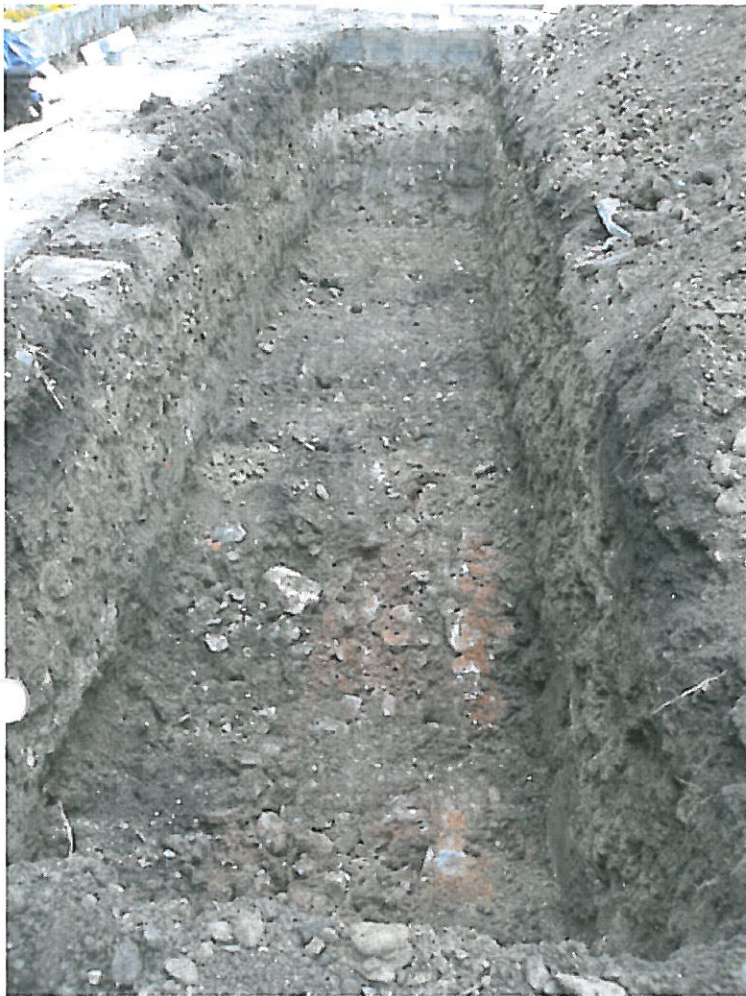
Plate 8. Burnt clay and stones in trench 2B, looking north. Note thick deposit of yellow clay/ gravel in sections.

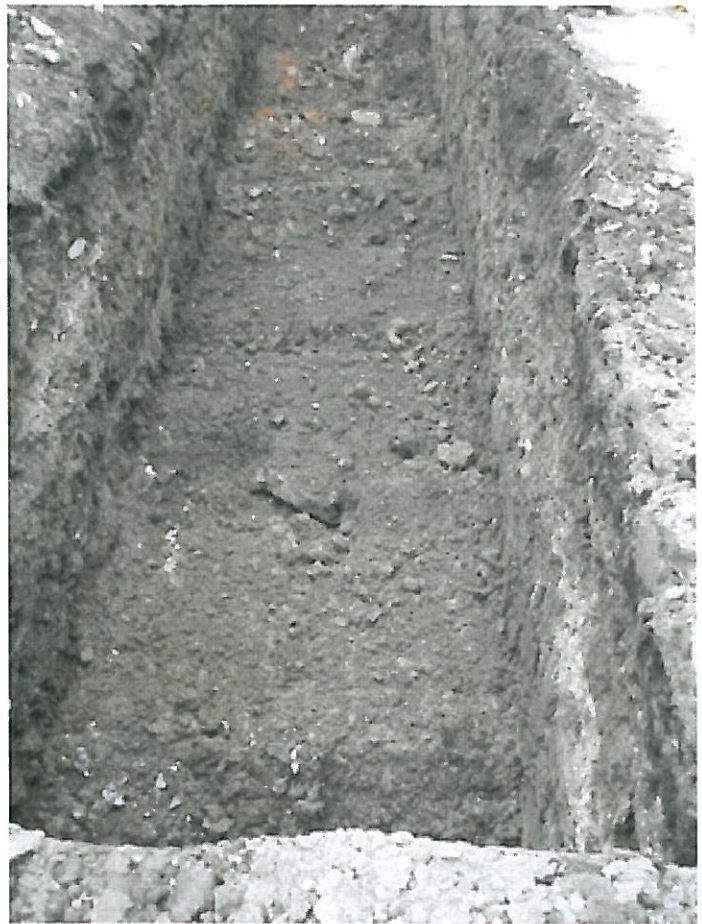
Plate 9. North end of trench 2, B, note mortar in sections.

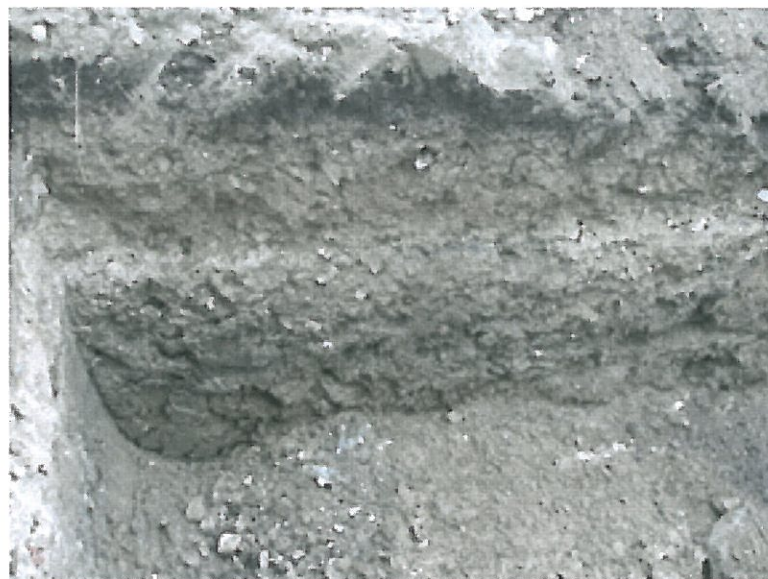
Plate 10. Soils in section of trench 2, B, north end.

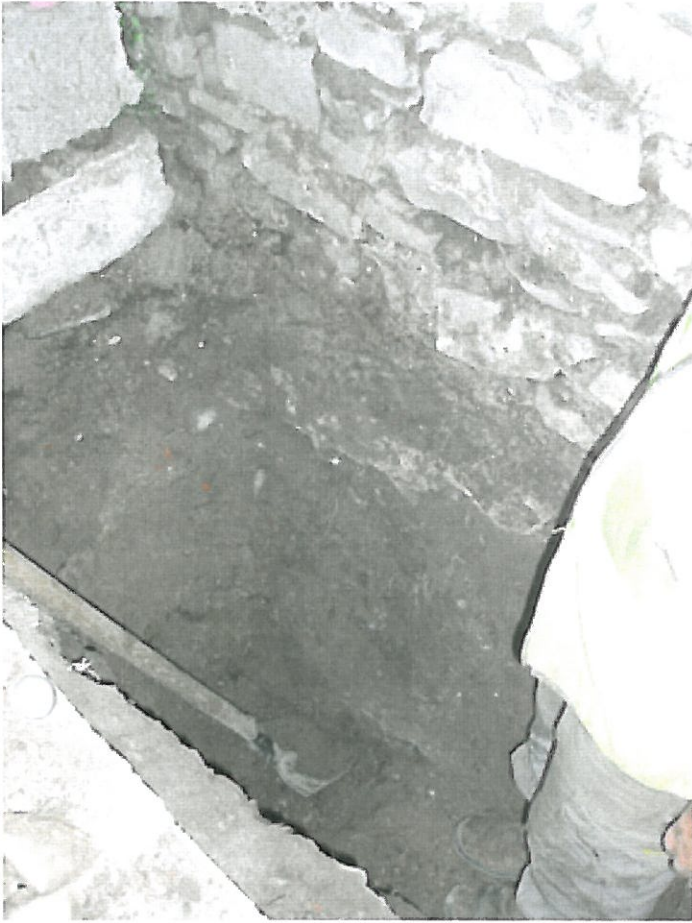
Plate 11. Trial pit 1, shovel at base of wall.

Test pit 1 (fig. 1, plate 11).

Present ground level is 46.22 MOD. The ground level at Back Lane is approx. 45.50. The test pit could not establish whether there is an earlier wall beneath the existing wall at Back Lane. However, this is likely as a wall is shown here on Rocque's 1758 map, which continued as far west as the mill race (see fig. 5). The external face of this wall has not been examined in any detail by this writer, however the eastern part was clearly the gable wall of the 1700 barracks. There is potential for an earlier wall beneath the present standing boundary wall, which may well be the town defences.

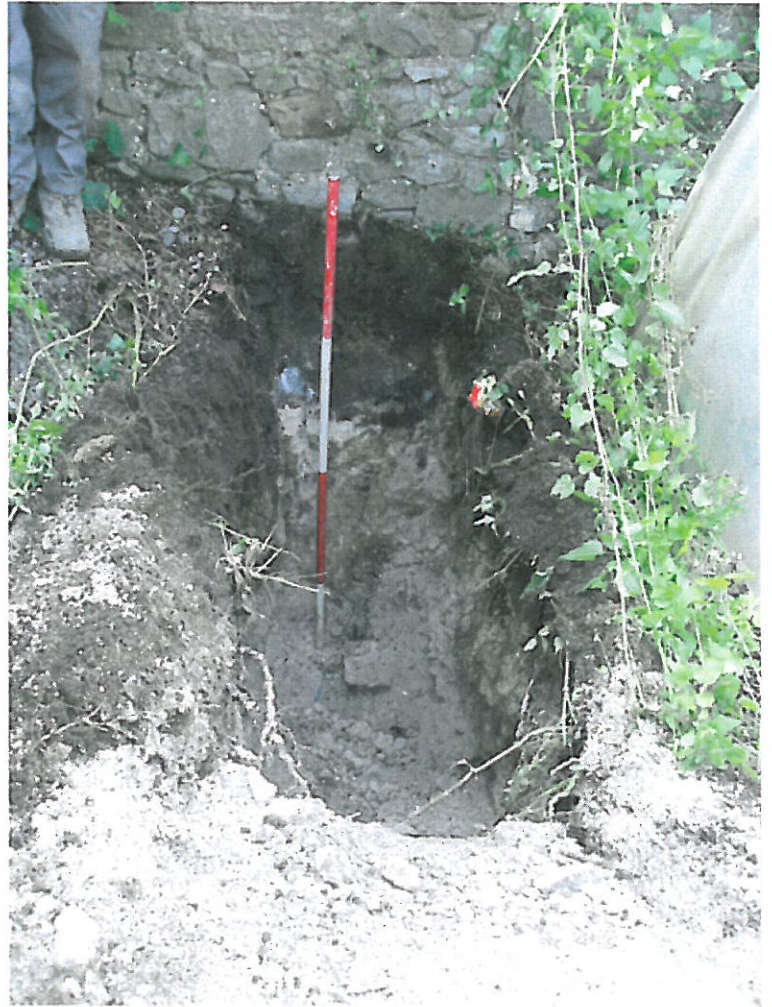
Plate 12. Trial pit 2, inside wall of barracks cellar.

Test pit 2 (Fig. 1, plate 12).

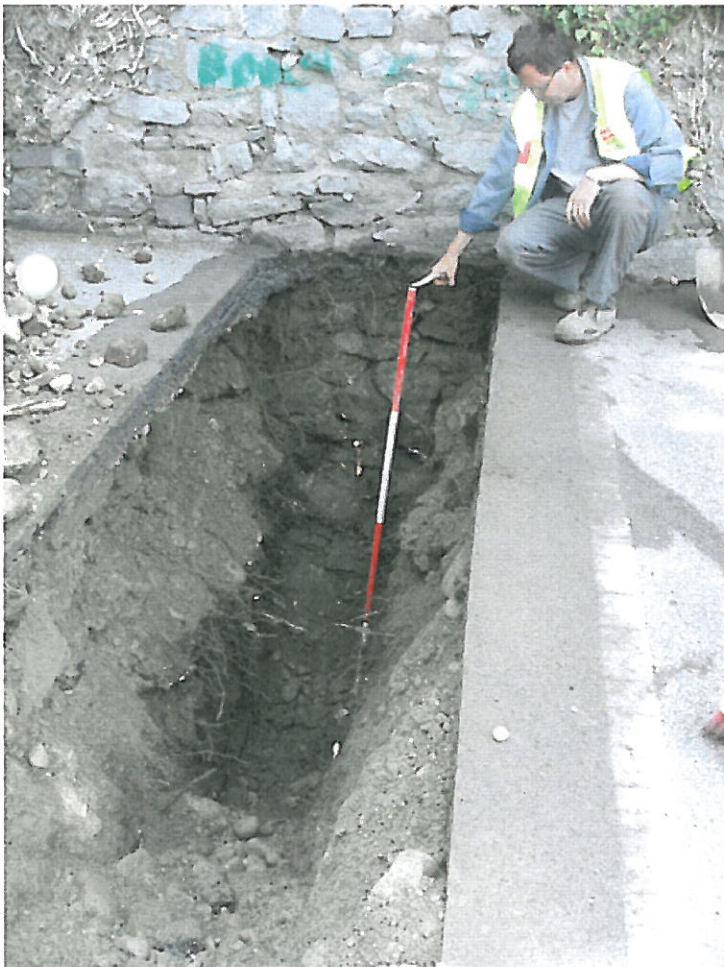
Plate 13. Trial pit 3 in mill race.

Test pit 3 (fig. 1, 2, plate 13).

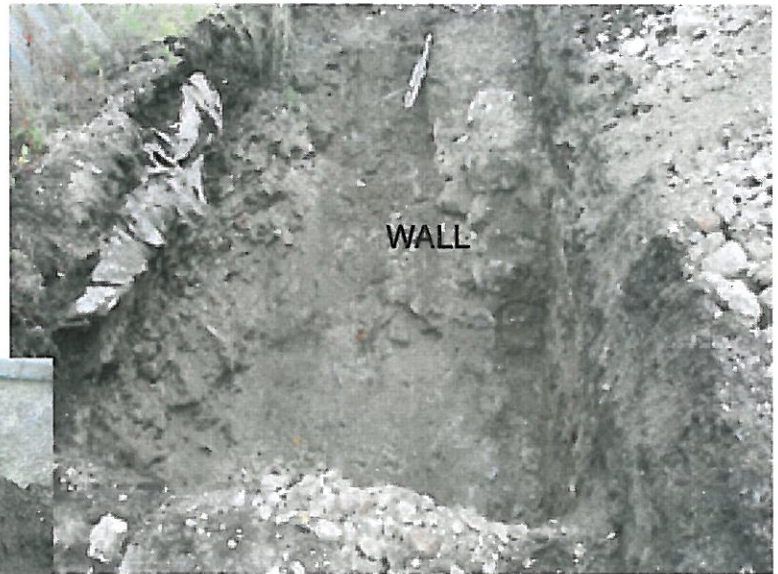
Plate 15. Trial pit 5, masonry of 1700s barracks just evident through cellar fill.

Test pit 5 (Fig. 1, plate 15).

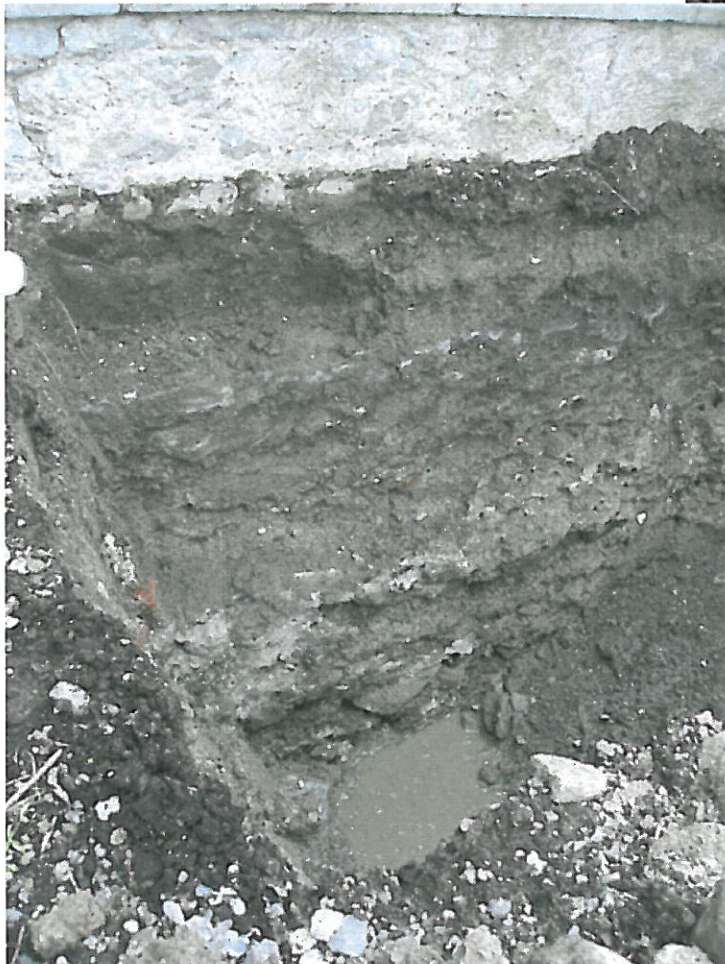
Plate 16. Trial pit 6, wall of Evans Home on 2 plinths.

Test pit 6 (Fig. 1, plate 16).

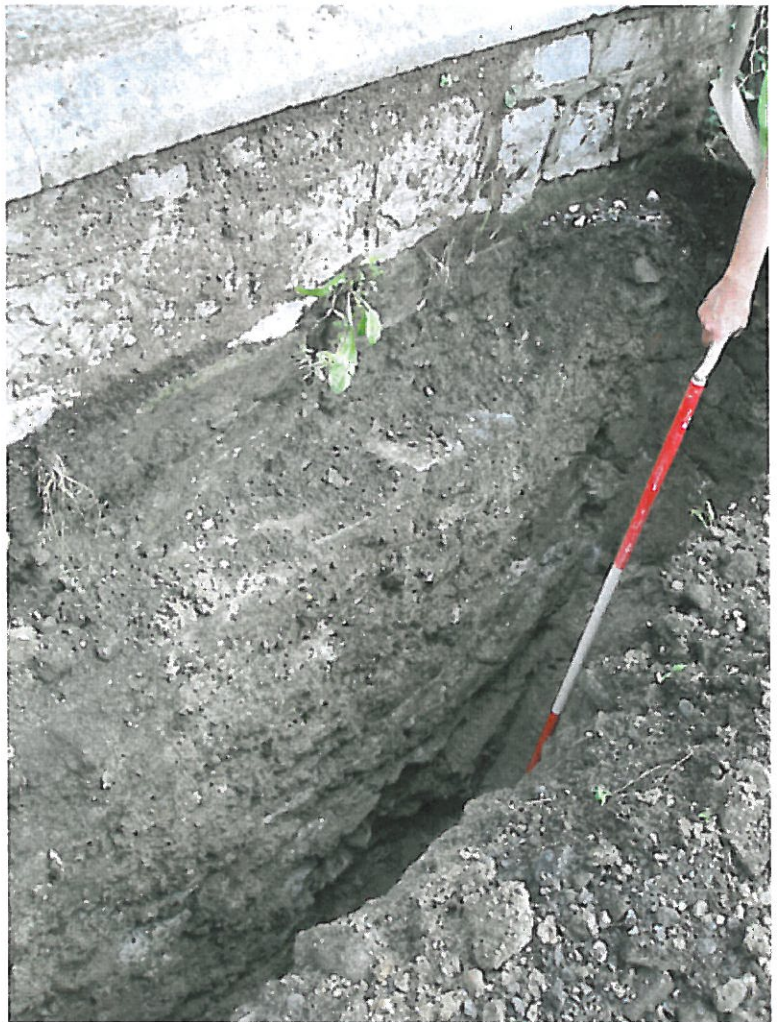
Plate 18. Construction cut for Evans Home wall cuts cobbled surface.

Test pit 8 (Figs 1, 2, plate 18).
