A GUIDE TO THE REPAIR OF HISTORIC BRICKWORK

Comhshaol, Oidhreacht agus Rialtas Áitiúil
Environment, Heritage and Local Government

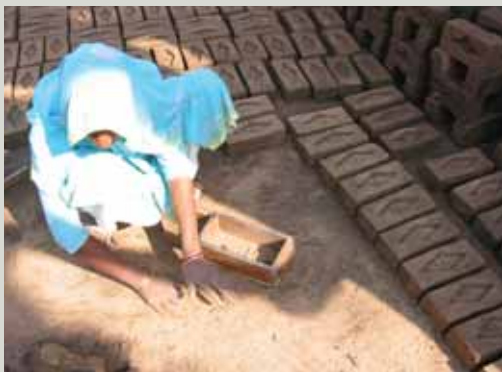
Moulding

Once fully dry the bricks were fired – the mineralogical content of the clay, the firing temperature, and the level of oxygen all influencing the final brick colour. The earliest method of firing was within temporary clamps consisting of layers of green bricks carefully arranged on a prepared base of parallel fire channels (or tunnels) formed with previously fired bricks. The outside of the clamp was then plastered with mud and the kiln set alight using brush or firewood, turf, coal, or culm as fuel in the tunnels. Later clamps, which used coal, did away with the fire channels and just had a base of coal across the length and width of the clamp. The firing took between several days and several weeks, depending on the size of the clamp. Once the fire was out and the clamp cooled, it was disassembled. The bricks produced varied in quality, depending on their position in the clamp, and had to be graded for use. Although this process produced a lot of waste bricks, a particularly large clamp could contain over a million bricks and was ideal for use where demand was intermittent and large numbers of bricks were needed seasonally.

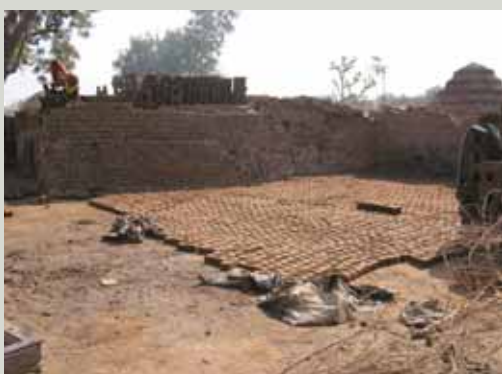
Drying

Moulding and drying was originally a seasonal activity. The clay was excavated in the autumn and left exposed to weather naturally during the winter months. Rain, snow, and frost broke down the clay, washing out unwelcome natural salts. The following spring, the weathered clay was prepared for moulding. It was delivered to the handmoulder, who rolled a selected quantity to shape and then threw (or cast) it down hard into a timber mould, which had been dampened and sanded to aid release. The excess clay sticking out of the top of the mould was trimmed off and removed before the green (unfired) brick was taken away for drying. The green bricks were initially laid out flat on the ground and turned over frequently, or later stacked loosely in rows to dry for several weeks before firing. Both these processes took place in an area called the 'hackstead'. With mechanisation came controlled, heated drying rooms that allowed brickmaking to take place all year round and speeded up the process, producing a more consistent and controllable quality in the final brick.

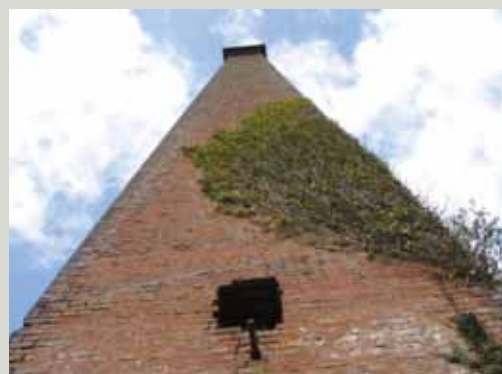
A kiln chimney at Youghal, Co. Cork, now disused

Kilns were permanent structures which, until the nineteenth century, had to be loaded (or set), fired, cooled, and un-loaded before they could be set and fired again. These are known as intermittent kilns. The first were updraught kilns, wasteful of fuel, where the fire was lit at the base, travelled up through the bricks and tiles, and exited at the top. By the middle of the nineteenth century the more efficient downdraught kiln was developed, whereby the heat was drawn over the top and down through the goods. This gave greater control and improved the quality and regular colour of the bricks. The second half of the nineteenth century saw the introduction of continuous kilns, where the fire travelling through the kiln never goes out. The bricks go through the pre-heating, firing, cooling and unloading processes in separate but interconnected chambers. The first was the 'Hoffmann Kiln' patented by Friedrich Hoffmann in 1856. Modern continuous kilns include the 'tunnel' kiln, where the bricks travel on rails through all the zones, or the 'moving-hood' kiln, which is brought to, and lowered over, the setting of bricks and then ignited.

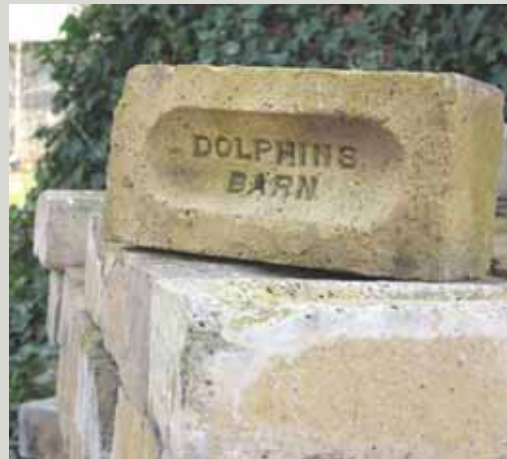
Machine-made brick from the Dolphin's Barn Factory in Crumlin dating from the early twentieth century is recognisable from its distinctive yellow colouring and the manufacturer's name impressed into the 'frog' or indentation in the bed face of the brick

Machine-made bricks are those made by a mechanised process, such as an extruded 'wirecut', pressed and 'simulated' handmade. Machine-made bricks can be solid, perforated, or panelled and are often stamped with the maker's name.

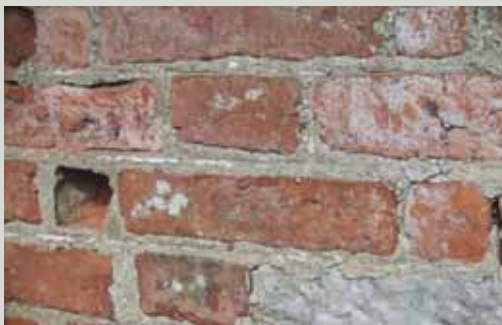
Colour washed bricks with traces of pencilling to the joints at the Hell Fire Club, Desmond's Castle, Askeaton, Co. Limerick

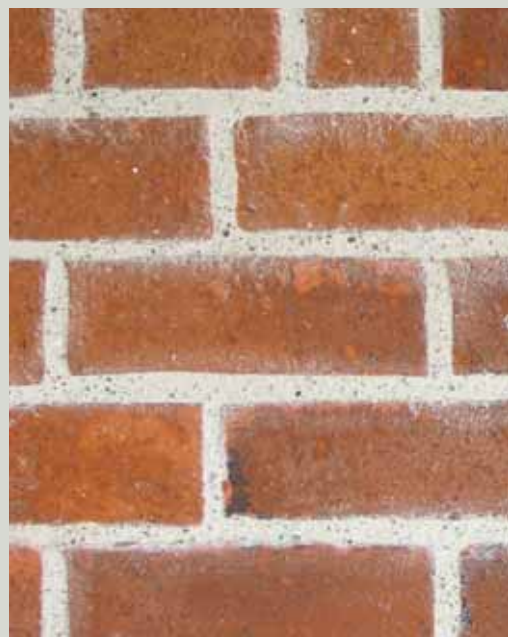
Recent repointing of a brick wall with a lime-based mortar

In most historic thick-walled masonry construction the pointing and bedding mortars were lime-based. These mortars complemented the original stones or bricks and did not restrict moisture and thermal movement. To undertake repairs, repointing, and re-construction of historic brickwork, the selection of the correct class of lime, associated materials (such as, aggregates, water, pigments and pozzolans), and their ratio to one another, are absolutely crucial.

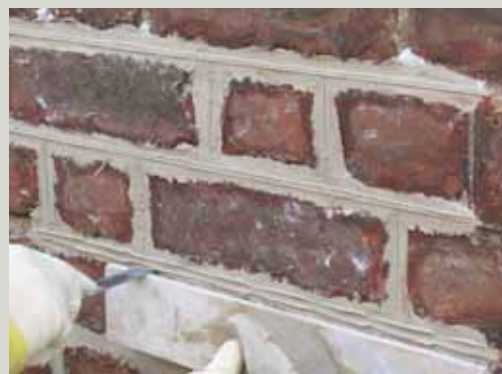
i) creating the bastard tuck profile

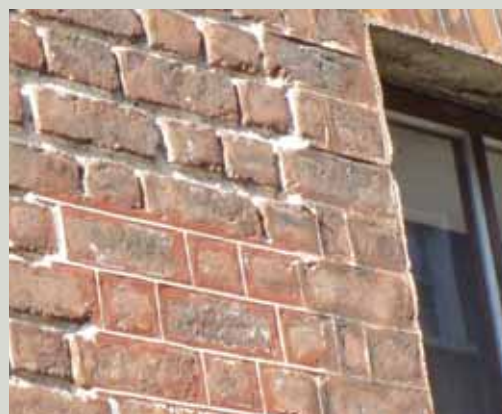
iii) the finished wiggging sample

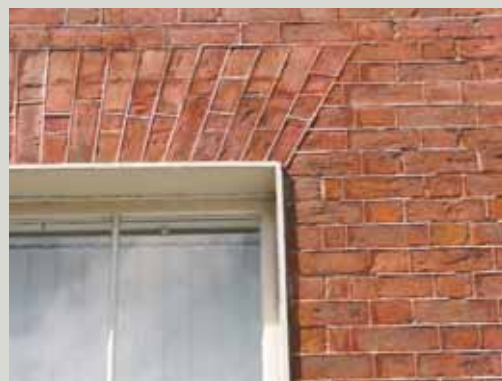
A typical Irish eighteenth-century flat arch window head. It differs from similar English flat arches of the period in that the arch does not splay widely at either end

Eighteenth-century window heads, formed with brick, usually have flat or straight arches. Camber arches, with a very slight rise in the centre, are also found. In high quality work, low-fired and soft-textured bricks, termed 'rubbing bricks' or 'rubbers', were often selected for this purpose and skilfully 'cut and rubbed' to the established radial shape so as to fit neatly and accurately together as arch bricks (or voussoirs) set with very thin joints of fine lime-rich mortar. In Ireland, more usually, flat arches were built using ordinary bricks, cut to shape radially, or

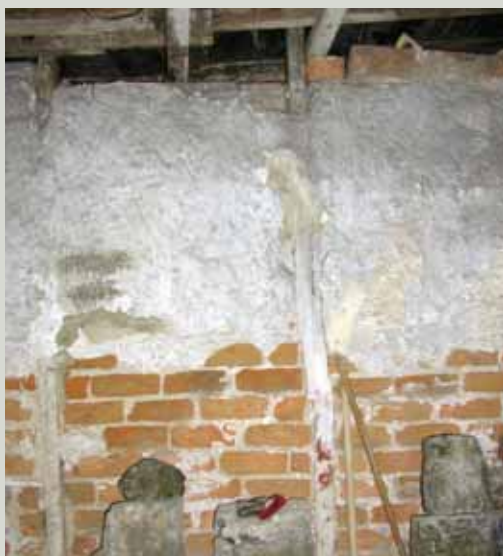
Handmade brick used in a brick nogged internal partition, now exposed where the original plaster coating has fallen away

Internal walls of brick, timber-framed walls infilled with brick (known as nogging), and brick wall linings are frequently seen in Irish buildings of the eighteenth and nineteenth centuries. In nearly all cases, this brickwork was plastered over and never intended to be seen. The stripping of plasterwork to expose internal brickwork is generally unsatisfactory because of the inferior quality of the brick selected for that specific purpose, the condition and appearance of the mortar joints and a frequently lower standard of overall workmanship. Sometimes however, brick vaults in basements and internal brickwork in garden buildings, stables, and out buildings were intended to be seen and were not rendered but simply lime-washed. This is an attractive finish that is practical and easy to maintain. Wherever possible, limewash finishes should be maintained or renewed.

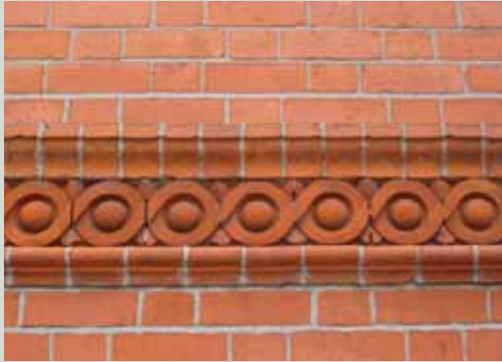
A example of the decorative use of moulded brickwork and terracotta in a stringcourse

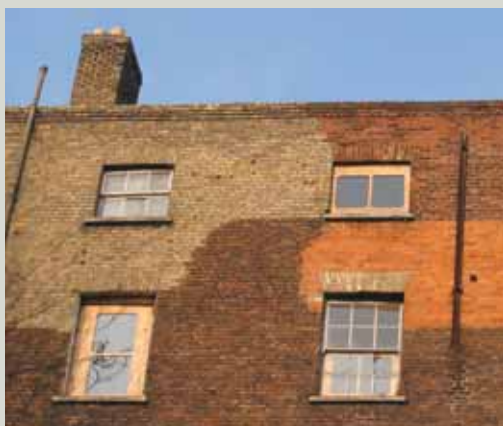
The gutters behind parapet walls are difficult to access and therefore are often poorly maintained. Many parapet walls show evidence of having been reconstructed over the lifetime of the building. This illustration shows the use of inappropriate replacement bricks in the repair of the wall

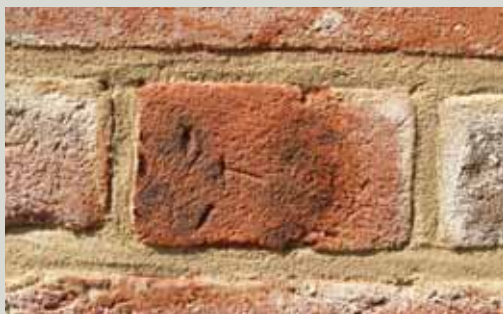
Remedial work in the form of a quality pigmented mortar repair. It shows that, when necessary, and executed with great skill, a mortar repair can provide a temporary repair that achieves the desired effect

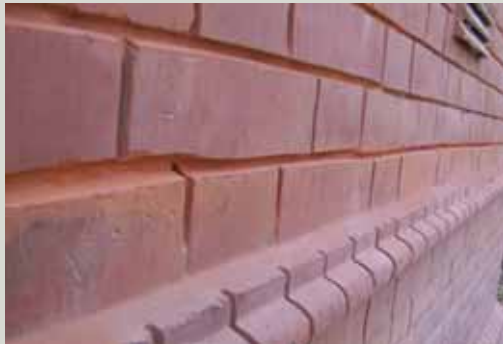
Existing mortar joints should not be cut out using mechanical cutters such as angle grinders as this will inevitably lead to damage of the edges, or arrises, of the bricks. The use of mechanical tools to remove cement repointing should generally never be used on historic brickwork unless specifically manufactured for use in historic brick repair and used only by experienced specialist conservators

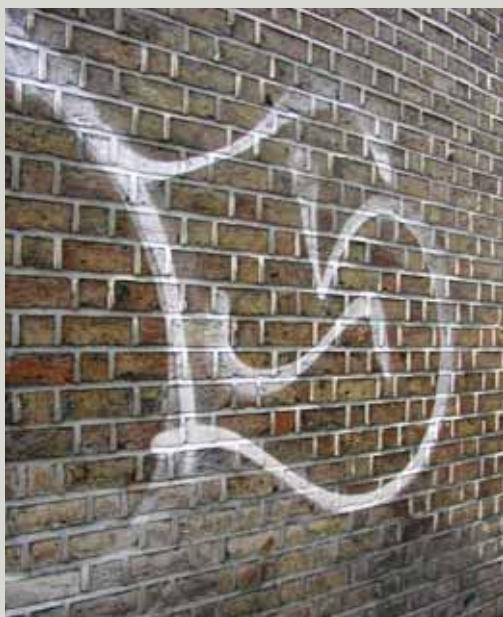
Graffiti on historic brickwork should be cleaned off as soon as possible as it will become more difficult to remove if the paint is allowed to dry and harden. A suitable poultice may be the solution

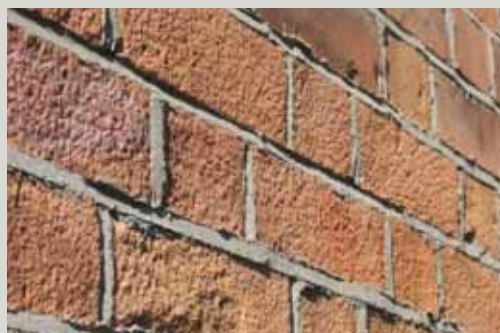
This brickwork shows evidence of damage by over-heavy abrasive cleaning which has removed the fireskin from the bricks making them vulnerable to accelerated decay exacerbated by the cementitious pointing
