advice series

THE CONSERVATION OF PLACES OF WORSHIP

*An Roinn*  
*Ealaíon, Oidhreacht agus Gaeltachta*  
*Department of*  
*Arts, Heritage and the Gaeltacht*

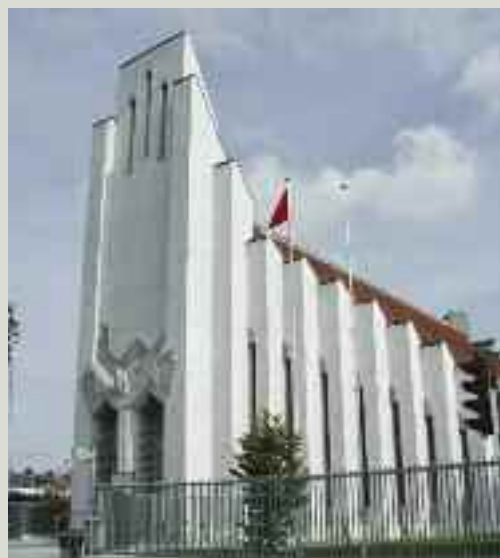
*The Church of Christ the King was designed by American architect F Barry Byrne who had trained with Frank Lloyd Wright in Chicago. Constructed in reinforced concrete using strong geometric forms, the church was built to cater for the growing Catholic population in the expanding suburbs of Cork City*

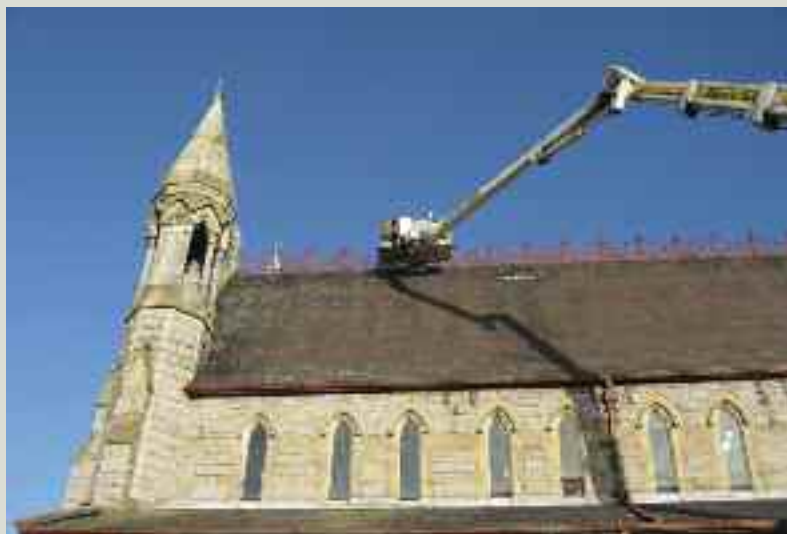
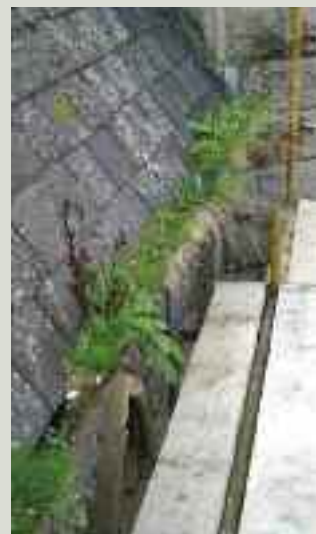
*The inspection of a church requires that close attention be given to roof coverings and rainwater goods, the elements that are hardest to reach. Neglect of the roof will, however, manifest itself in a myriad of problems throughout the fabric, starting, as seen here, with blockage of the rainwater goods*

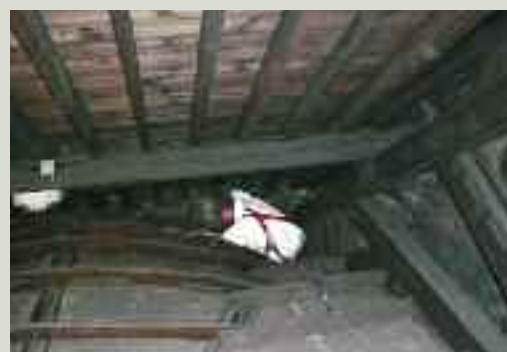
*A quinquennial inspection is a detailed examination of the whole of the structure, including areas that are hard to reach such as roof spaces. Fitting electric lighting makes inspection of these areas easier and safer, thereby reducing the risk of damage from unnoticed water ingress. Note that a safety harness is being used because of the fragile nature of the ceiling construction*

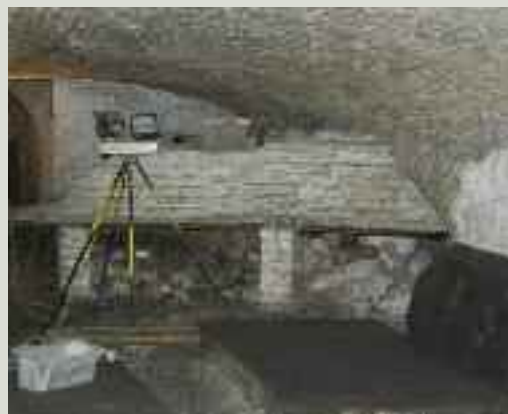
*Inspecting a crypt presents risks such as trip hazards, toxic fumes, asbestos and rodent or fungal infestation. Personal protective equipment and adequate lighting are essential to reduce the risk of accident to the inspector or damage to the structure*

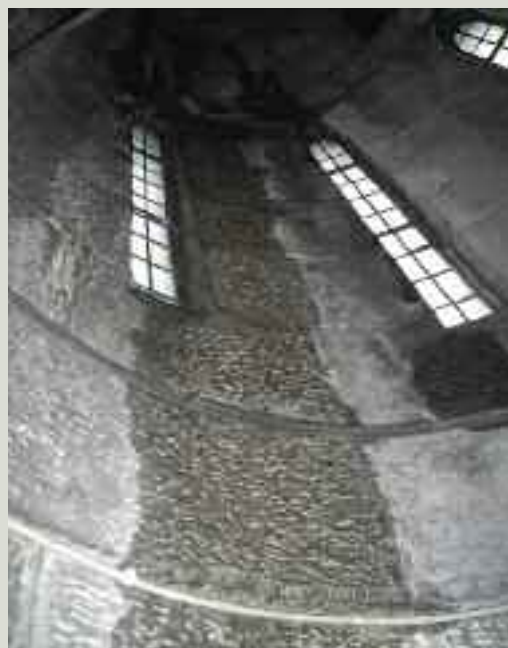
*Difficulty of access no doubt contributed to lack of maintenance of this church tower, resulting in ingress of water to saturation level in the masonry. This will lead inevitably to serious damage unless it is remedied*

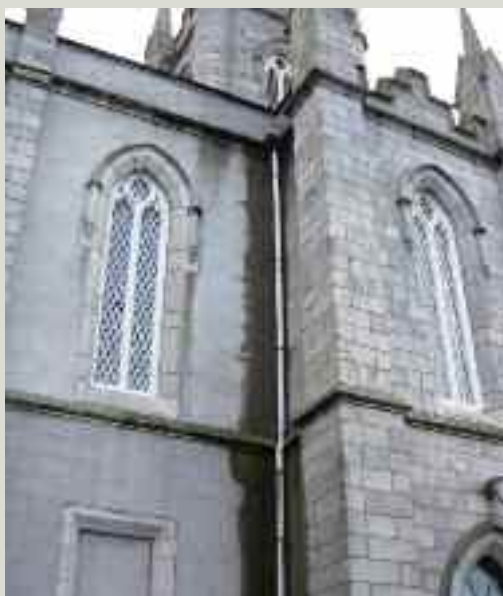
*Walls will quickly become saturated if rainwater cannot be shed effectively from the roof. Staining, discolouration and plant growth behind and beside downpipes are signs of problems at eaves or parapet level that require immediate attention*

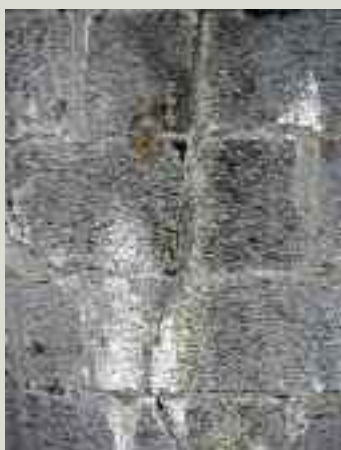
*This wall has become overly rigid due to the use of cement mortars, which resulted in the mortar becoming harder than the stone. Structural movement in the church is seen in the vertical cracking through the ashlar stones rather than the mortar*

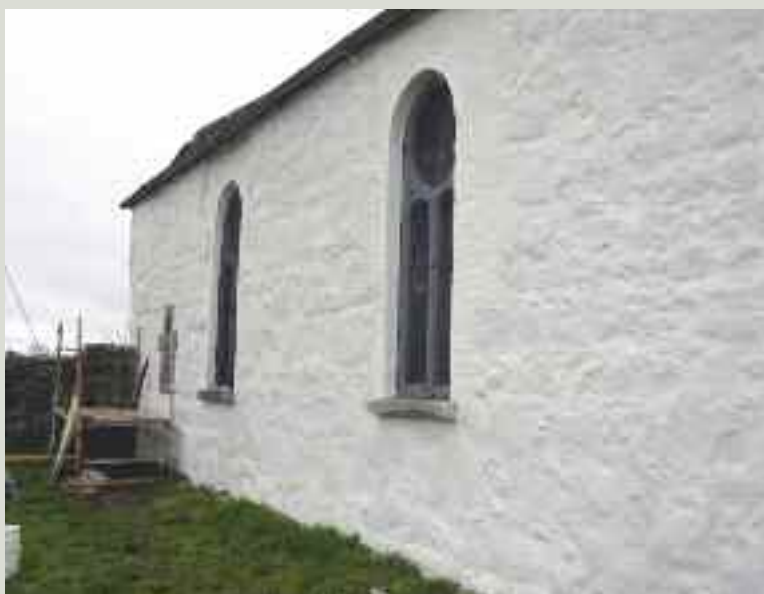
*The rubble walls on this medieval parish church were stripped of roughcast cement render and re-rendered using a soft lime mortar. This helped the interior of the building to dry out, assisting to preserve the significant Romanesque stone carving*

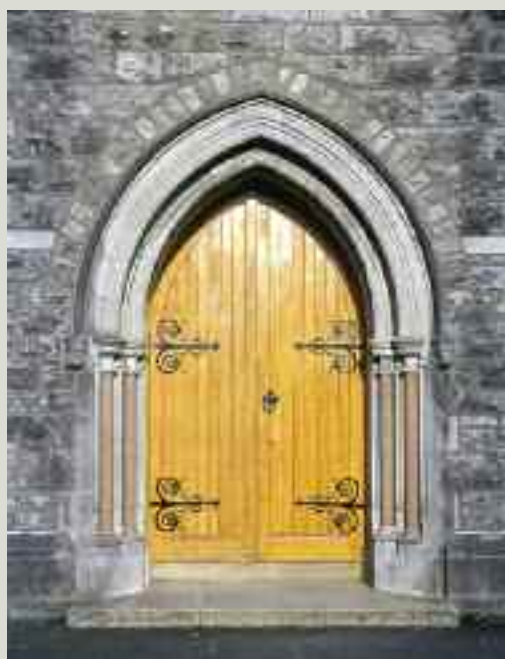
*Historic doors and door furniture should be maintained and repaired as necessary in line with best conservation practice*

Original external doors are typically well-proportioned, attractively detailed and well-made using robust timber. They should be retained wherever possible and repaired, and only replaced as a last resort. Where a replacement is unavoidable, an exact copy should be made using good quality well-seasoned pine, or Douglas fir, with accurately profiled mouldings. The use of standard doors from catalogues is unlikely to be appropriate in a historic building and should be avoided. Original doors and windows should be repainted periodically and, where new replacements are required, these should be given a painted, rather than a stained finish, except where there is evidence of staining or graining being the original historic finish. Where a door has deteriorated beyond the point of reasonable repair, its original door furniture and fixings may well be perfectly salvageable and should be reused on the replacement door.

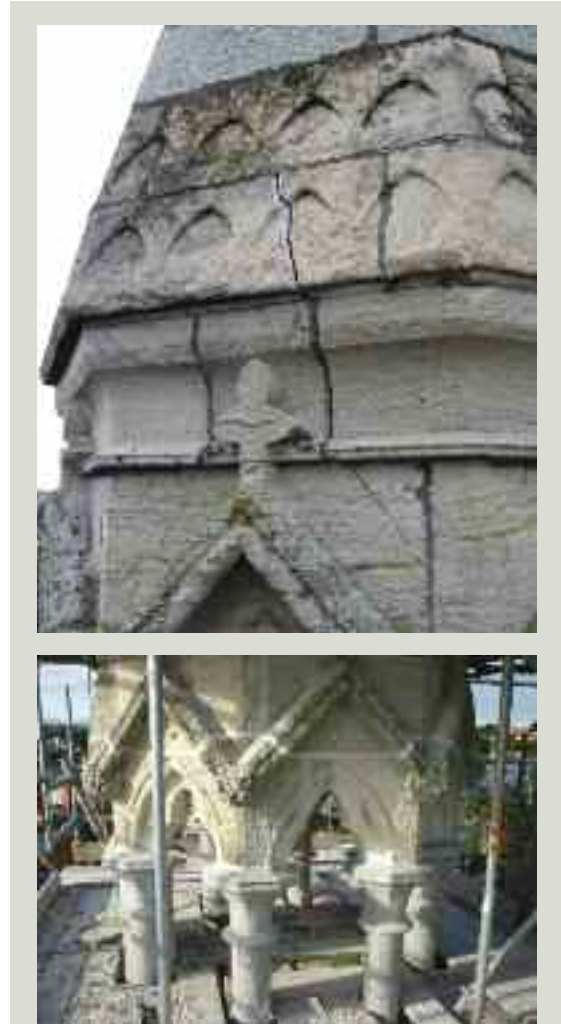
*This Bath stone turret, which is also a bell-tower, is in a highly exposed location. Several stones cracked due to rusted cramps and the poor condition was exacerbated by previous misguided cementitious repair. New stainless steel collars and ties were fitted and the turret was repointed*

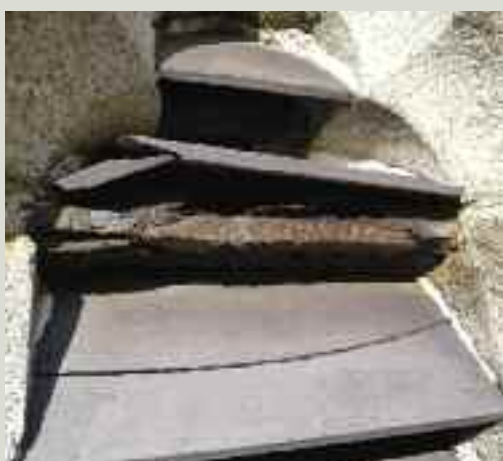
*Embedded metal tie bars in this bell tower corroded and expanded, causing fractures in adjacent granite and slate louvres. Part of the repair solution involved installing a cathodic protection system to reduce the corrosion rate of the embedded ironwork*

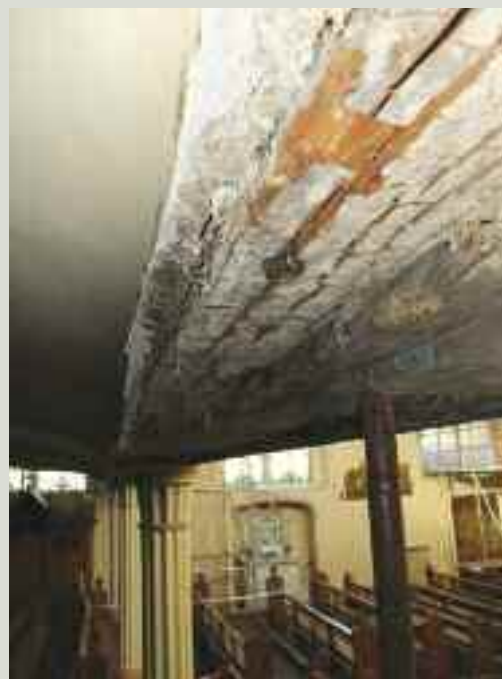
*Regular inspections and scheduled maintenance work should prevent rot from taking hold to the degree that it causes structural damage, as has happened to this beam which supports an organ gallery*

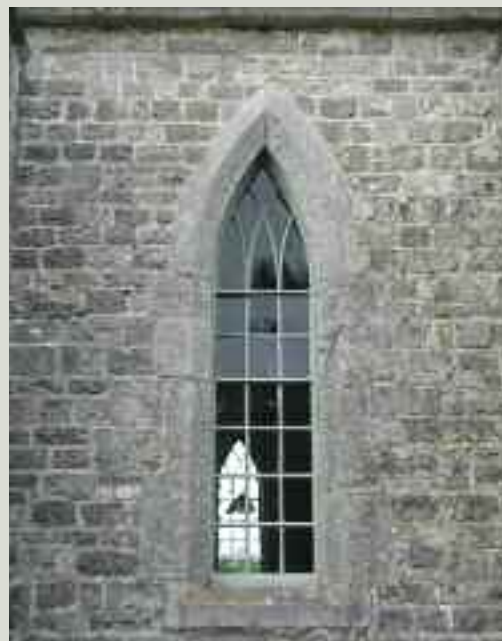
*The simple iron glazing in the lancet windows of this rural Board of First Fruits church is enhanced greatly by the survival of crown and cylinder glass. The windows, and the church, are clearly well cared for*

century churches, the original clear glass has survived in either leaded lights or metal-framed lights. This glass predates the era of modern and regular float glass and has a delightful rippled quality, producing subtle distortions. Every effort should be made to protect such glass.

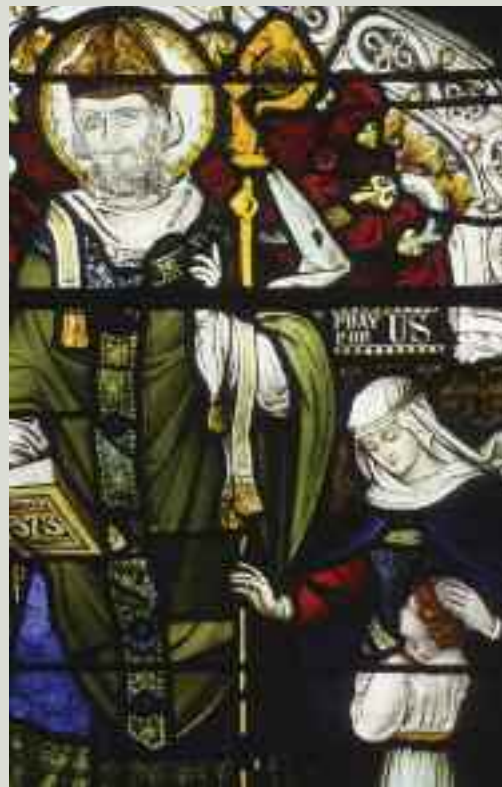
*In this example, the face of Saint Brendan and some other intrusions do not match the quality of the original glass-painting*

Glass is breakable! Damage to stained glass can be caused by accident or by vandalism. However, some of the most insidious damage is that caused by unskilled restorers who, at some time in the past, have replaced original pieces of glass with poorly matching replicas, known as intrusions. Unfortunately there are few glass-painters nowadays with the skills required for drawing the cartoon, selecting the glass and matching the style of glass painting. It is all too easy to compromise the integrity of a window by the introduction of poor quality intrusions.

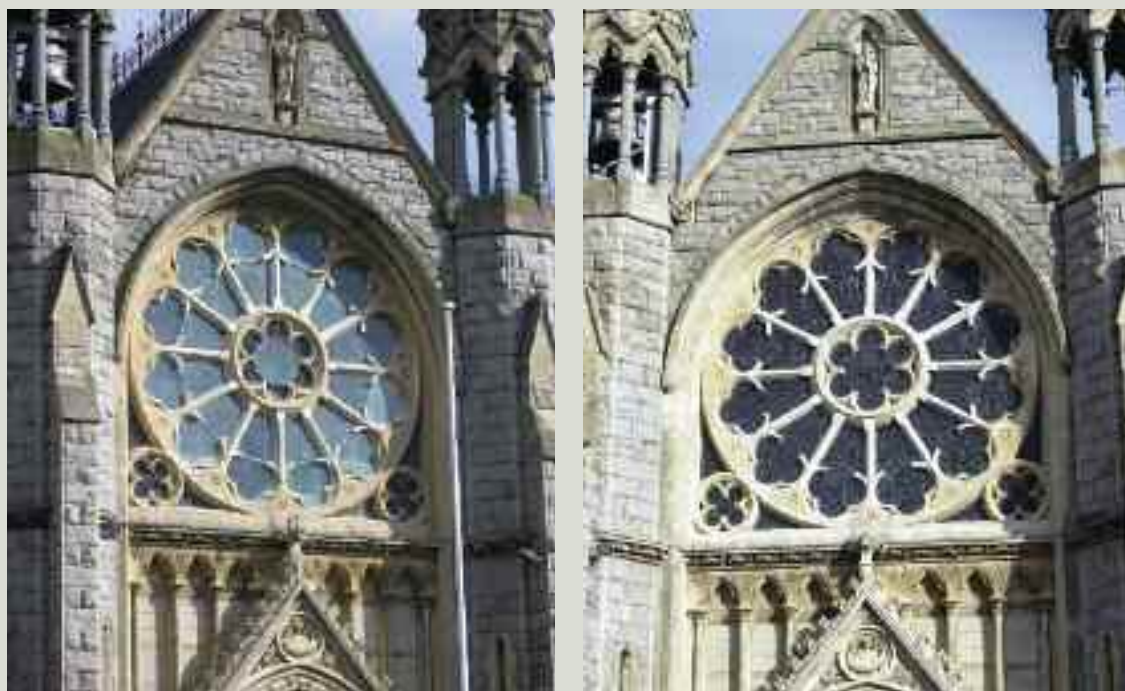
*The storm glazing of this rose window was removed and powder-coated stainless-steel wire guards were fixed to the masonry. As a result the window is less likely to suffer from the effects of humidity and heat on the glass and leadwork. There is no loss of clarity to the stained glass and the stone tracery reads more clearly from the exterior*

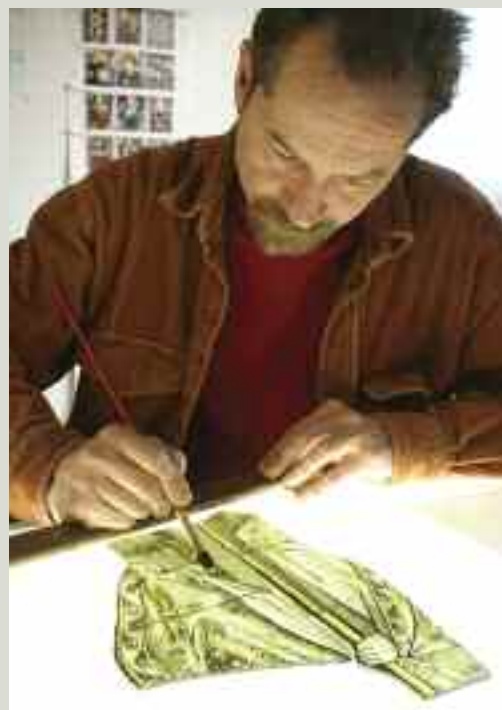
*Traditional techniques of painting faces, drapery and other detail must be studied by the stained-glass conservator, each used for painting missing pieces as his or her experience judges them to be appropriate*

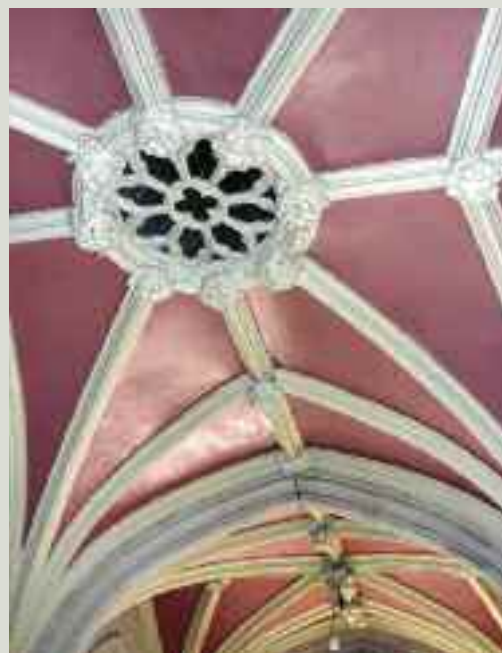
*Ceiling grilles should be checked to ensure that the warm, humid air rising into the roof space is ducted through and discharges to the exterior to avoid raising the moisture content of the roof timbers to a level that might make them vulnerable to insect or fungal attack*

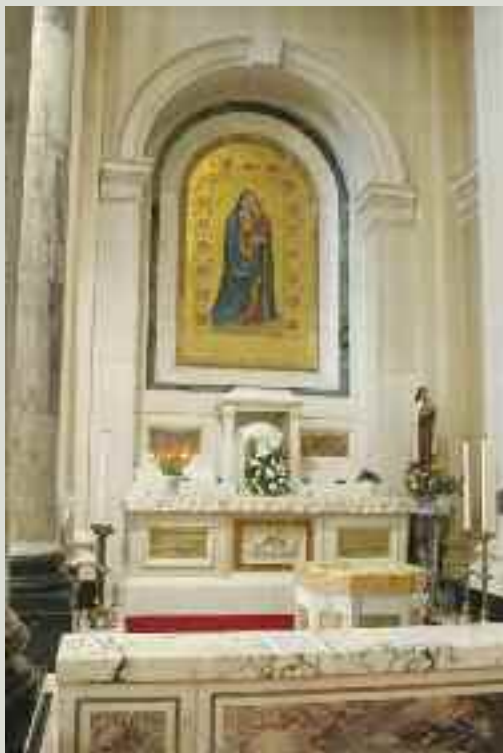
*This richly decorated Neoclassical baptistry is separated from the body of the church by Connemara marble columns, which have polished black limestone plinths. The Carrara marble-clad niche houses an Italian gold-leaf mosaic panel*

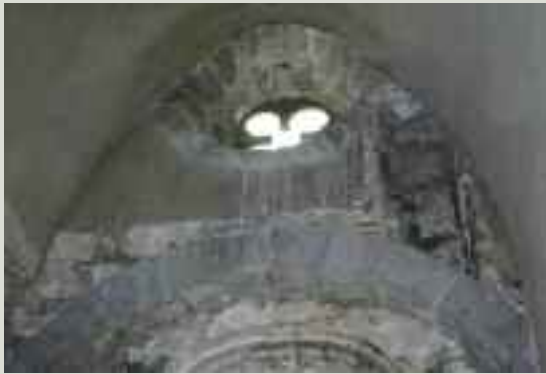
*The cement plaster on this Romanesque church, which was damaging the stonework and associated timbers, was carefully removed and replaced with a soft lime plaster*

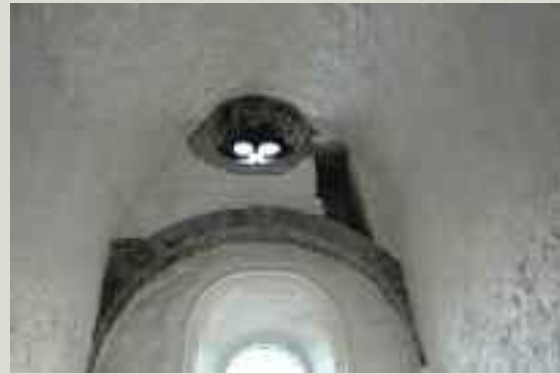
*The vaulted ceiling of this late nineteenth-century cathedral is claimed to have been painted by an Italian artist. The black background contributes to the dark atmosphere of the interior, but as an original feature of the design it forms part of the character of the protected structure and should not be altered in any redecoration of the interior. Cleaning and conservation of paintwork and gilding of this quality requires specialist skills*

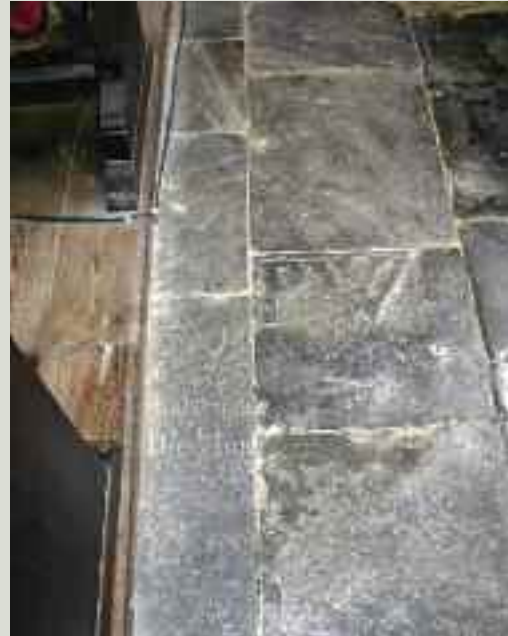
*Floor surfaces may be of significance for historic or social reasons. The paving of this cathedral floor contains cut down and reused grave slabs*

Worn-looking, historic floor finishes are sometimes covered with thin vinyl or linoleum in the form of sheeting or tiles. This practice is damaging as these materials are usually impervious and can lead to a build-up of moisture on their concealed side that can cause the original finish to deteriorate further. Worn flooring is a sign of the use of the building over a long period and in many instances adds to a building's character. Intervention should only be considered if the flooring presents a trip hazard, in which case, sensitive repairs of uneven units can be made using carefully matched replacements.

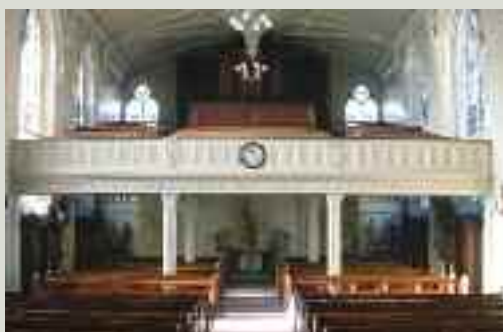
*The gallery of this church is finely detailed and contributes significantly to the spatial quality of the nave*

Galleries are usually constructed with timber beams, supported on timber or cast-iron columns. It is important that the floor joists in galleries are not notched to take building services as this reduces the strength of the structural members and may lead to excessive deflection. The staircases leading up to galleries may contain fine historic joinery and should be preserved accordingly. Steps are usually timber but some are of stone, and may have worn nosings from long use. Often old staircases are felt to be unsafe due to the low heights of handrails, wear on the treads or the steep pitch of their flights. Each case should be assessed individually and the patterns and frequency of use taken into consideration before deciding whether or not an intervention is necessary to make the staircase safer or more accessible. Where pews run right up to the front edge of a balcony the height of the effective guarding might be dangerously low requiring a simple rail to improve safety (possibly set back behind the gallery front).

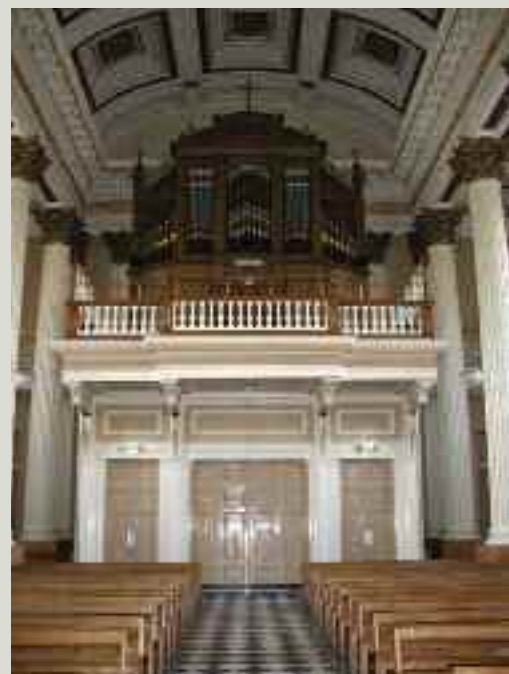
*Organs are often immense fixtures, but their very size masks a vulnerability towards environmental changes. They require dry, stable conditions and expert care*

Organs require specific temperature and humidity conditions to be maintained to prevent them going out of tune. Usually a specific heating system local to the organ is employed for this purpose. If an existing system is being altered in a church with an organ the impact of the new heating output needs to be considered.

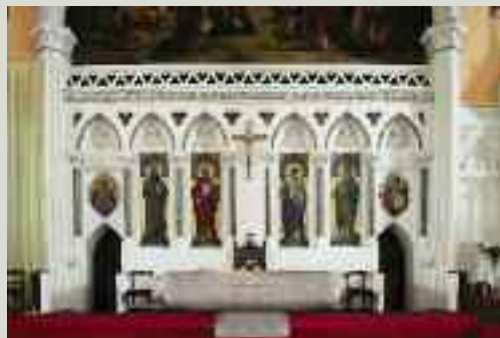
*The noted church architect J J McCarthy most likely designed this Gothic Revival reredos in 1860 when he is recorded as having been commissioned to design the high altar for SS Peter and Paul, Ennis. It was executed in carved stone by noted church decorators John Hardman and Company of Birmingham, a firm closely associated with A W N Pugin. The post-Vatican II granite altar table is an unobtrusive introduction*

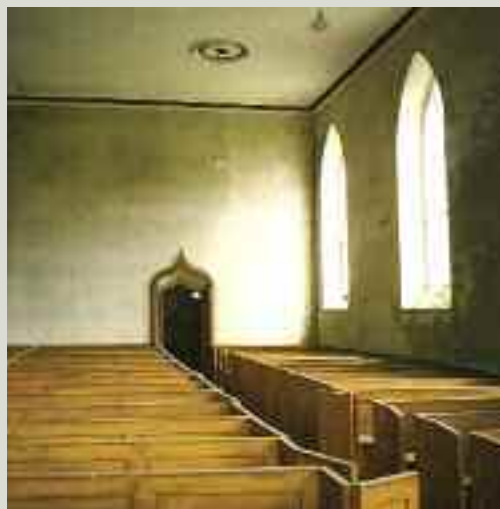
*Reformed churches are often simply furnished, with fitted furniture such as box pews contributing much to the character of the interior*

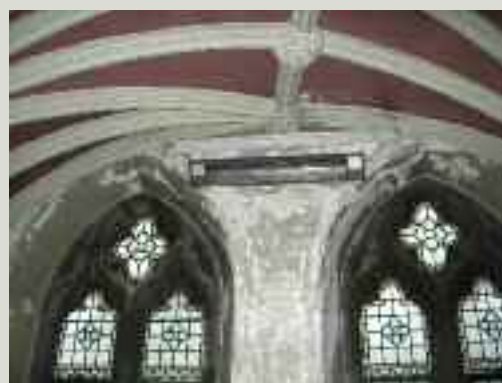
*Church lighting and heating systems may evolve on an ad-hoc basis as funds become available. In this case, strip lights and electric bar heaters were fitted to some of the aisles. Conservation works to the church will include the removal of these fittings and repairs to the roof above to eradicate the damp in the wall*

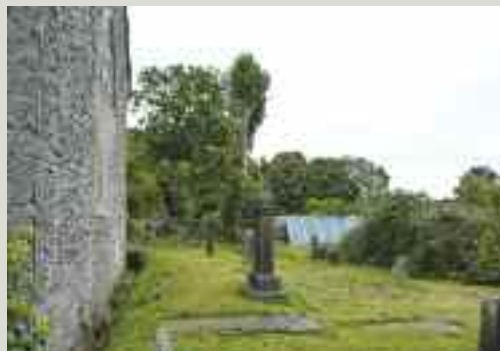
*The decision to install solar, or photovoltaic, panels should be based on a thorough analysis of the needs of the building as well as of the site itself. The panels are sited in an unobtrusive part of the graveyard and all services are run on the surface. The panels are easily demountable*

parochial meeting room. Solar panels mounted on the roof of a place of worship can be visually intrusive; a roof slope with a southerly orientation, not visible in important views of the building, such as within the valley of a roof, is ideal. Such an installation may be suitable for use on protected structures and within architectural conservation areas, subject to planning permission. For many church roofs it may prove difficult to conceal such panels. Some disturbance of the historic fabric is also inevitable, so careful consideration and attention to detail are essential. Where there are ancillary buildings these might be used successfully to accommodate panels, or alternatively, appropriate ground-level sites might be feasible.

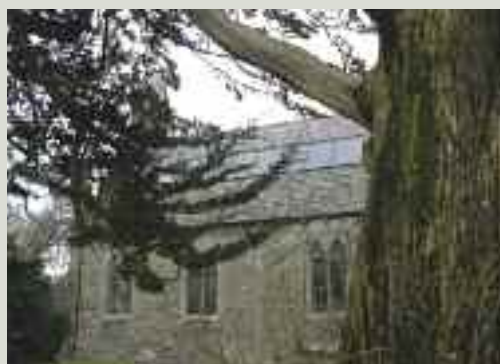
*There may be an opportunity to install solar panels on the less visible slopes of a roof. In this case the heat generated by the panels is taken to an underfloor system providing a certain amount of background heating which keeps the building fabric in good condition (Image courtesy of Margaret Quinlan Architects)*

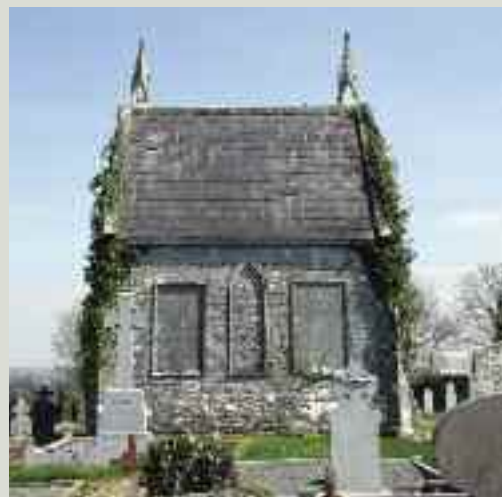
*Some mausolea are shaped like miniature churches, containing high quality architectural details and materials. Mausolea require sufficient maintenance to prevent them slipping into a state of neglect, damaging the remains within and endangering visitors to the graveyard*

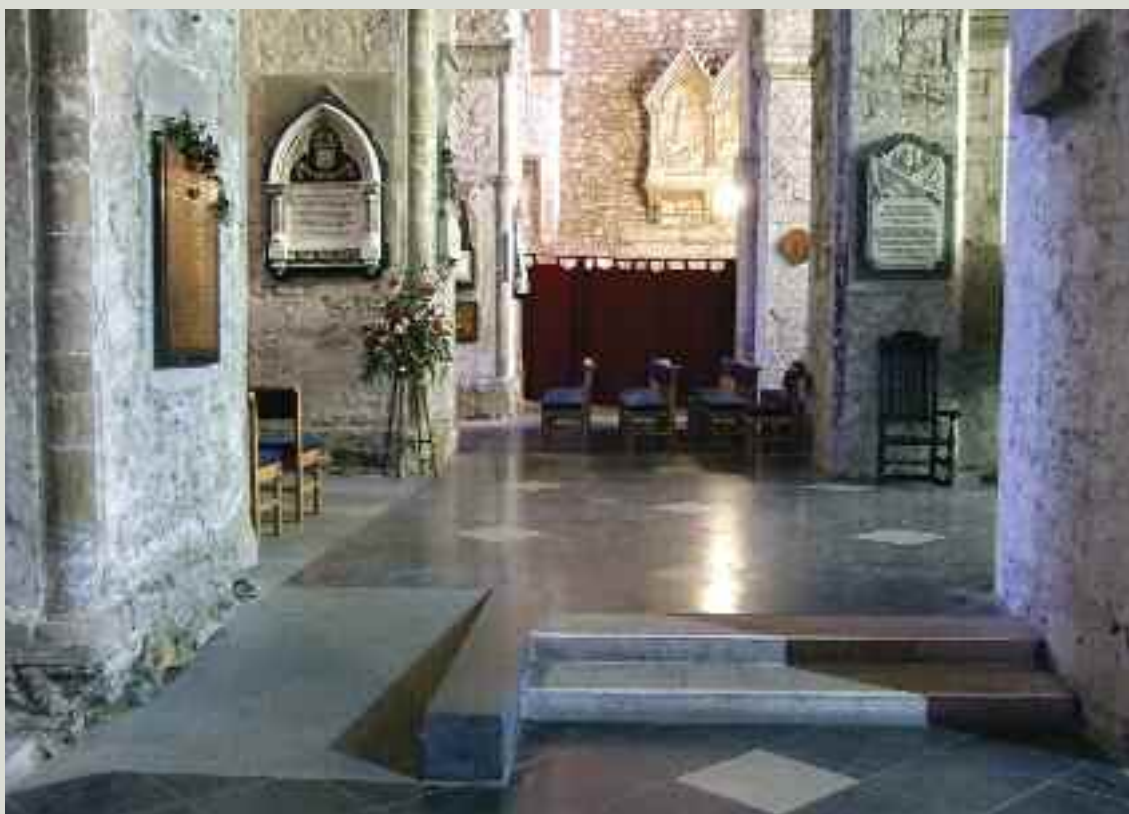
*Improving access where there are several changes of floor level within a church requires careful consideration. Where the church is a medieval structure, there is the possibility of burials beneath the nave which preclude lowering of the floor level. Ideally, the improvement of access should be an integrated part of an overall conservation strategy*

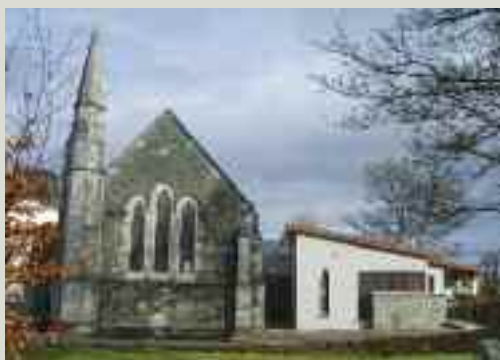
*The Methodist Church, Killarney, County Kerry was extended to provide pastoral facilities. The extension was designed in a contemporary style that complements the original historic fabric (Image courtesy of Mott MacDonald Ireland Ltd)*

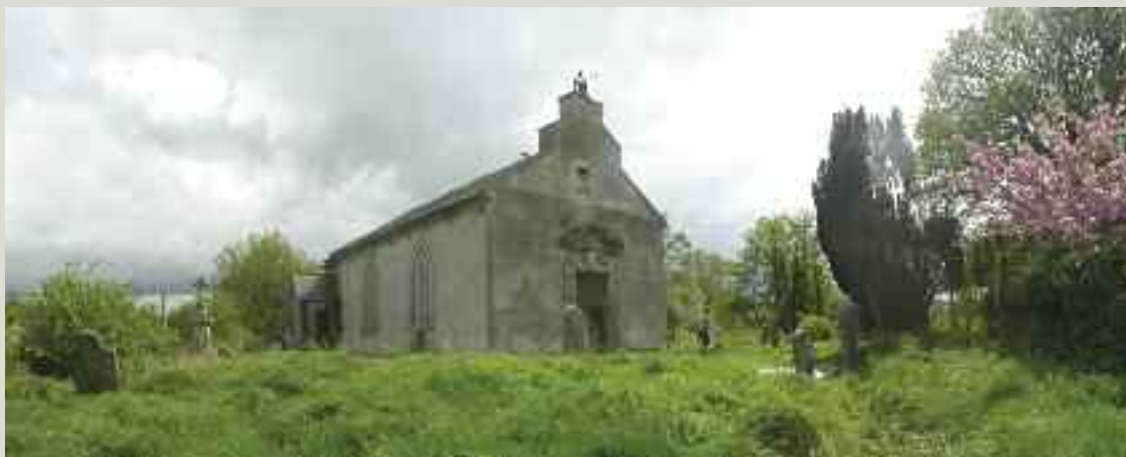
*This redundant Church of Ireland church was 'mothballed' to prevent deterioration while decisions are made on its future*

The period of transformation from redundancy to dereliction, aided by vandalism and neglect, can be alarmingly brief. If a new use is not found quickly once a church becomes redundant, its viability reduces rapidly as the fabric deteriorates and repair and renovation costs soar. Potentially valuable buildings become uneconomic to redevelop and invaluable historic fabric is lost forever. In an attempt to buy time for an abandoned church, the Redundant Churches Trust in the United Kingdom devised a process known as 'mothballing' to maintain unused churches in a state of reasonable repair. 'Mothballing' includes a range of measures such as boarding up windows; encasing delicate internal features and details; securing doors from unauthorised entry; repairing roofs and rainwater courses; and maintaining internal ventilation. In this way the valuable historic fabric is protected and preserved at relatively low cost to await a sensitive and viable alternative use.

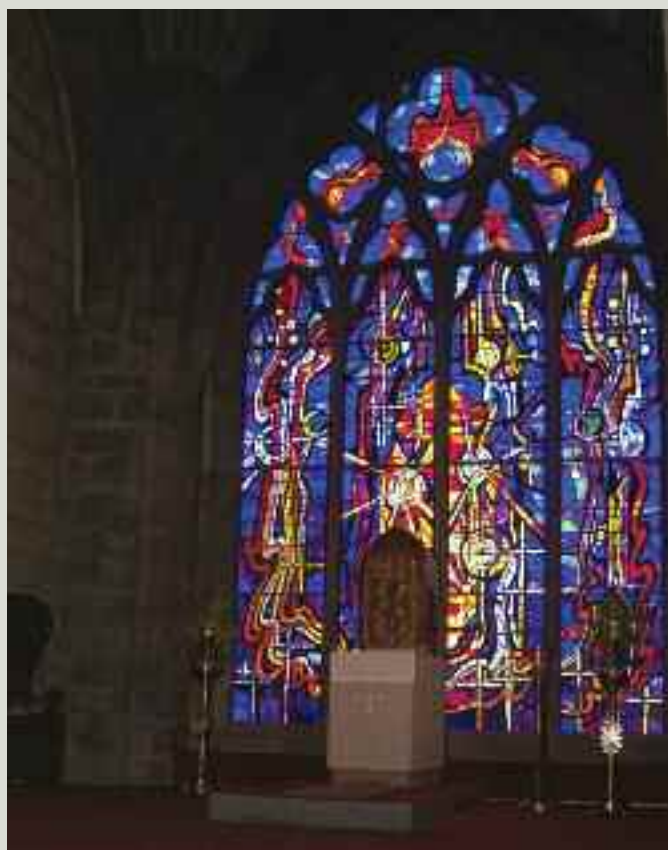
*The east window of the multi-period Black Abbey Church, Kilkenny, founded in 1225, was fitted with stained-glass windows in the late-twentieth century, amongst many post-Vatican II changes. It provides a dramatic contrast to the nineteenth-century stained-glass windows elsewhere in the church designed by the studio of Earley and Powell*
