Ballyhale Flood Relief Scheme

**Factual Ground Investigation
Report**

Project No. 23434

REPORT ON A SITE INVESTIGATION
FOR A FLOOD RELIEF SCHEME
AT BALLYHALE
COUNTY KILKENNY
FOR
KILKENNY COUNTY COUNCIL
AND
DBFL
CONSULTING ENGINEERS

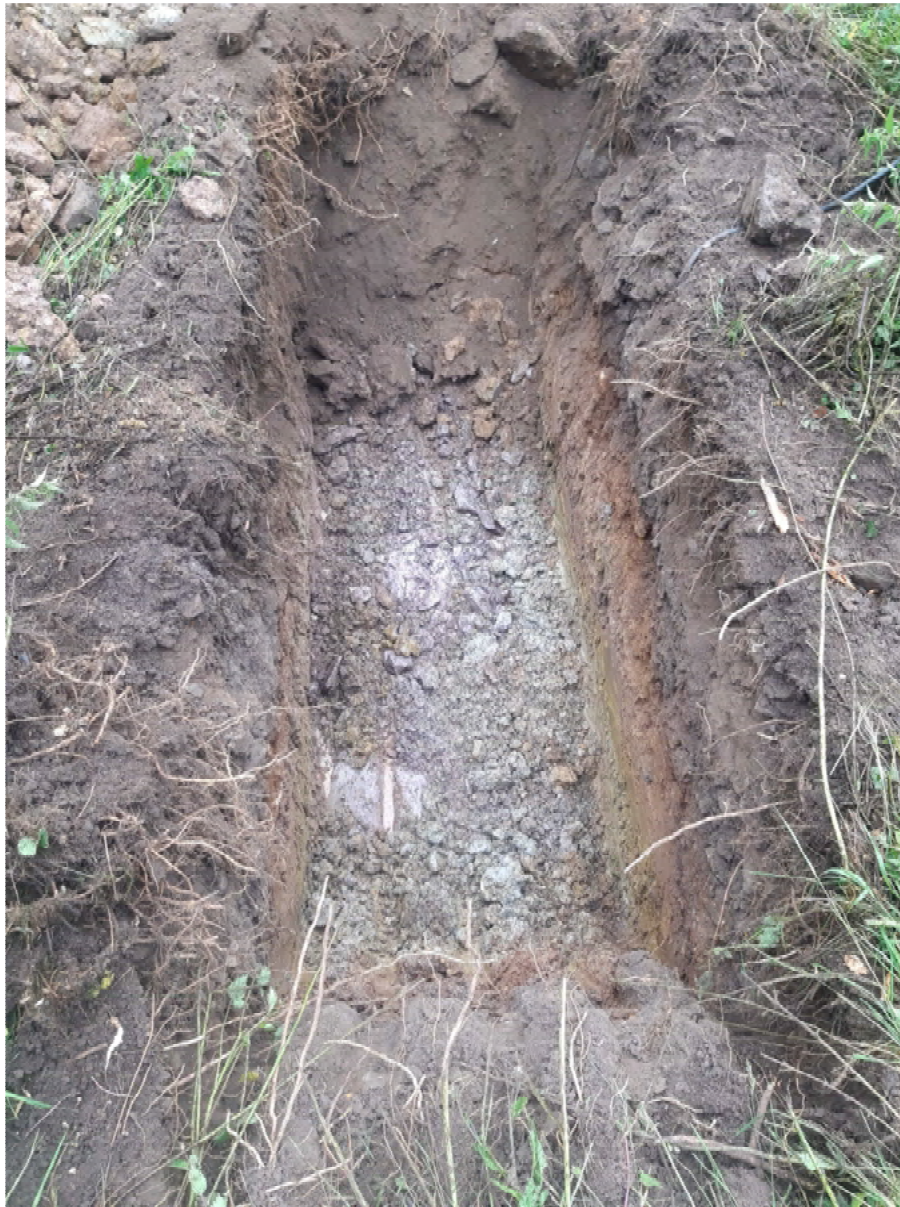
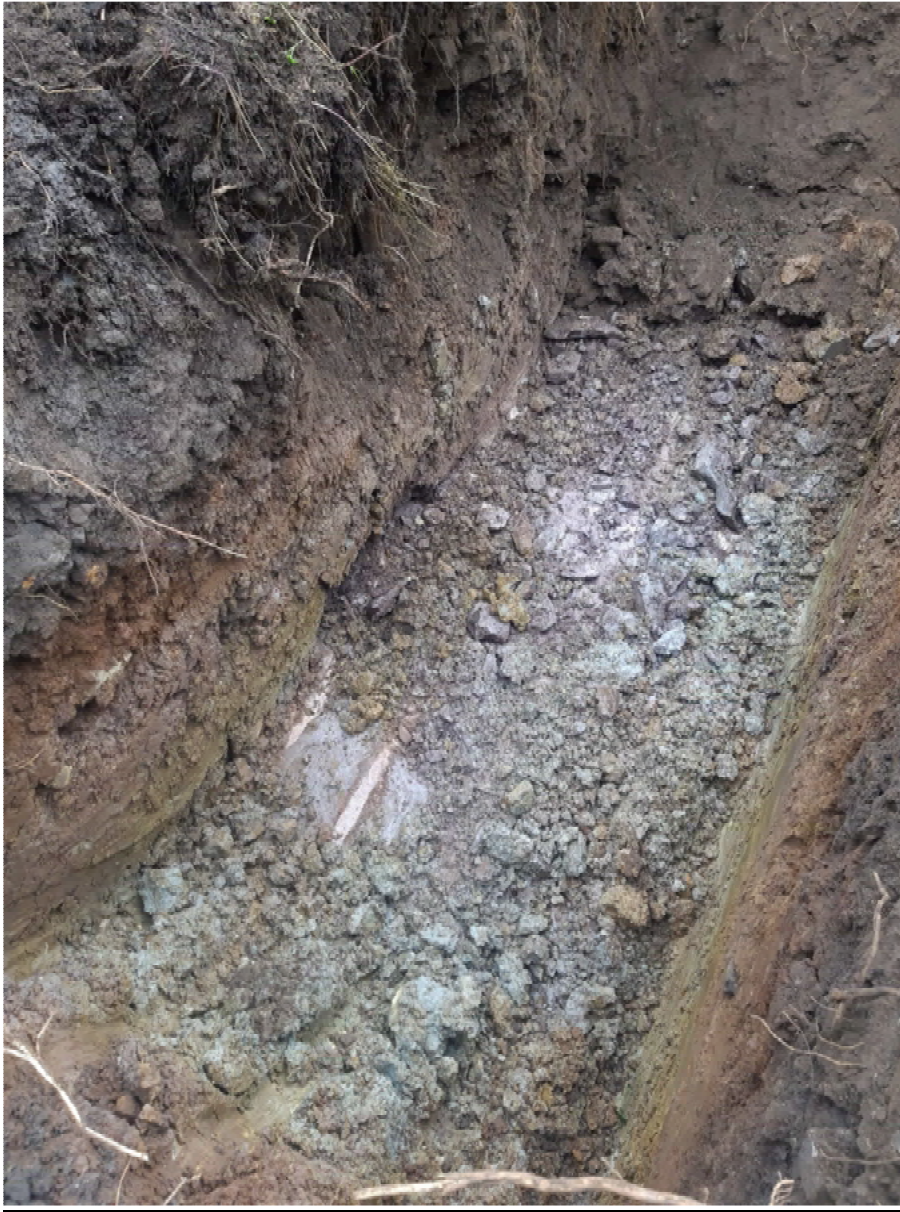
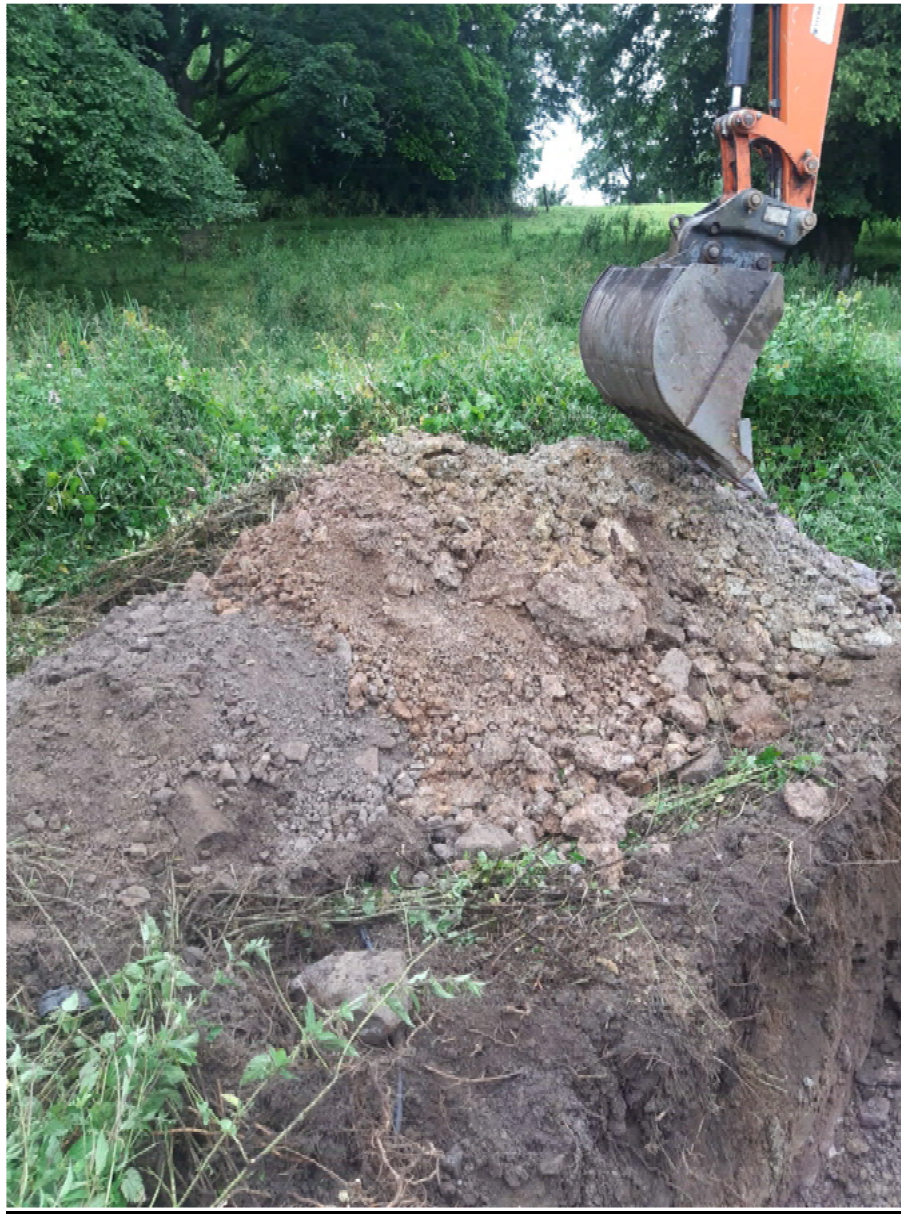
TP01

Geotechnical Description	Legend	Depth (m)	Elevation	Water Strike	Samples			Vane Test (KPa)	Hand Penetrometer (KPa)
						Sample Ref	Type	Depth		
0.0	TOPSOIL									
	MADE GROUND firm brown sandy gravelly CLAY with plastic and glass bottles. Gravels are sub angular to sub rounded and fine to coarse.		0.20	55.50						
	Firm to stiff grey sandy gravelly CLAY with medium cobble content and low boulder content. Gravels cobbles and boulders are angular to sub angular and fine to coarse.		0.40	55.30						
			0.70	55.00		AA155654	B	0.50-0.50		
1.0	Firm to stiff multicoloured green purple and yellow slightly sandy silty gravelly CLAY. Gravels are angular to sub rounded and fine to coarse. Pit terminated - refusal on weathered yellow and red sandstone bedrock.									
			1.50	54.20		AA155655	B	1.30-1.30		
	End of Trial Pit at 1.50m									
2.0										
3.0										
4.0

Dry

Stable

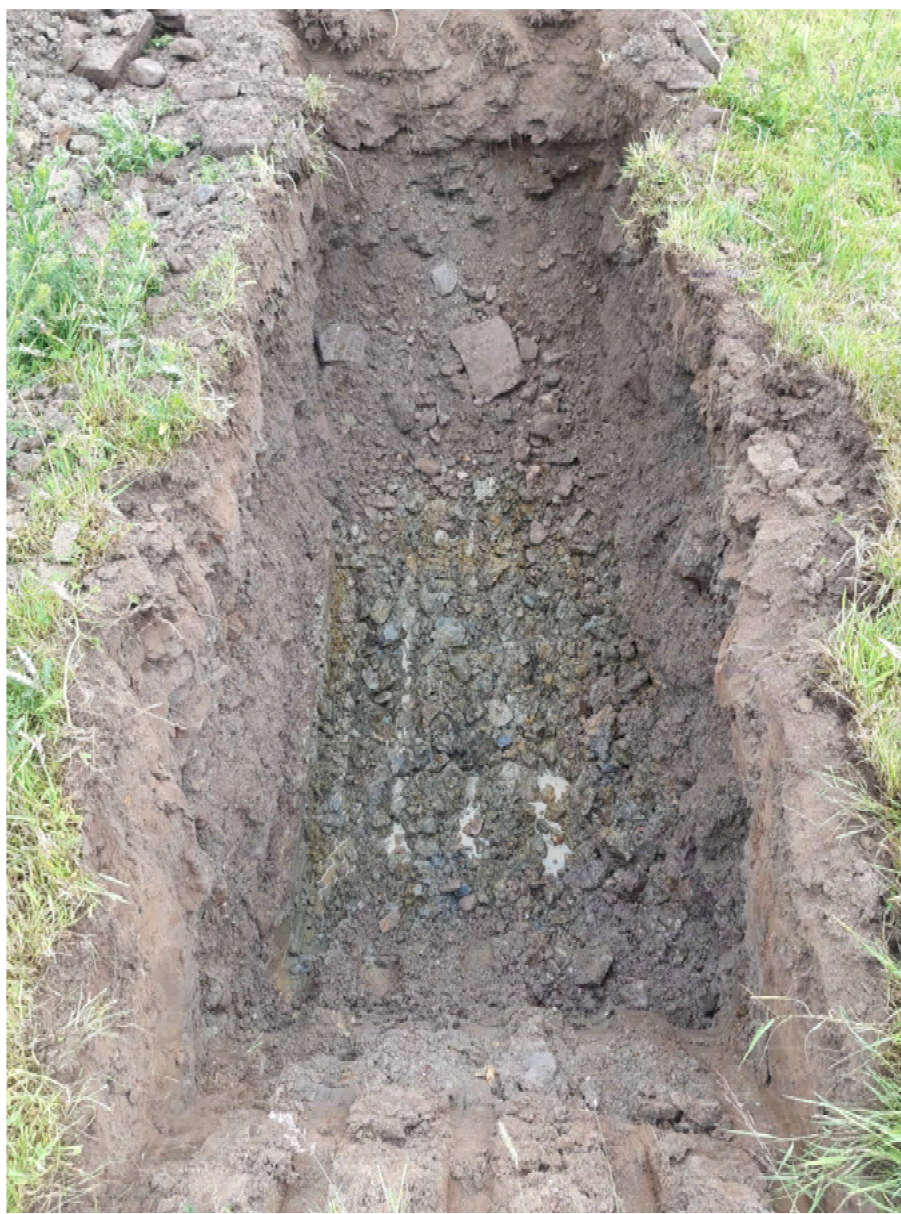
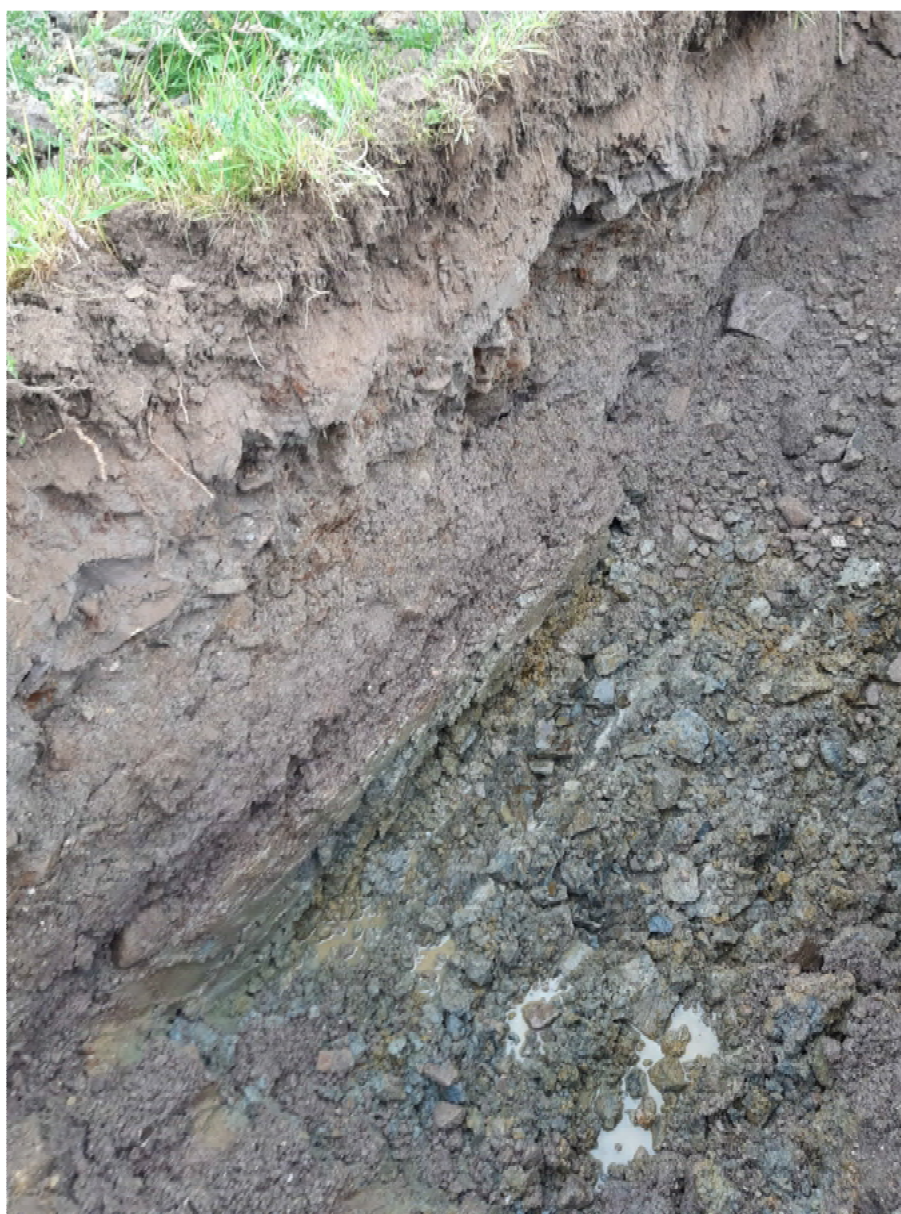
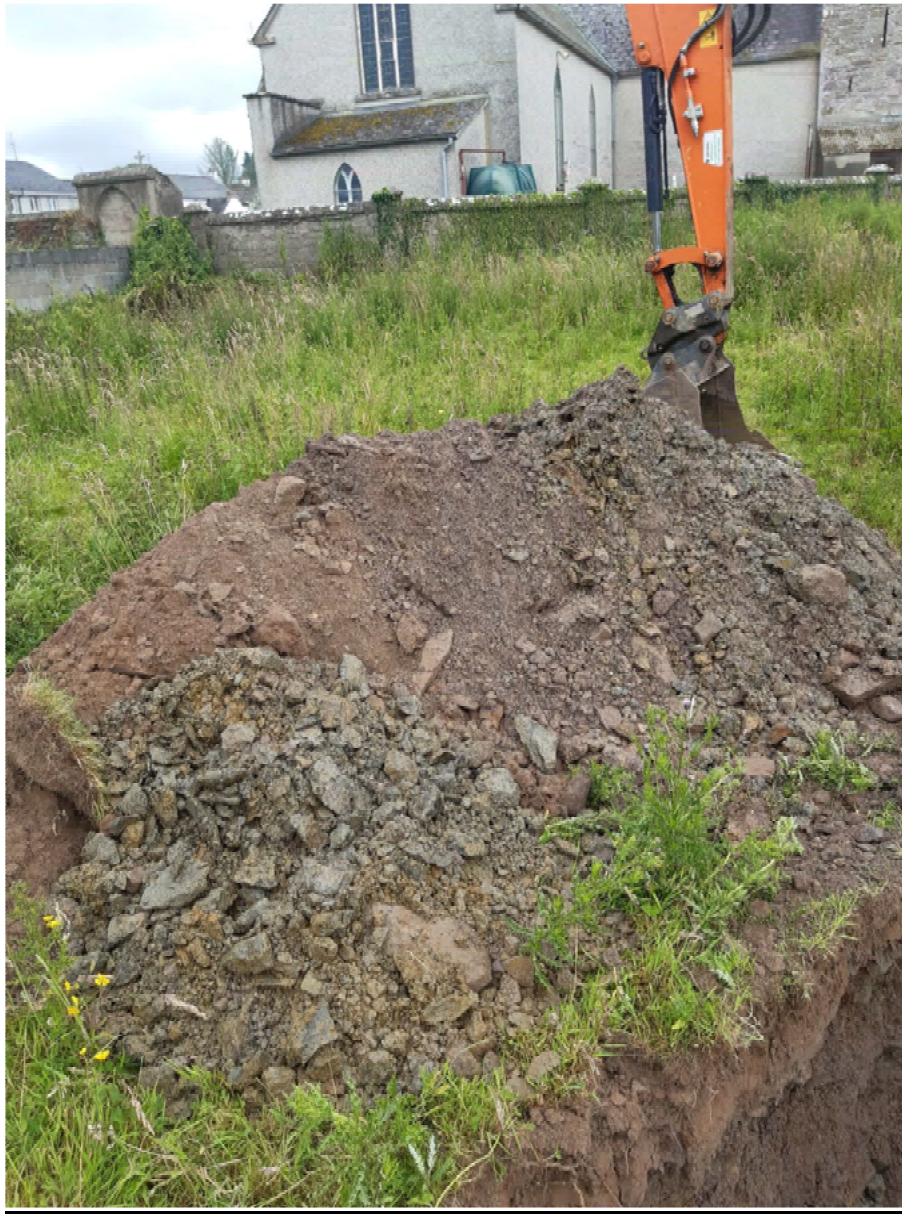
TP02

Firm grey sandy gravelly CLAY. Gravels are angular to sub angular and fine to coarse.

0.20	53.75						
	Medium dense purpleish grey mottled brown very gravelly SAND with medium cobble content and low boulder content. Gravels cobbles and boulders are angular to sub rounded and fine to coarse.

AA155656	B	0.50-0.50		
1.0	Firm greenish grey mottled yellow slightly sandy very gravelly CLAY. Gravels are sub angular to sub rounded and fine to coarse. Pit terminated - refusal on weathered yellow and red sandstone bedrock.

Groundwater Conditions Seepage 1.3m	
Stability Stable	
General Remarks CAT scanned location for services

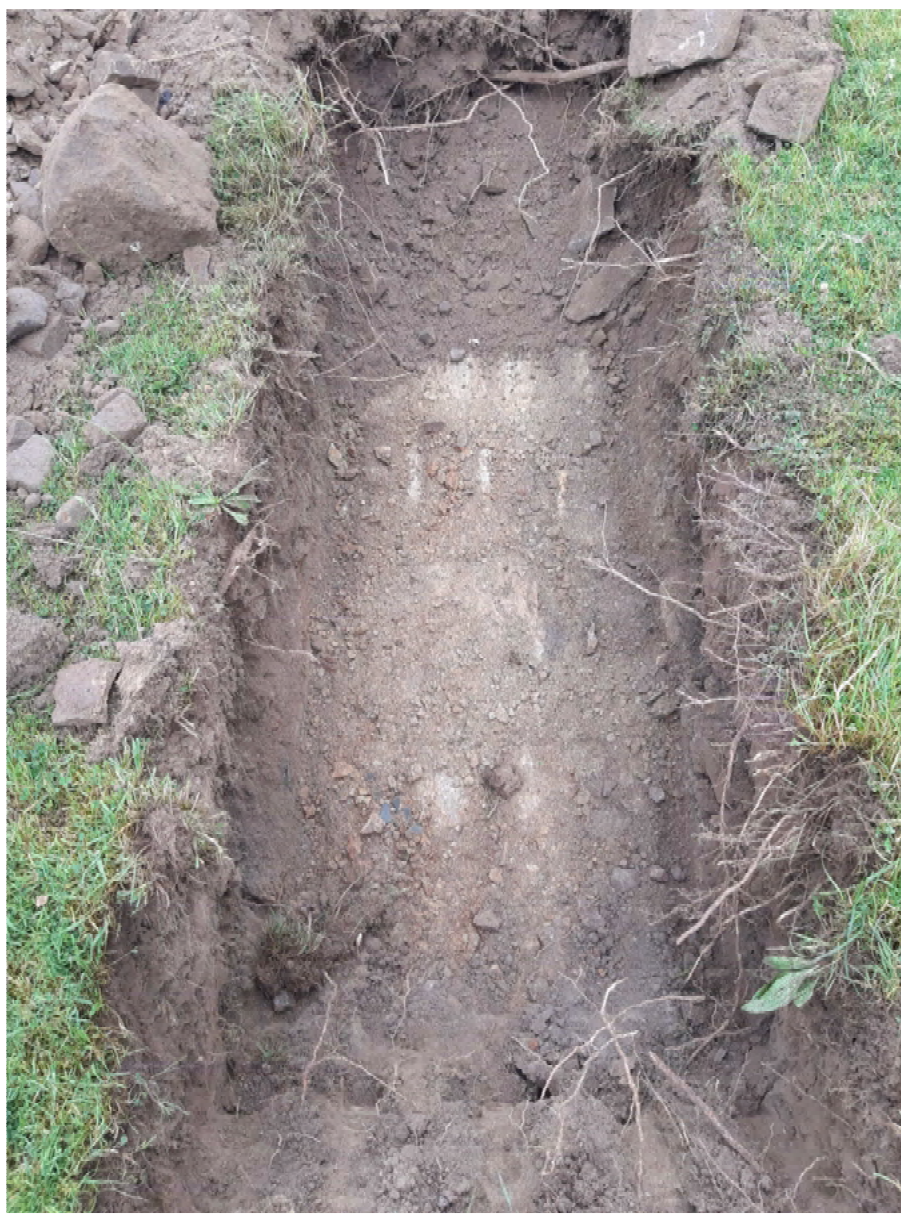
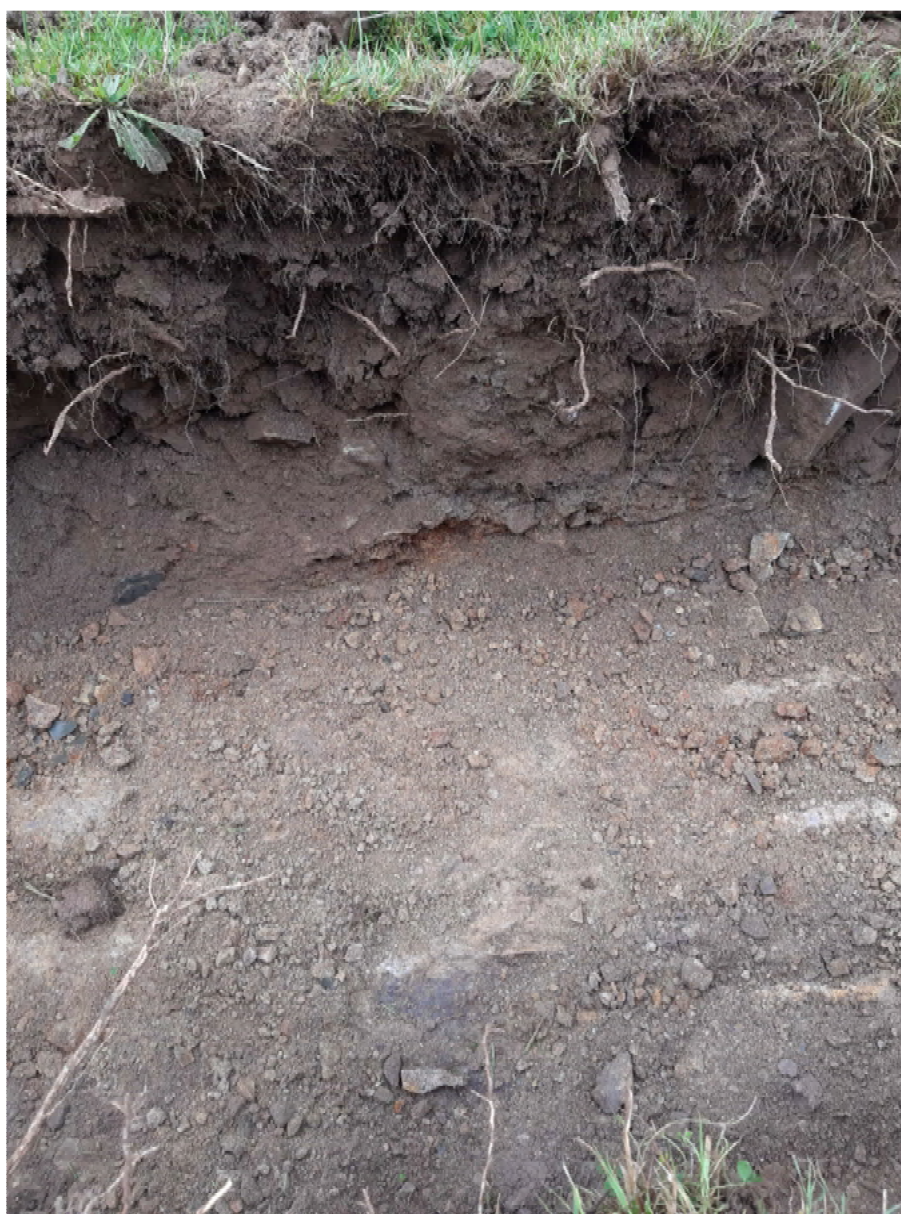
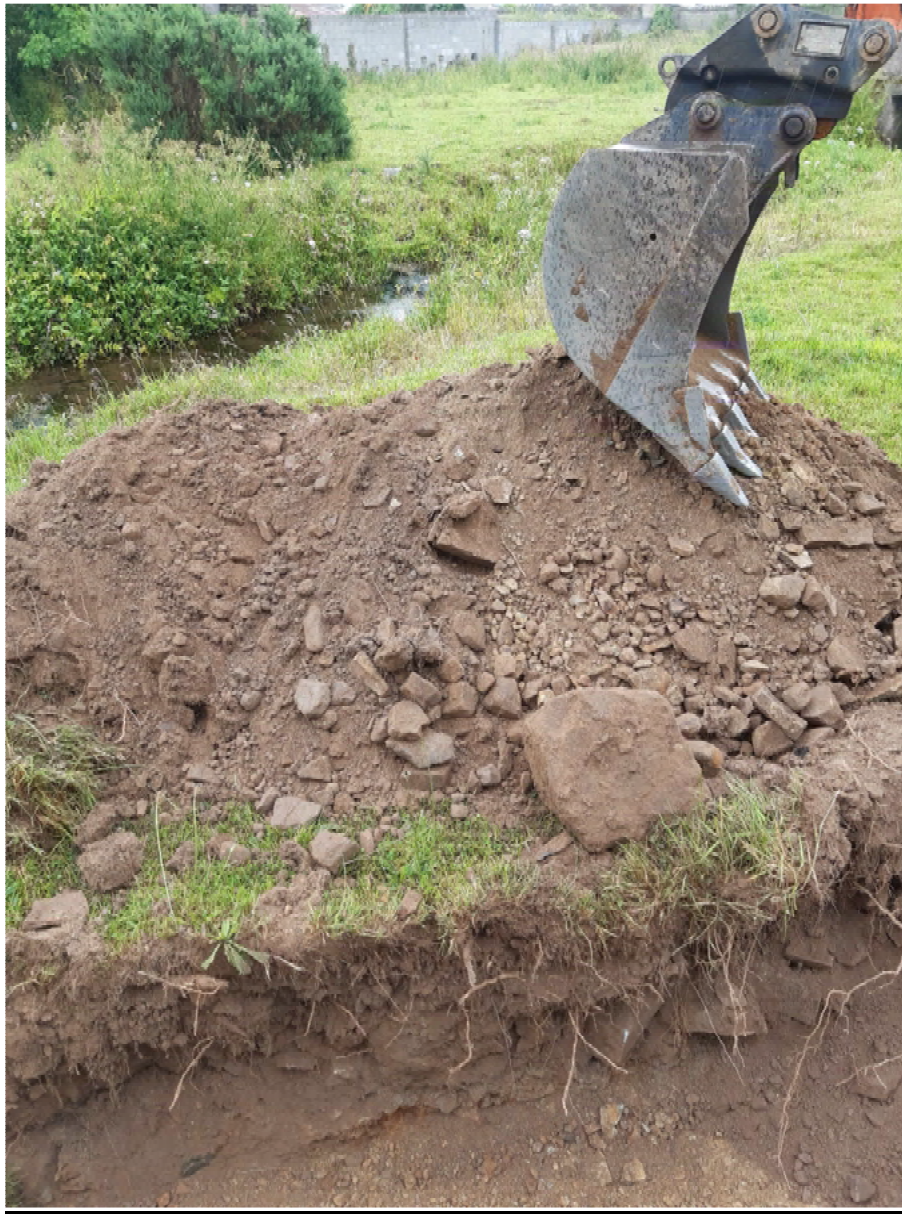
TP03

Geotechnical Description	Legend	Depth (m)	Elevation	Water Strike	Samples			Vane Test (KPa)	Hand Penetrometer (KPa)
						Sample Ref	Type	Depth		
0.0	TOPSOIL									
	Firm brown slightly sandy gravelly CLAY with medium cobble content. Gravels and cobbles are angular to sub rounded and fine to coarse.		0.20	53.66						
	Yellowish brown firm sandy gravelly CLAY with medium cobble content and low boulder content. Gravels cobbles and boulders are angular to sub rounded and fine to coarse. Pit terminated - refusal on weathered yellow and red sandstone bedrock.		0.40	53.46						
1.0	End of Trial Pit at 1.00m		1.00	52.86		AA155658	B	0.70-0.70		
2.0										
3.0										
4.0

Dry

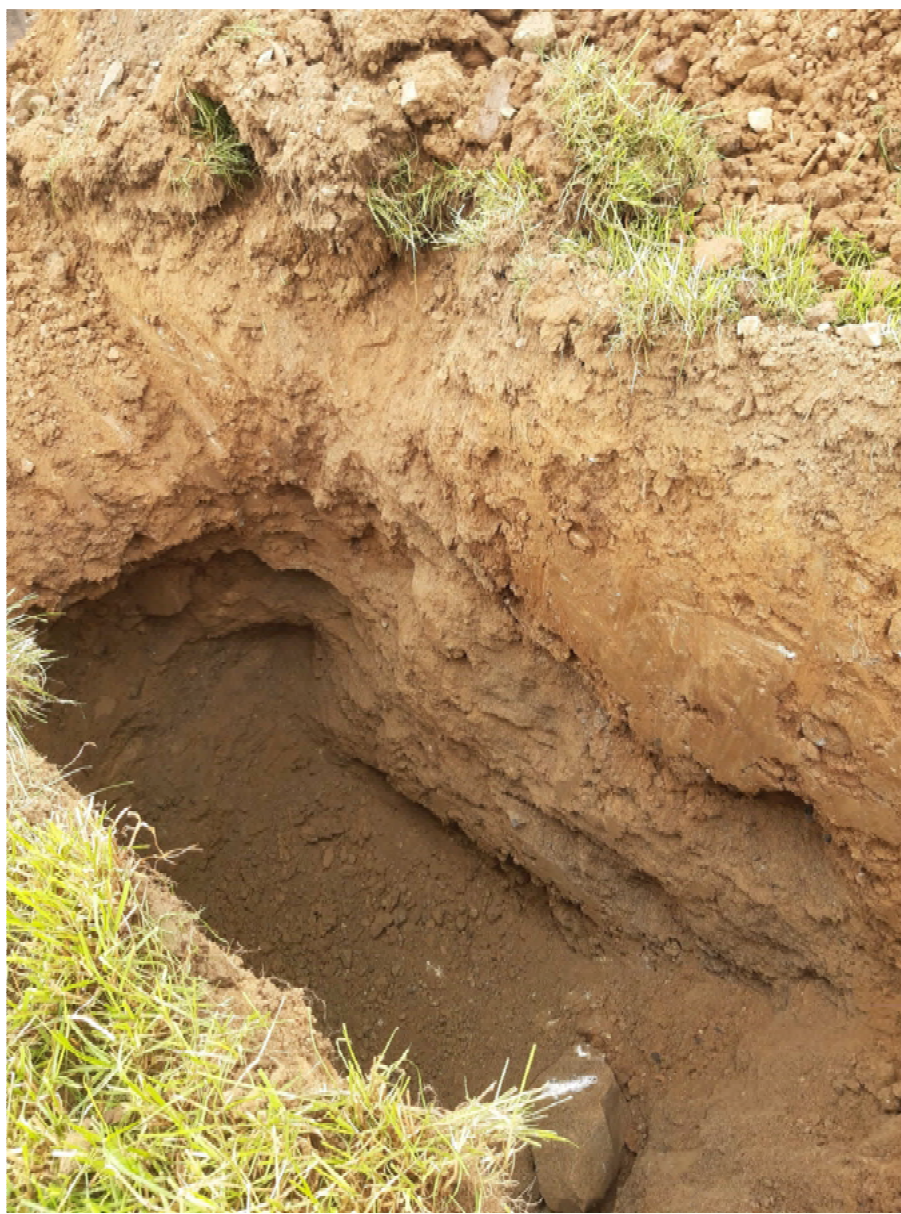
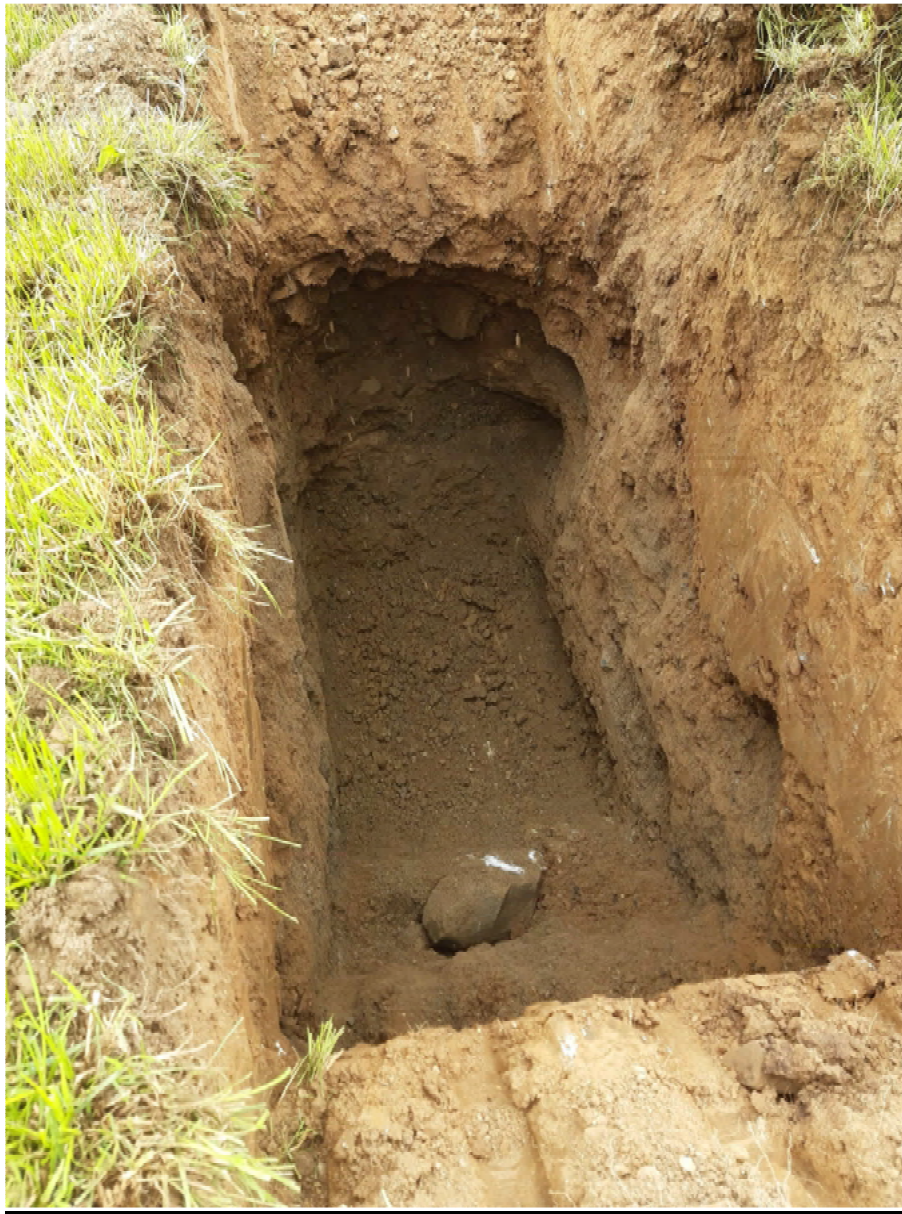
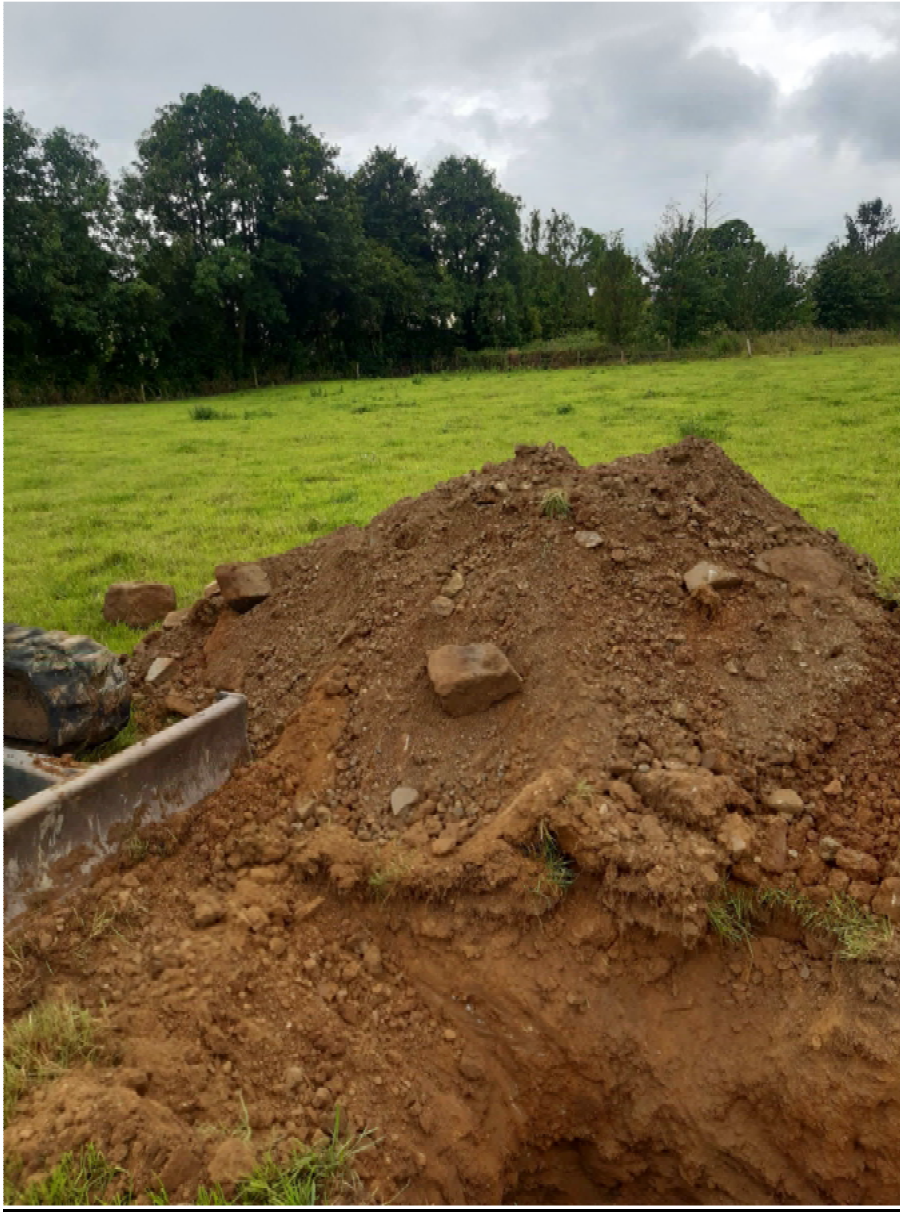
TP04

Firm light brown sandy silty gravelly CLAY. Gravels are angular to sub rounded and fine to coarse.

0.25	59.01						
	Firm to stiff light brown sandy silty gravelly CLAY with medium cobble content and medium boulder content. Gravels cobbles and boulders are angular to sub rounded and fine to coarse.

AA155659	B	0.60-0.60		
	Medium dense brownish grey clayey very gravelly SAND with medium cobble content and medium boulder content. Gravels cobbles and boulders are angular to sub rounded and fine to coarse. Pit terminated - refusal on moderately weathered yellow and red sandstone bedrock.

2.80	56.46						
4.0										
Groundwater Conditions Dry										
Stability Stable										
General Remarks CAT scanned location for services

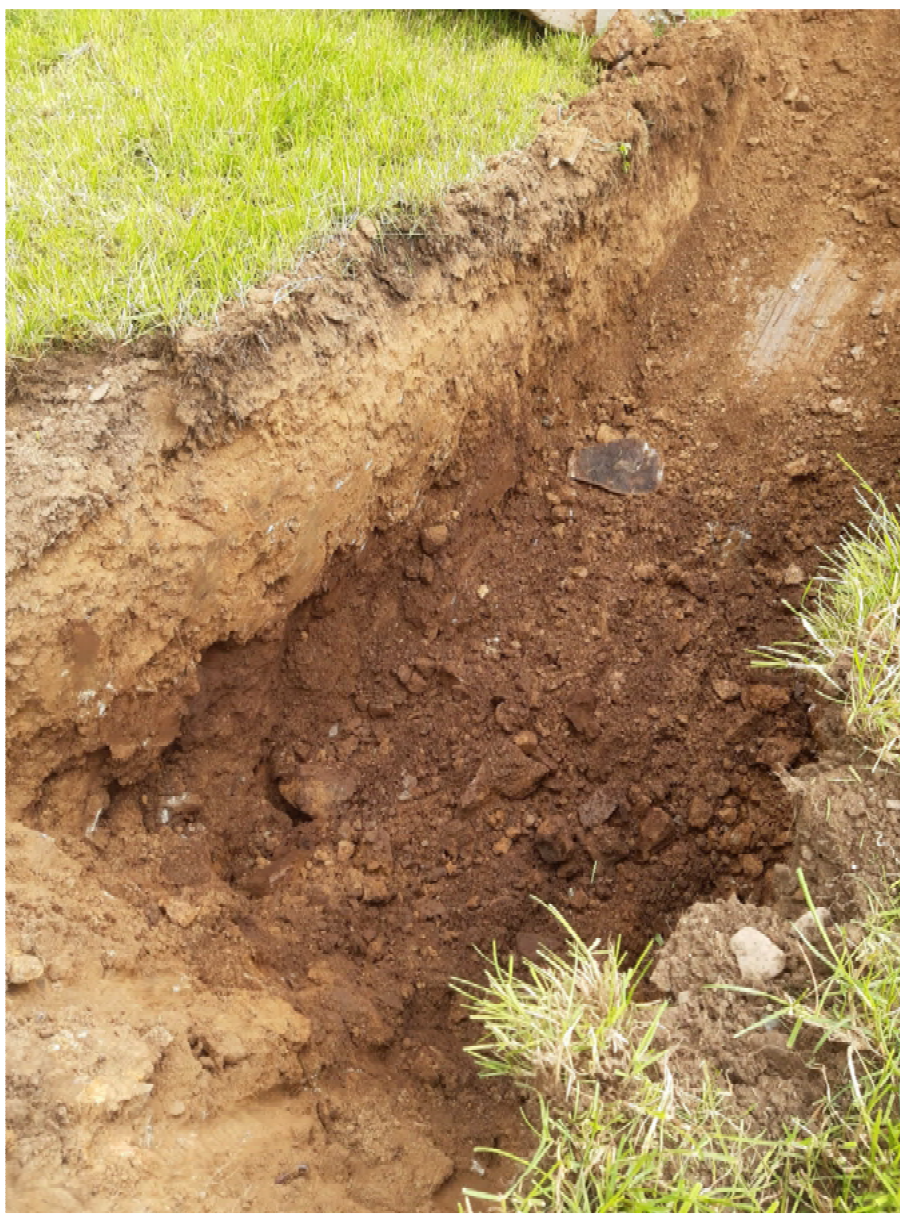
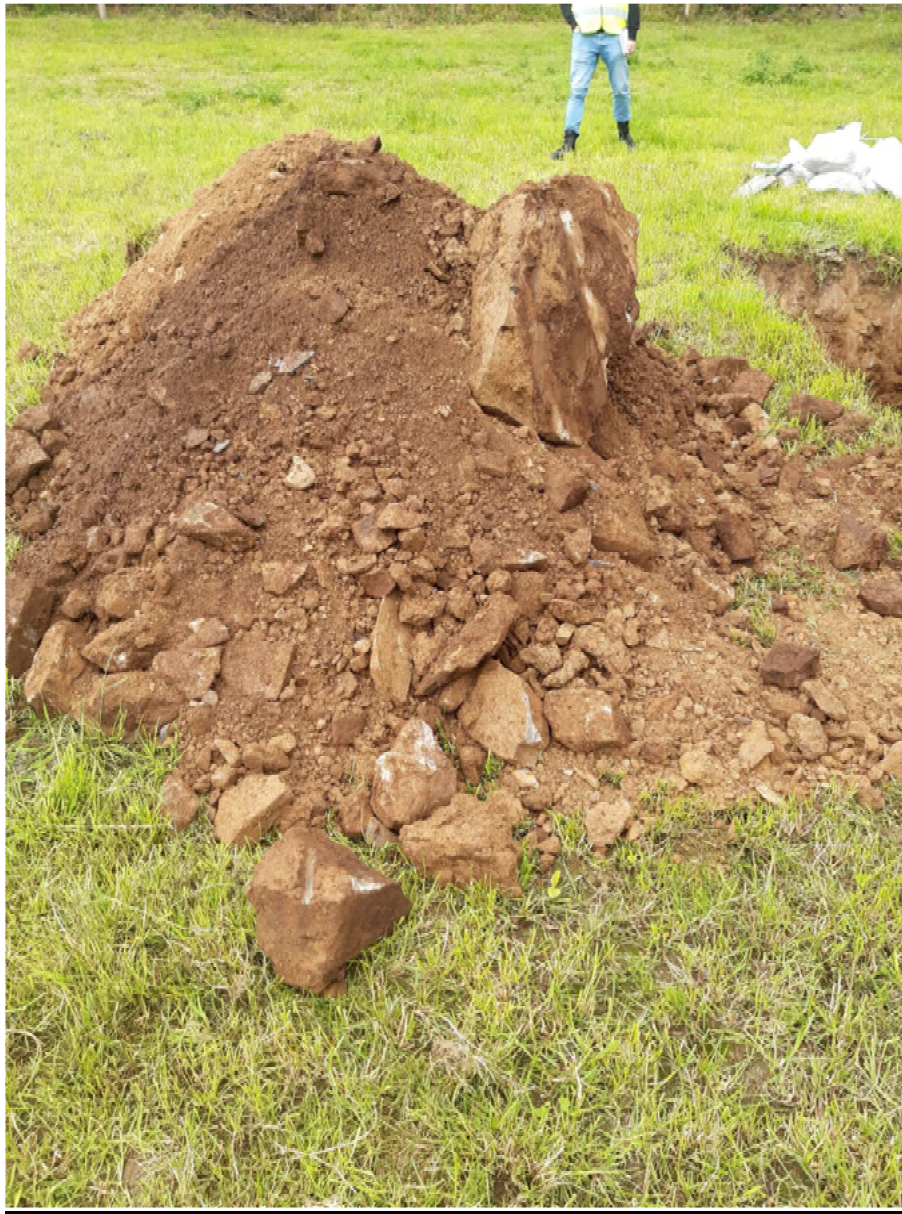
TP05

Firm brown sandy gravelly CLAY with medium cobble content. Gravels are angular to sub rounded and fine to coarse.

0.25	60.08						
	Firm to stiff yellowish brown sandy very gravelly CLAY with medium cobble content and medium boulder content. Gravels cobbles and boulders are angular to sub rounded and fine to coarse.

0.80	59.53						
1.0	Weathered rockhead recovered as angular cobbles and boulders of green and red sandstones and dark brown clay. Pit terminated at 1.1 m. End of Trial Pit at 1.10m

Groundwater Conditions Dry
Stability Stable
General Remarks CAT scanned location for services

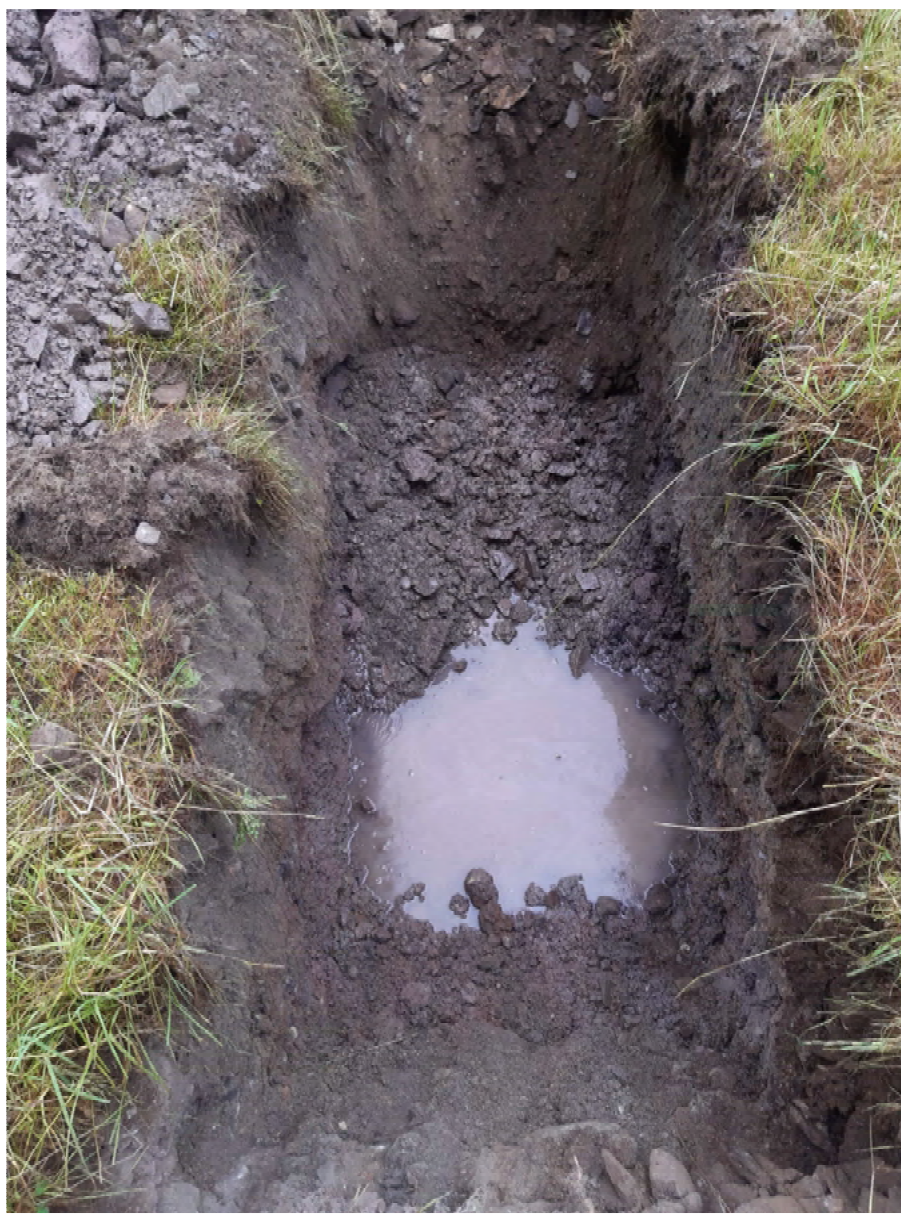
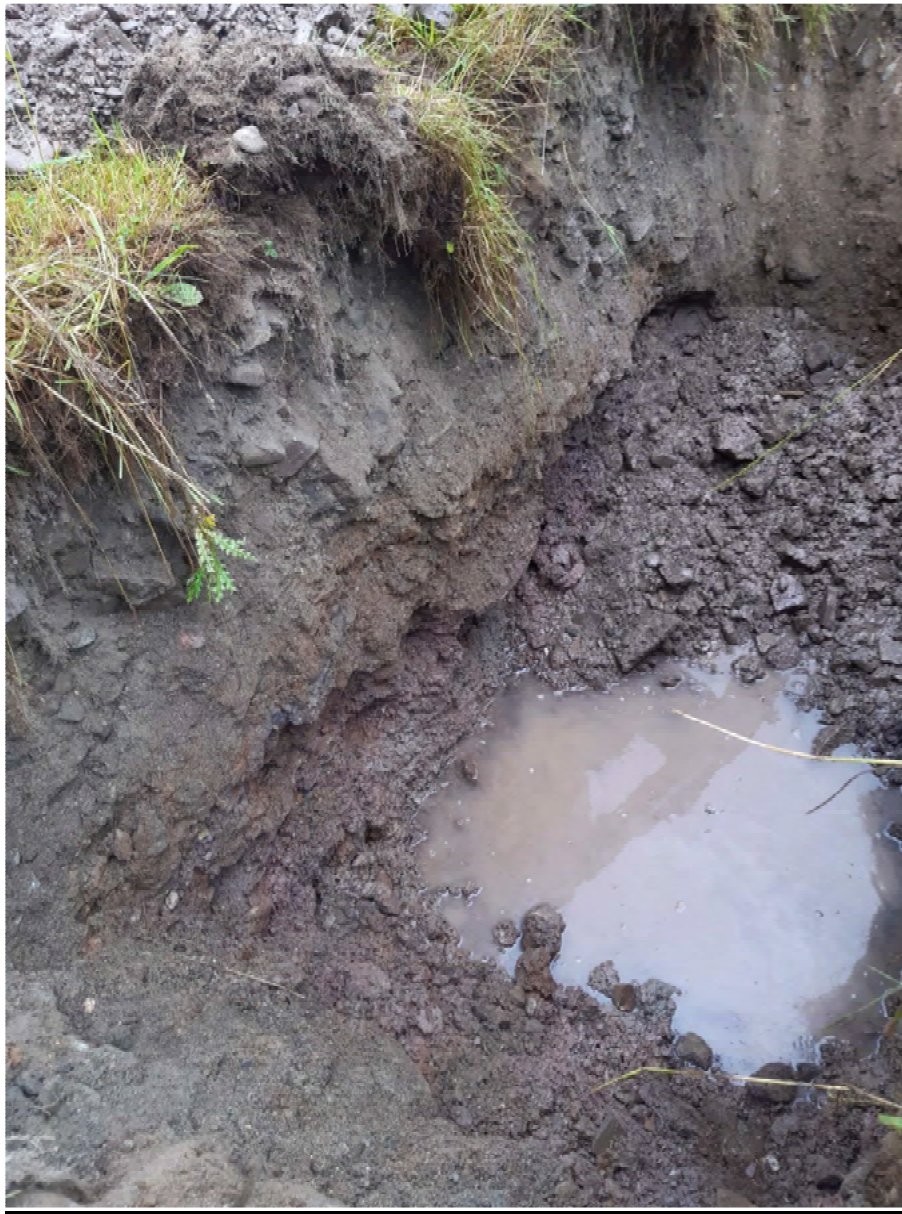
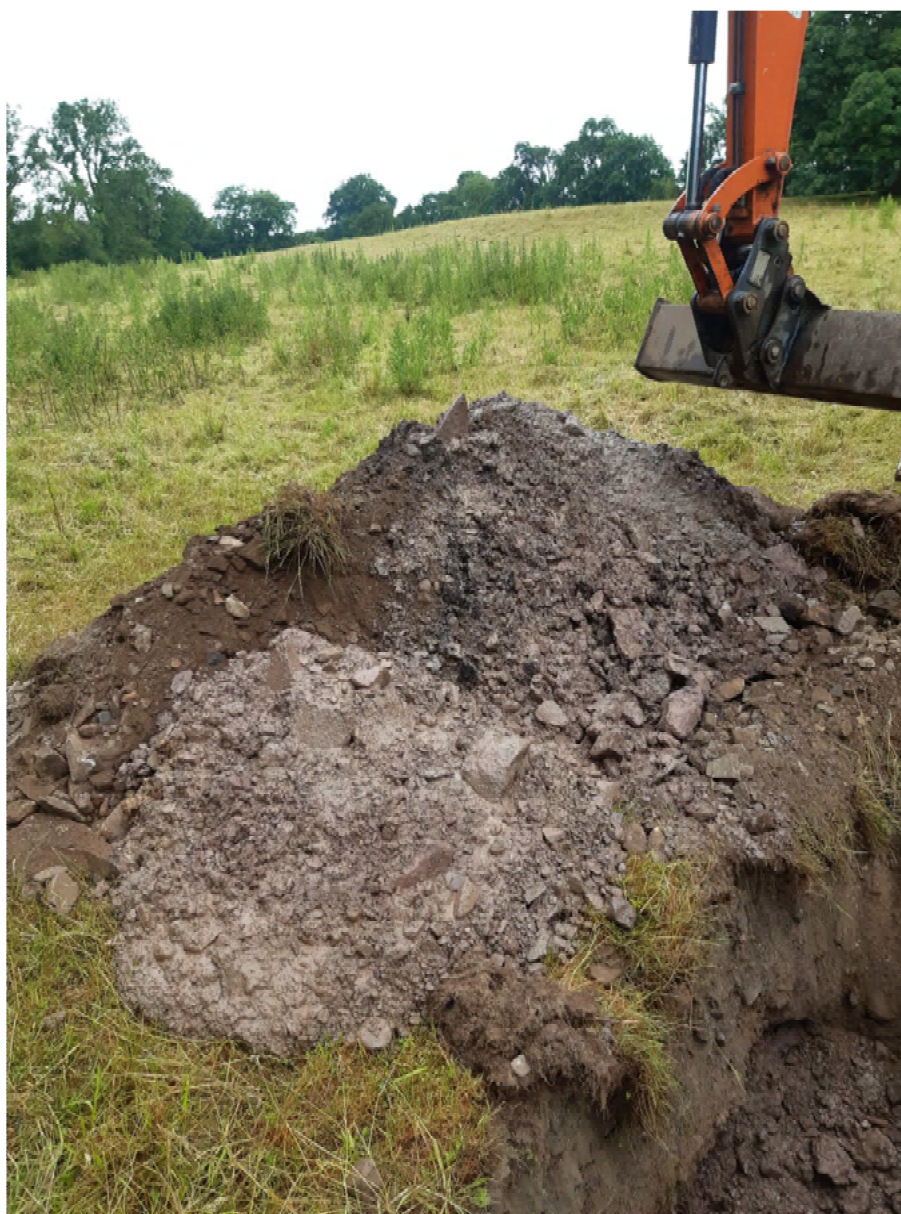
TP06

Medium dense light grey clayey very sandy GRAVEL with high cobble content and low boulder content. Gravels cobbles and boulders are angular to sub rounded and fine to coarse.

0.20	56.16						
	Medium dense greyish brown very gravelly SAND with high cobble content and low boulder content. Gravels cobbles and boulders are angular to sub rounded and fine to coarse.

1.0	Firm to stiff purplish grey slightly sandy very gravelly CLAY with medium cobble content and low boulder content. Gravels cobbles and boulders are angular to sub rounded and fine to coarse. Pit terminated at 1.4 m to wet to continue excavating or sample.

Groundwater Conditions Fast flow at 1.4m	
Stability Stable	
General Remarks CAT scanned location for services

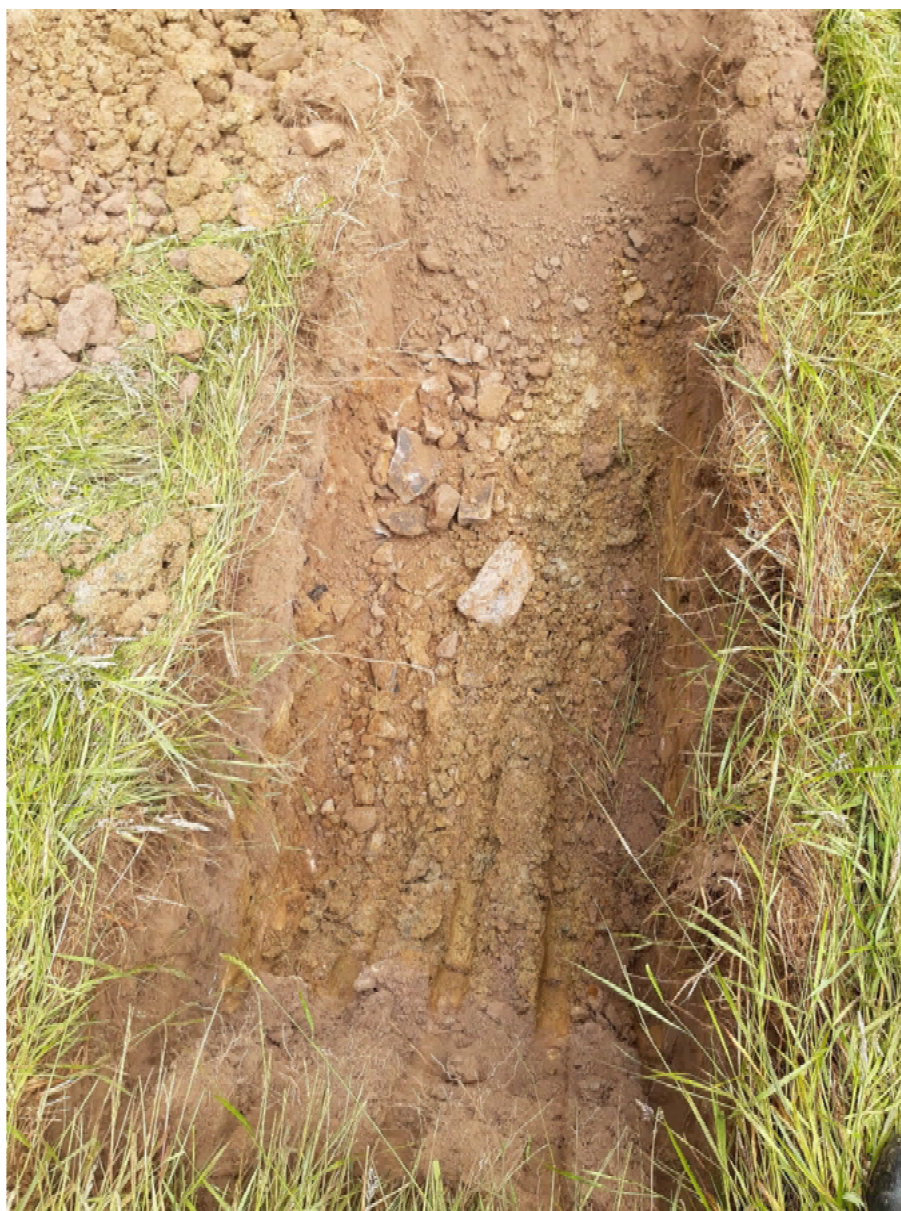
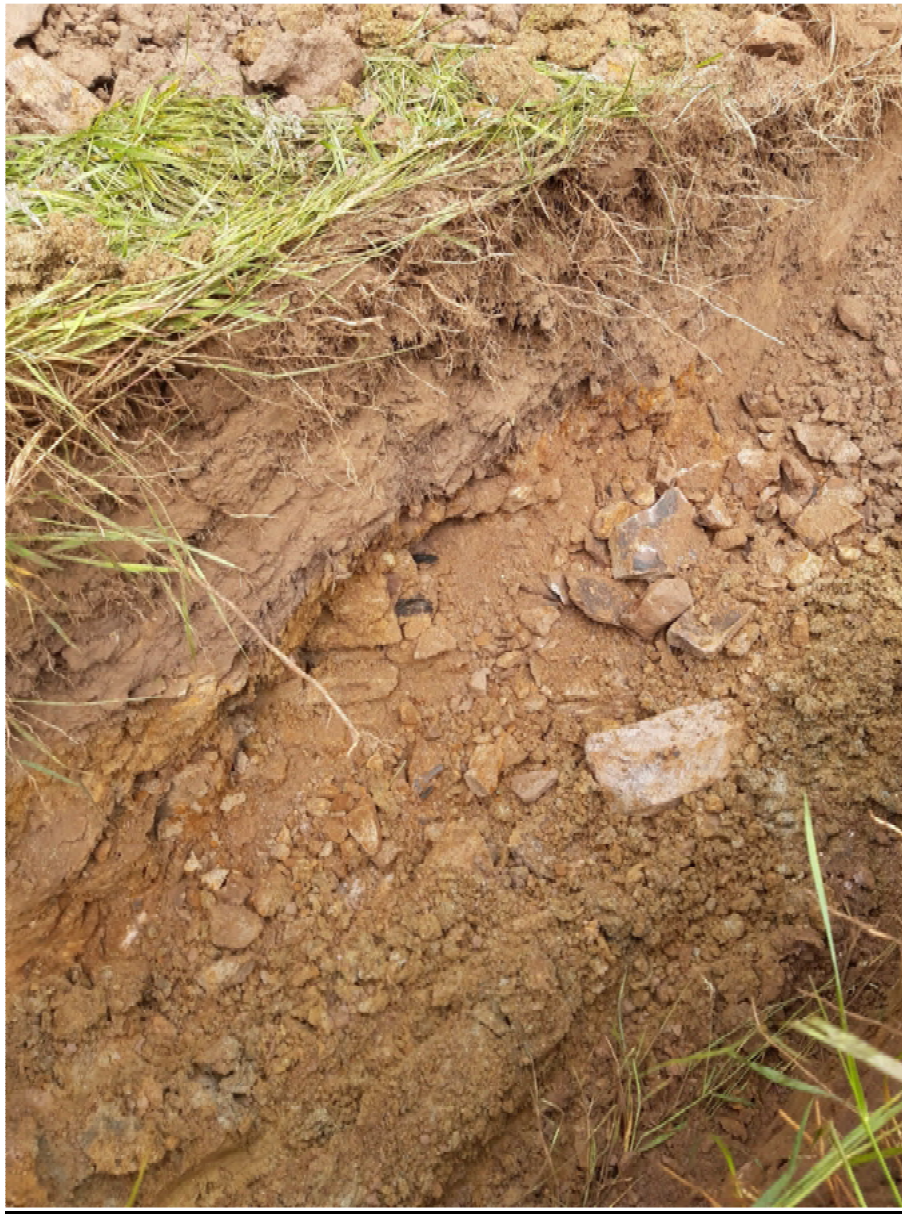
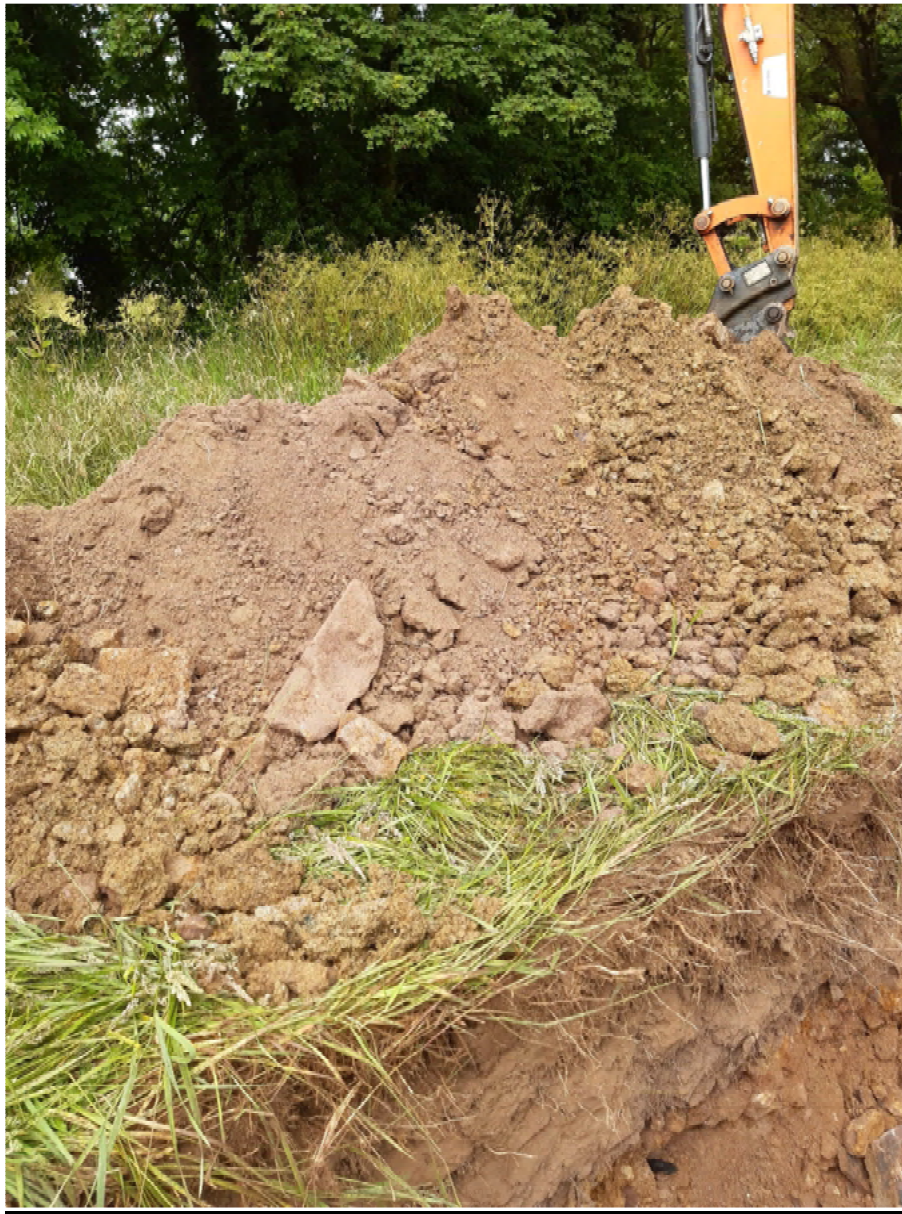
TP07

Firm greyish brown sandy gravelly CLAY. Gravels are sub angular to sub rounded and fine to coarse.

0.20	56.14						
	Stiff yellowish brown slightly sandy gravelly CLAY with high cobble content and low boulder content. Gravels cobbles and boulders are angular to sub rounded and fine to coarse. Pit terminated - refusal on weathered yellow and red sandstone bedrock.

1.0	End of Trial Pit at 1.00m		1.00	55.34						
2.0										
3.0										
4.0										
Groundwater Conditions Dry										
Stability Stable										
General Remarks CAT scanned location for services
