Ballyhale Flood Relief Scheme

**Factual Ground Investigation
Report**

Project No. 23434

REPORT ON A SITE INVESTIGATION
FOR A FLOOD RELIEF SCHEME
AT BALLYHALE
COUNTY KILKENNY
FOR
KILKENNY COUNTY COUNCIL
AND
DBFL
CONSULTING ENGINEERS

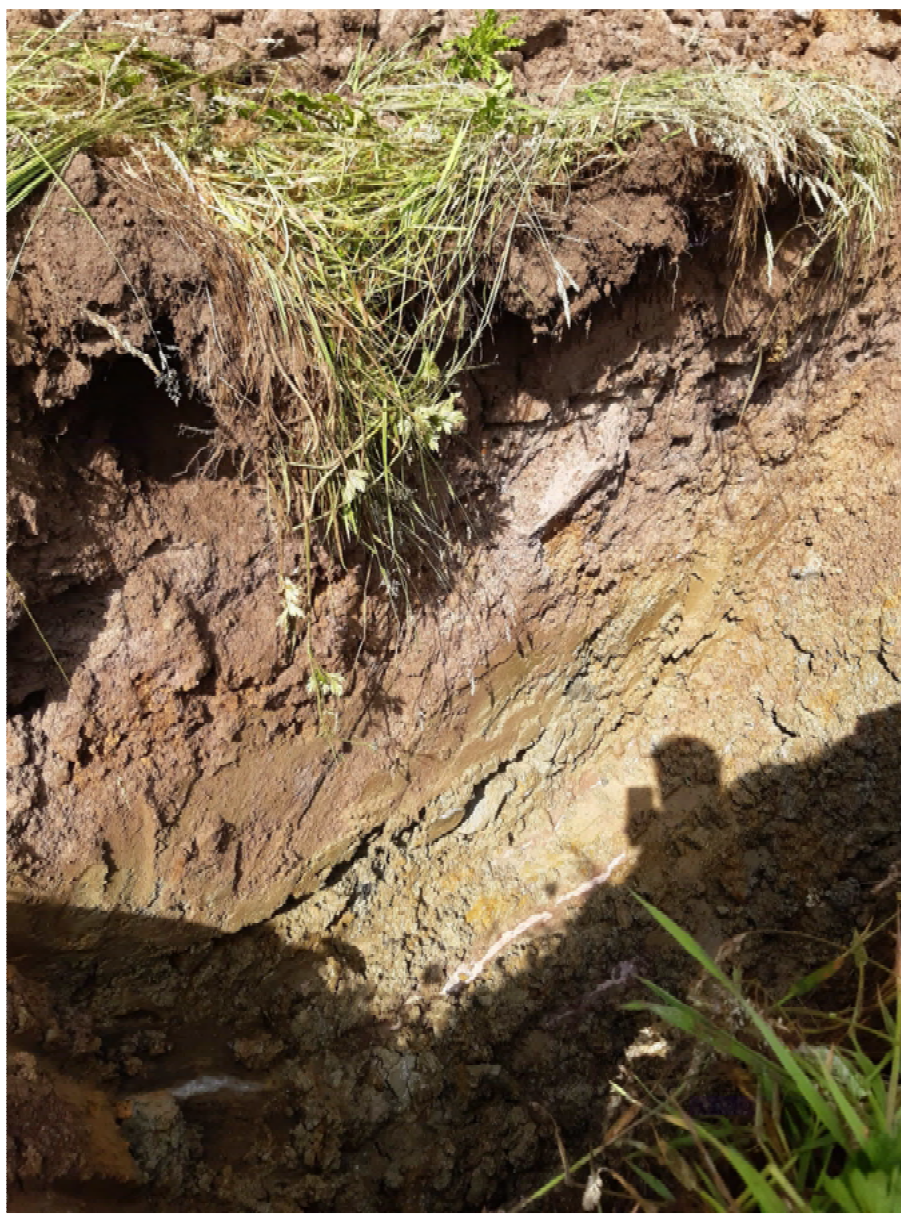
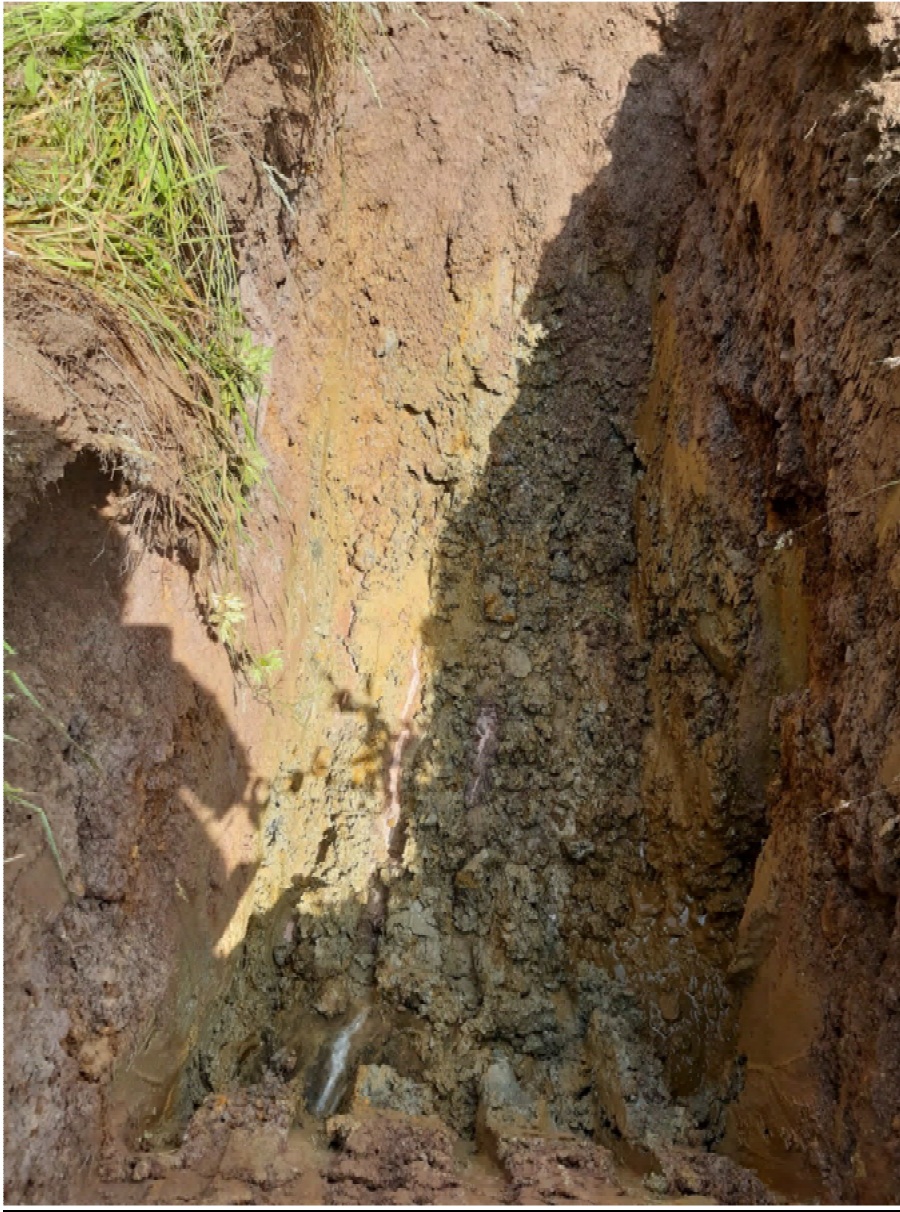
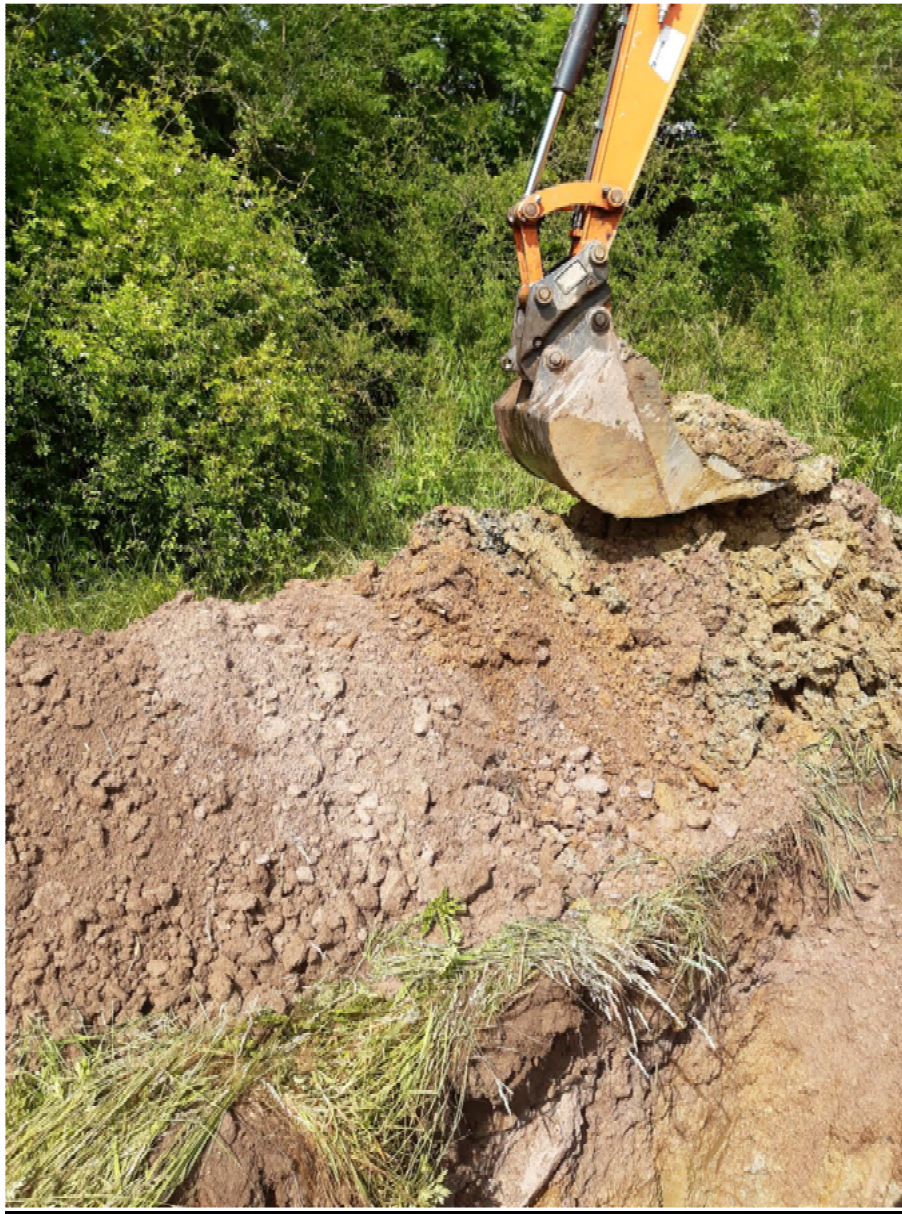
TP08

Firm greyish brown sandy CLAY.

0.20	56.50						
	Medium dense purpleish grey clayey gravelly SAND with medium cobble content and low boulder content. Gravels cobbles and boulders are angular to sub rounded and fine to coarse.

0.70	56.00		AA155665	B	0.50-0.50		
1.0	Firm to stiff pale green mottled yellow slightly sandy slightly gravelly silty CLAY with low cobble content and low boulder content. Gravels cobbles and boulders are angular to sub rounded and fine to coarse. Pit terminated - refusal on weathered yellow and red sandstone bedrock.

Groundwater Conditions Dry										
Stability Stable										
General Remarks CAT scanned location for services

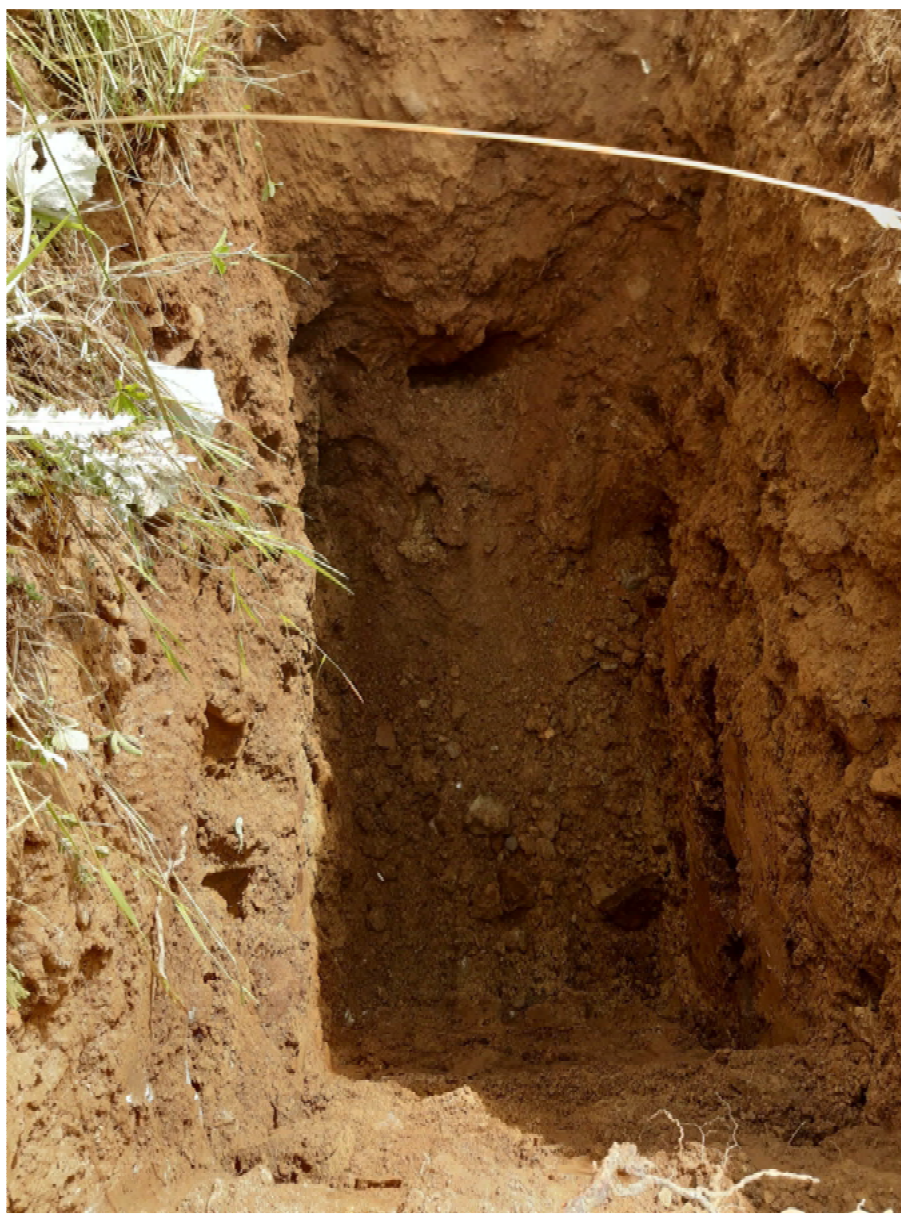
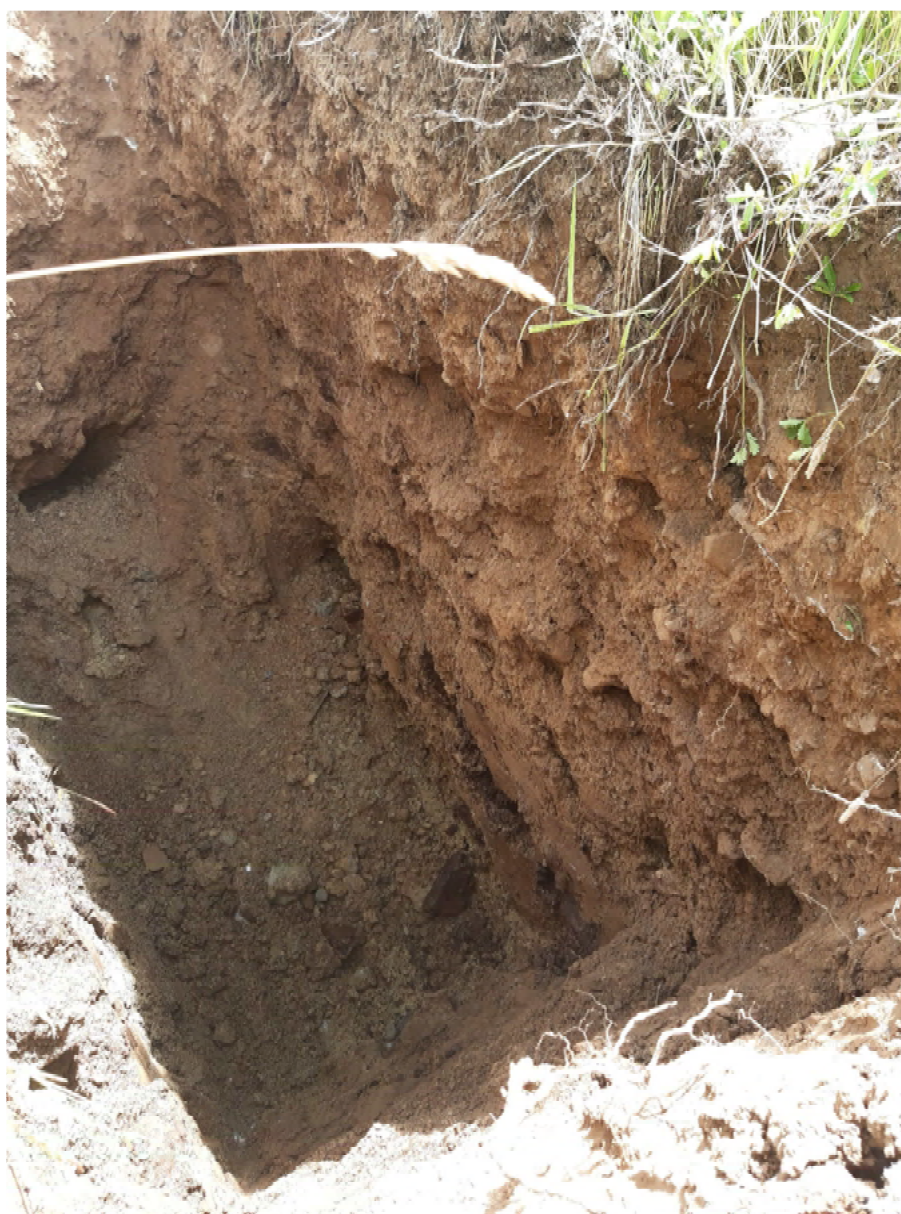
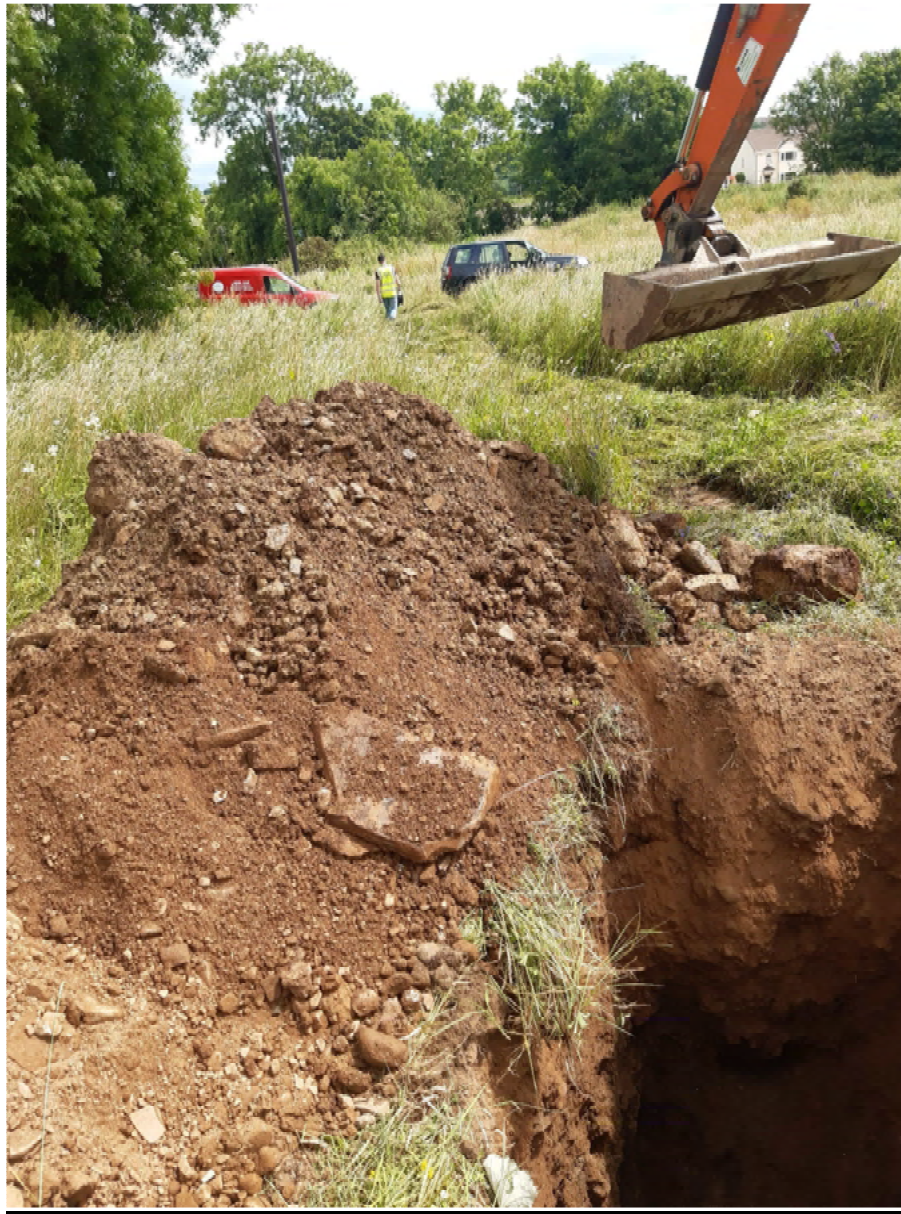
TP09

Groundwater Conditions Seepage at 2m										
Stability Stable										
General Remarks CAT scanned location for services

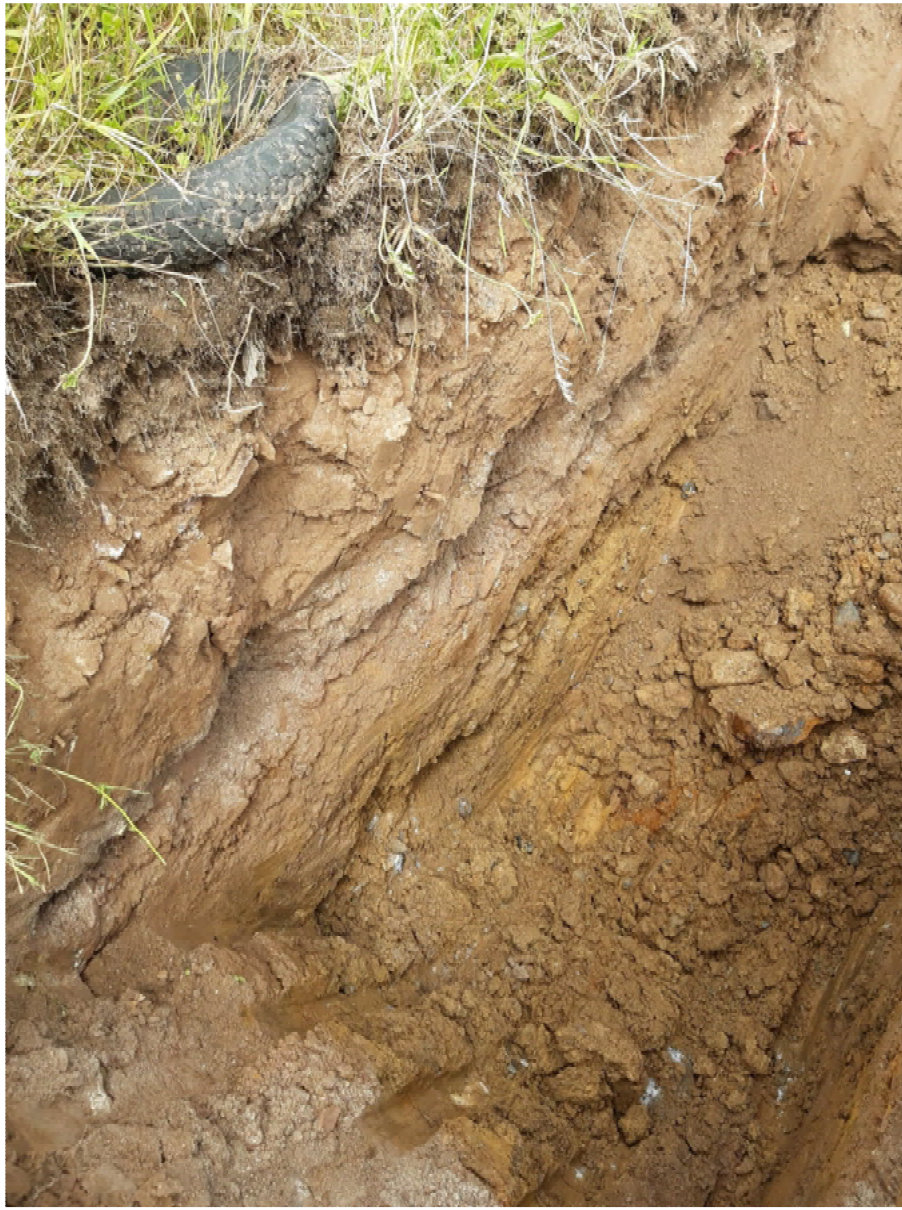
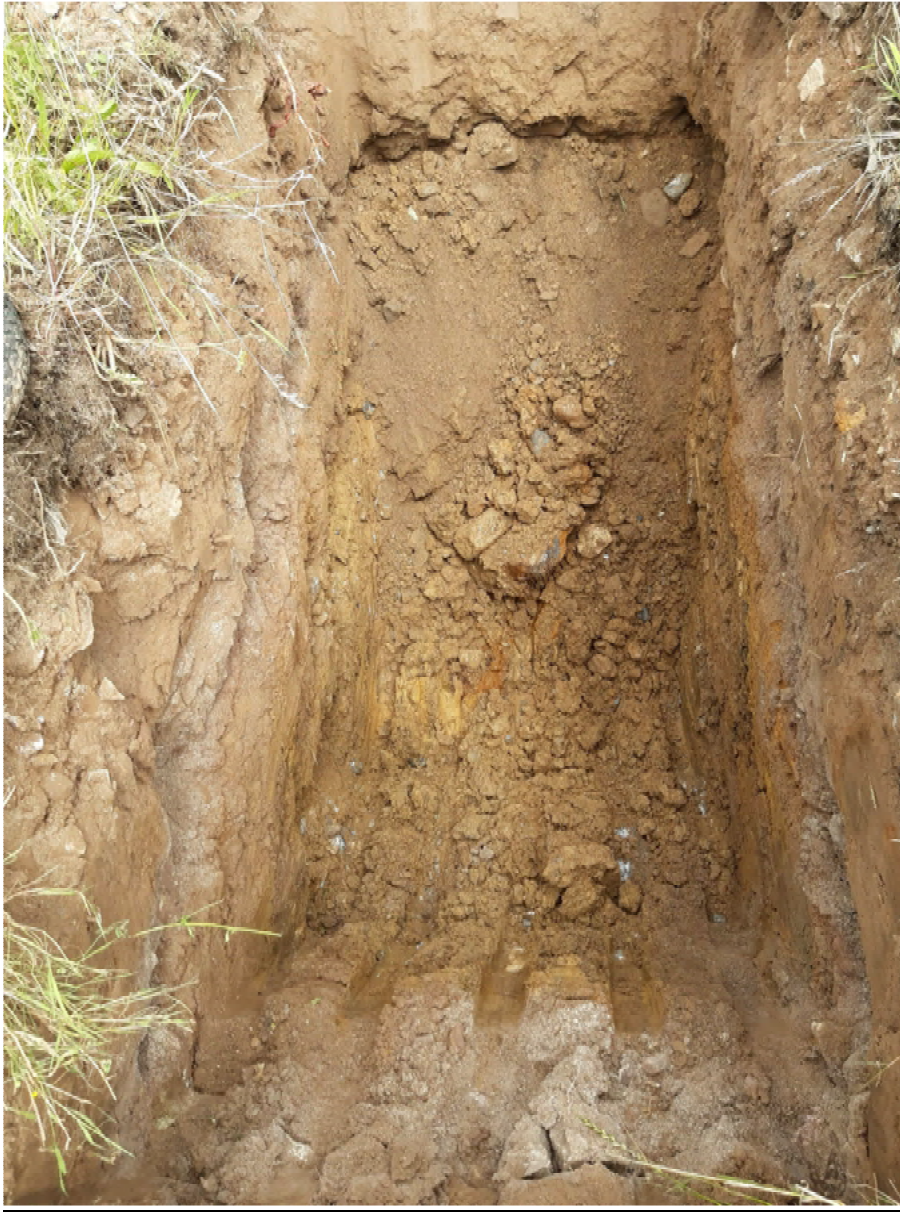
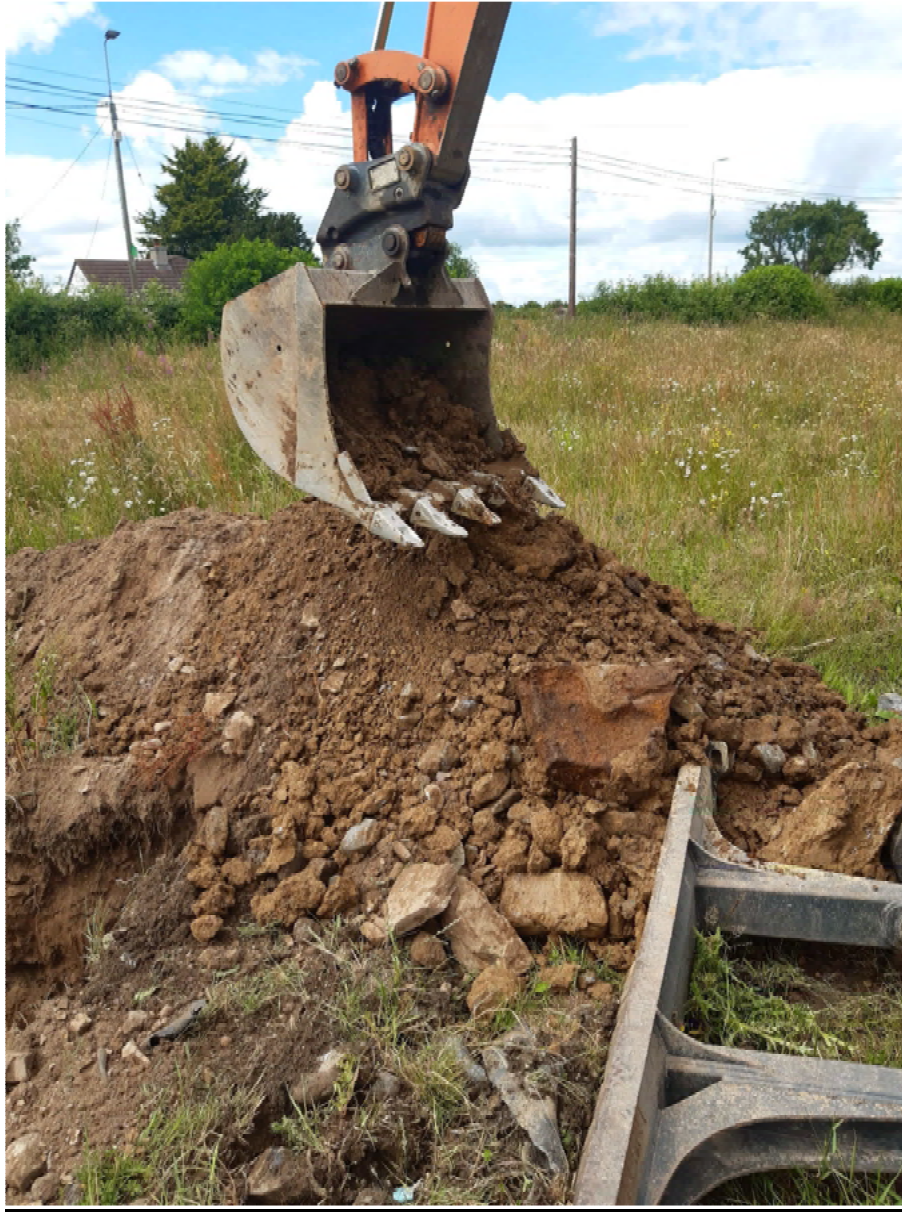
TP10

Groundwater Conditions Dry
Stability Stable
General Remarks CAT scanned location for services
